Church of All Saints, Netheravon, Wilts.

Comprising a west tower with remains of flanking and westward annexes. So wrote H.M.Taylor in vol. one of his "Anglo-Saxon Architecture" (pages 456-459). The church is built of flint rubble and to a high degree covered in a coating of once ancient plaster. However since Taylor visited the church in the mid 20th century it has, in recent years, been resurfaced. On the tower this has built up the thickness and the pre-conquest windows and the quoins are now unfortunately 'set back' from the face of the plaster and this is not how they were presented beforehand. Taylor commented *"... a coating of ancient plaster, which has been worked thin with the trowel at the edges, so to finish flush against the dressed-stone facings and quoins."* Unfortunately these skills today are not in evidence and the effect is clumsy and crude and shows a lack of understanding of how the plaster should be presented.

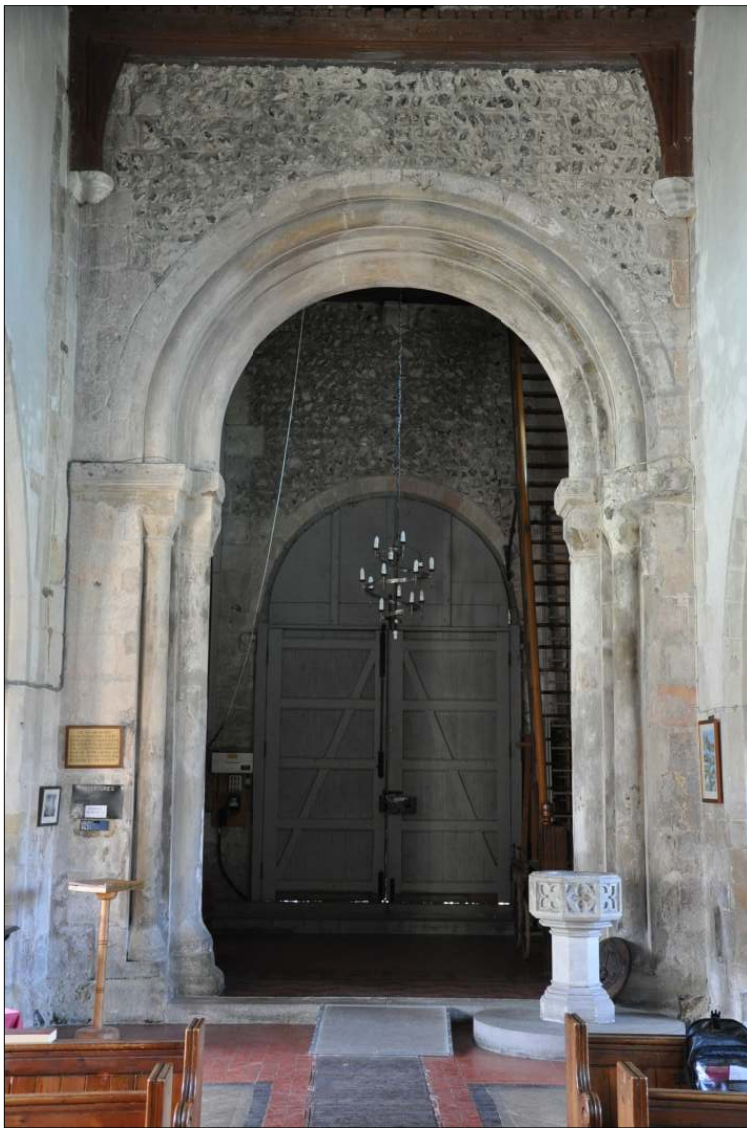
5. East face of eastern archway to the tower. This archway is different in detail, and larger, compared to its western sister (see page 2) and shows signs of heavy repair in plaster/whitewashed cement rendering. I might add here, just to throw in a query, and since there is much 'restoration' and filling to be seen on the east face of this archway, it would need either a ladder to investigate (or binoculars) but there might just be a line of fill running around the outer order. It can be seen as a darker 'line' and might it just be more tidying' to mask and fill a half-round hollow, as seen undisturbed at the chancel arch at Stoughton church (see later pages for the restoration, or interference, with the arch here in more detail).

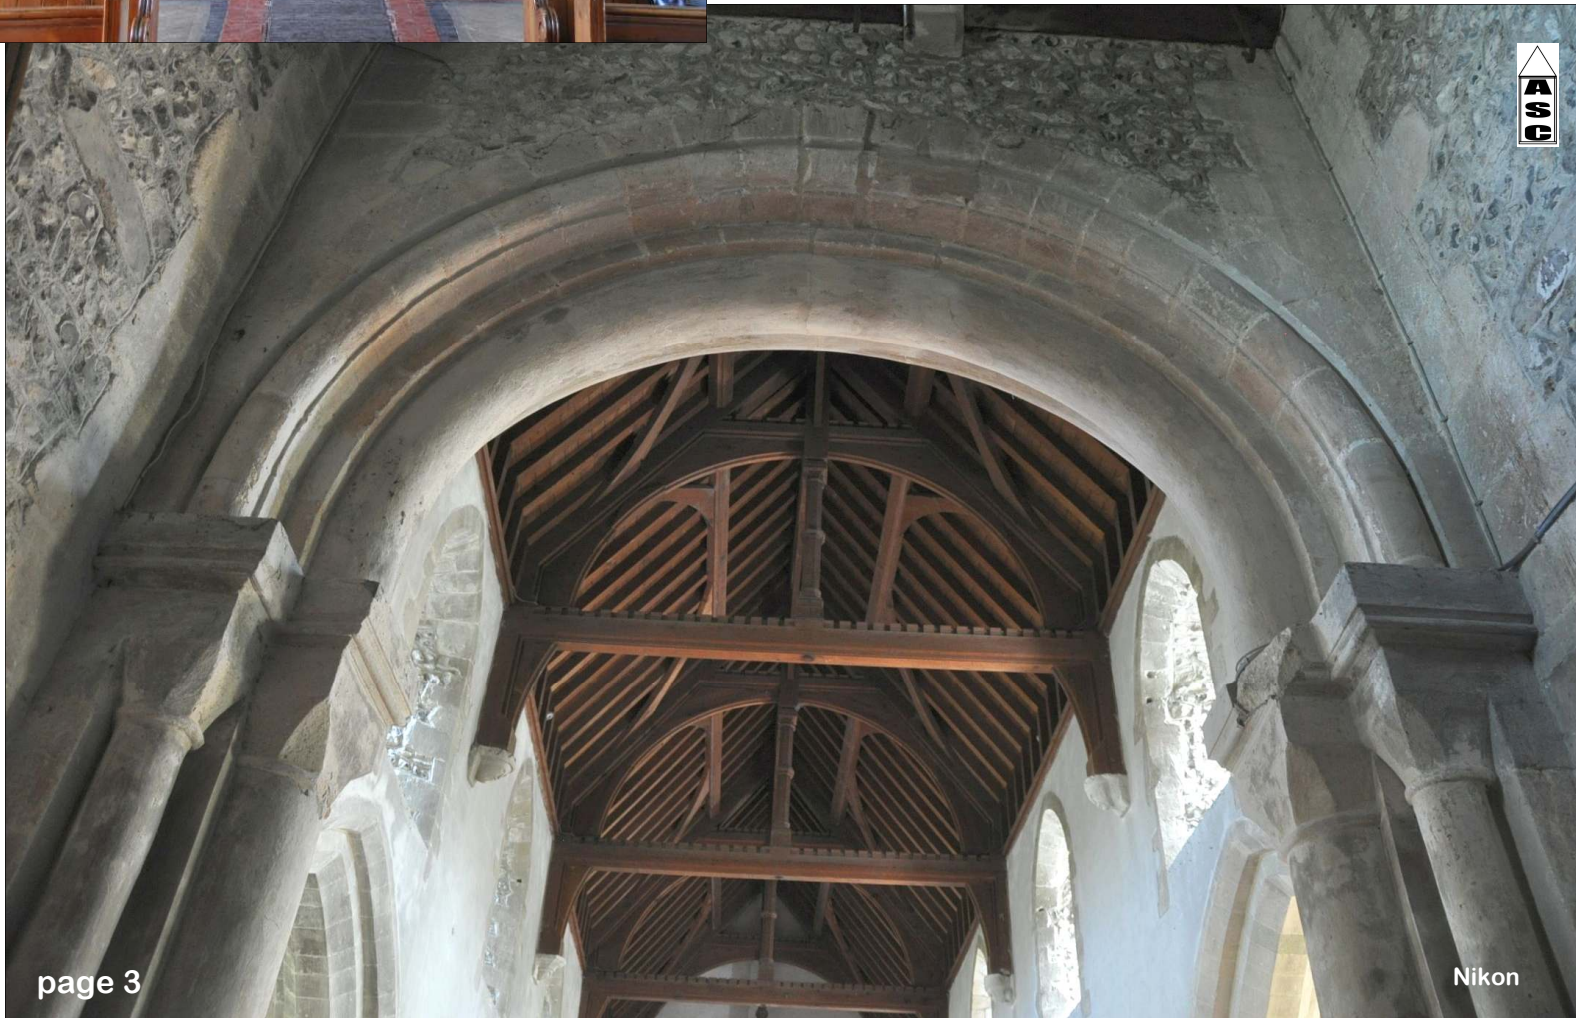
6. Viewed from under the tower its east face has suffered less from the restorers hand and the joints in the archway are evident. There are two orders, the inner having a bold soffit roll and the outer has a roll on each arris. The capitals are of cubical form and the restorers hand is evident in the form of the moulded impost. This is particularly obvious where the mouldings of the south impost are badly damaged and its opposite sister shows traces of brick under the mouldings where the cement build up has crumbled away. I will show which is post medieval and which is original Anglo-Saxon work. To this end my line drawing in picture 20 attempts to show its original form and I show in detail the post medieval work exposed.

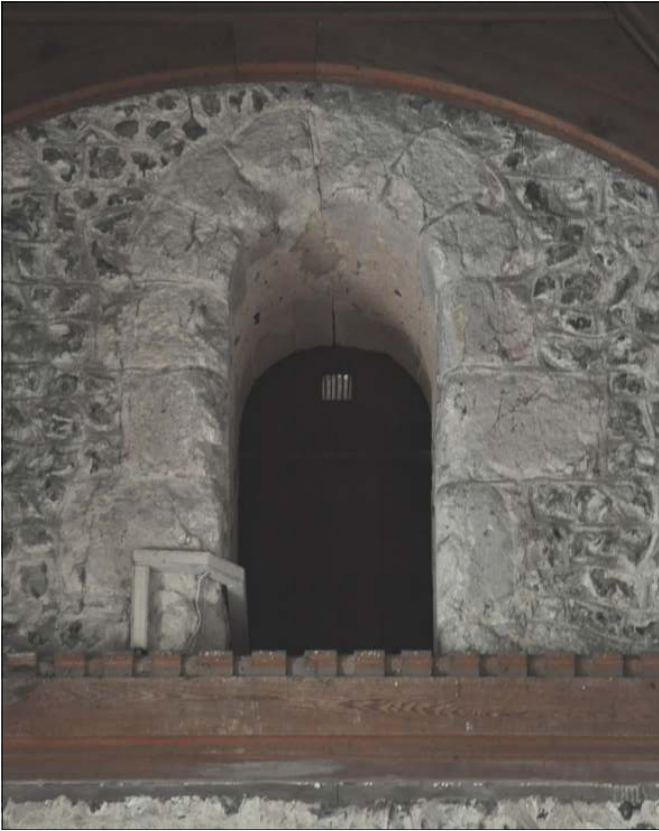
7. The elevated arched opening in the east wall of the tower (seen from the nave) and situate above the arch in photo 5. Note the typical pre-conquest style non-radial voussoirs.

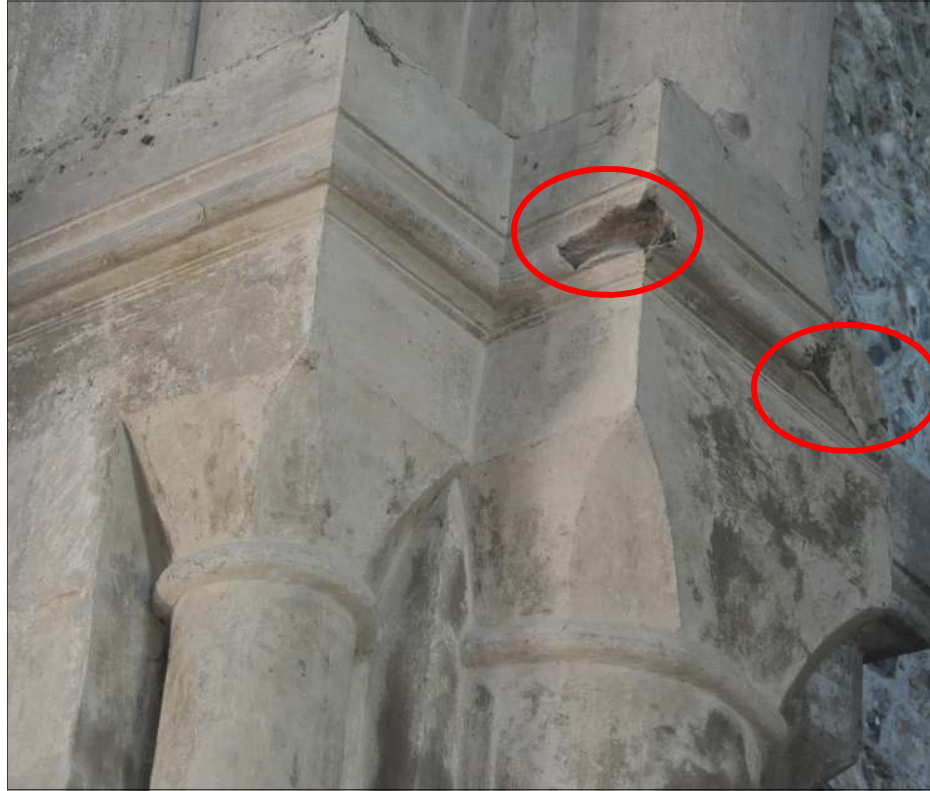
8. The nave (east) archway, southern impost. The cement rendering broken away here to reveal the post medieval mouldings constructed in brick/cement (circled in red line).

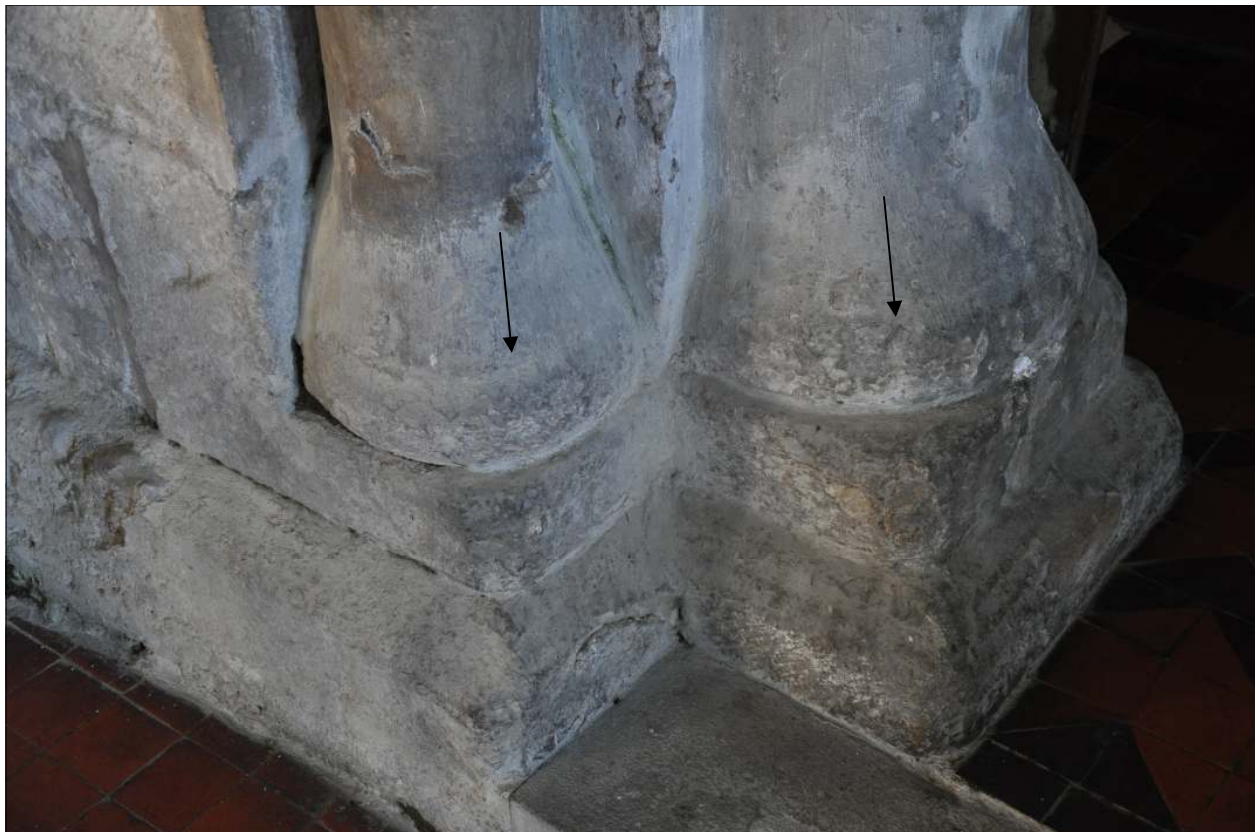
9. The base of the south jamb of the nave archway. Note the later 'faired in' stonework/cement rendering thus disguising the original shape/style of the bases which were of concentric ring mouldings in a similar way to the west archway (see also photo 23). See also line drawings 19 & 20 of this archway 'restored' to see how it may have looked before being 'modernised'. These alterations and the later cement rendering have masked its strong pre-conquest style. I feel this may well have been carried out before the Victorian era. Refer also to my remarks about picture 5 on the previous page.

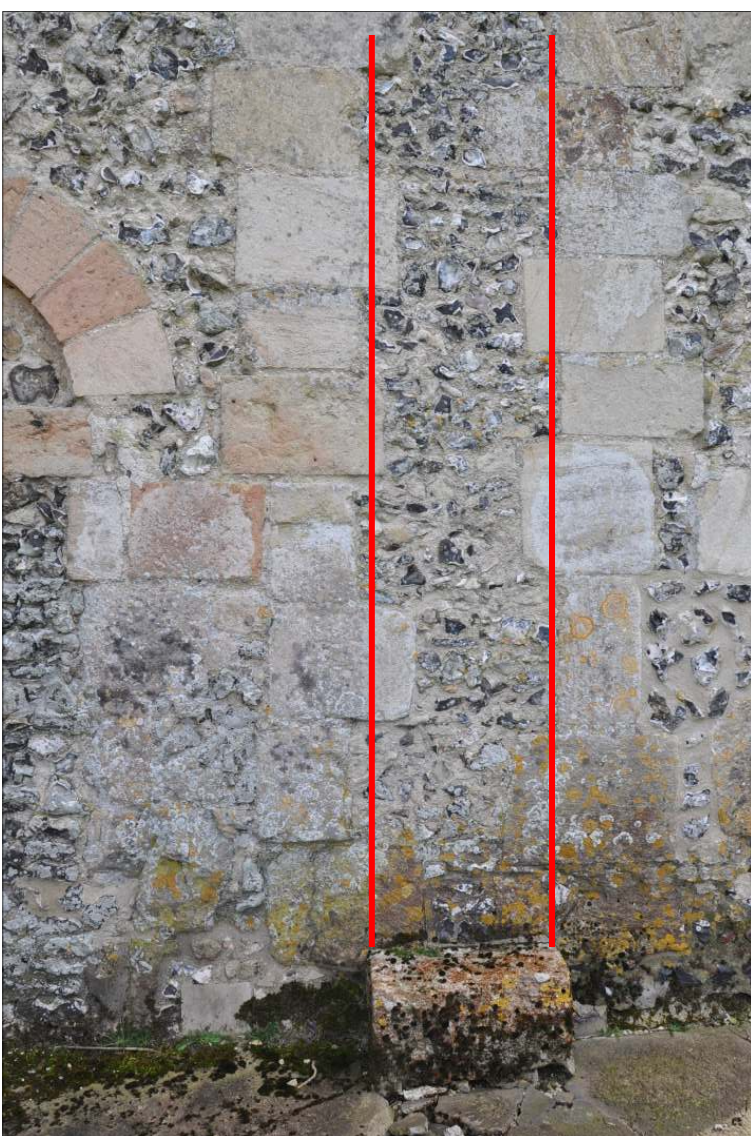
14. North face of the tower walling seen to the right (west) of the blocked archway. The twin rows of faced stones are the remains of the quoin re-entrants (as seen at St. Mary, Stoughton). Here the vertical red lines delineate the extent of the now vanished wall which was the west wall of the north porticus. The protruding (base) stone is all that now remains of this wall. Its east wall is now partly extant as the westernmost wall of the north aisle to the nave. In exactly the same way is that to the south aisle and seen in picture 15.

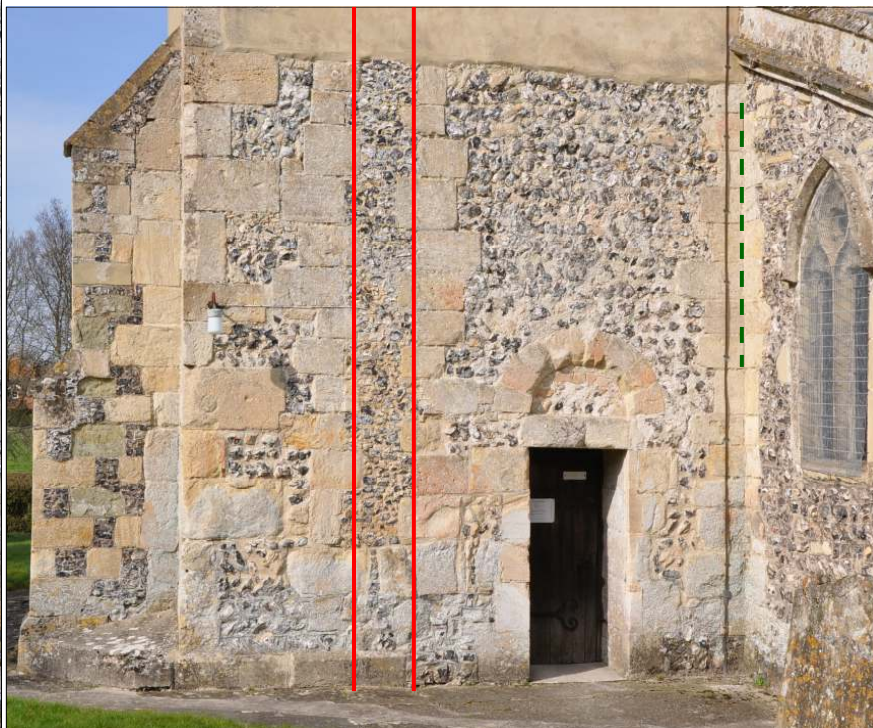
15. South face of the tower. Marked with red lines the vanished west walling and its re-entrant quoins of the south porticus. The corner of the re-entrant quoins relating to the east wall of the south porticus are delineated by a shortened green pecked line (not to be confused by the black line which is an awkwardly placed lightning conductor!). With the east and west walls fixed in this

picture it may be appreciated that the archway is centrally placed, as is its sister the north archway. I say 'archway' as that was their original use, to give access from the tower to the two porticus.

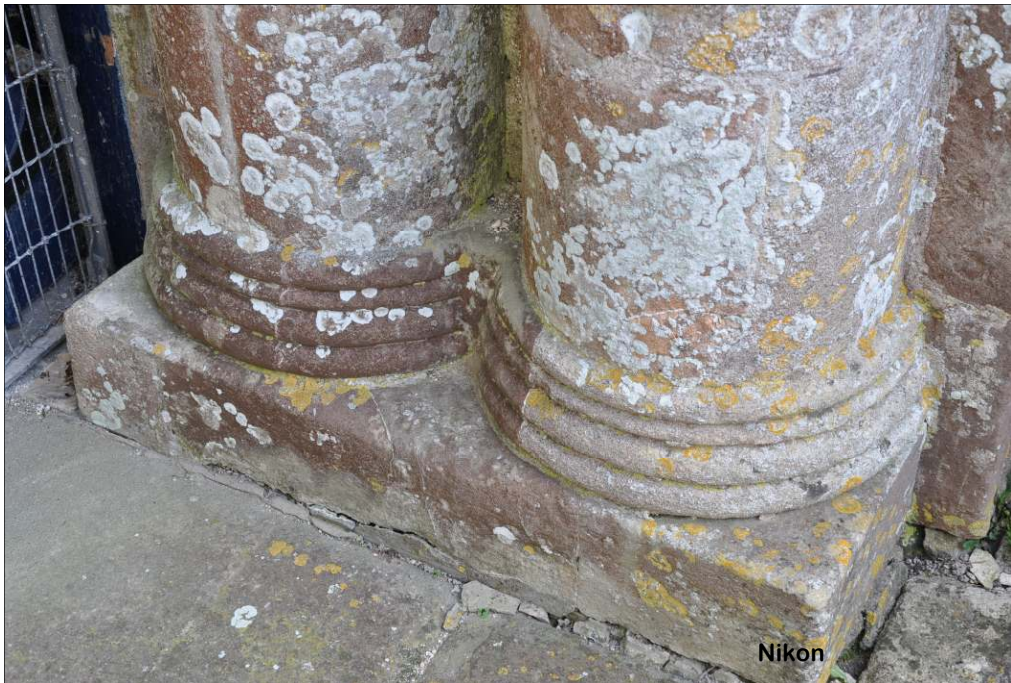
16. The base of the south jamb of the west archway of the tower and carved to show two attached half-round shafts. The bases of

these half-round shafts are finished with four concentric rings and rest upon simple rectangular plinths. Both jambs are extremely similar but their capitals are dissimilar and despite being partly weathered at least the side nearest to the door is somewhat protected and the fine carving has survived. See pictures 4, 17 & 18.

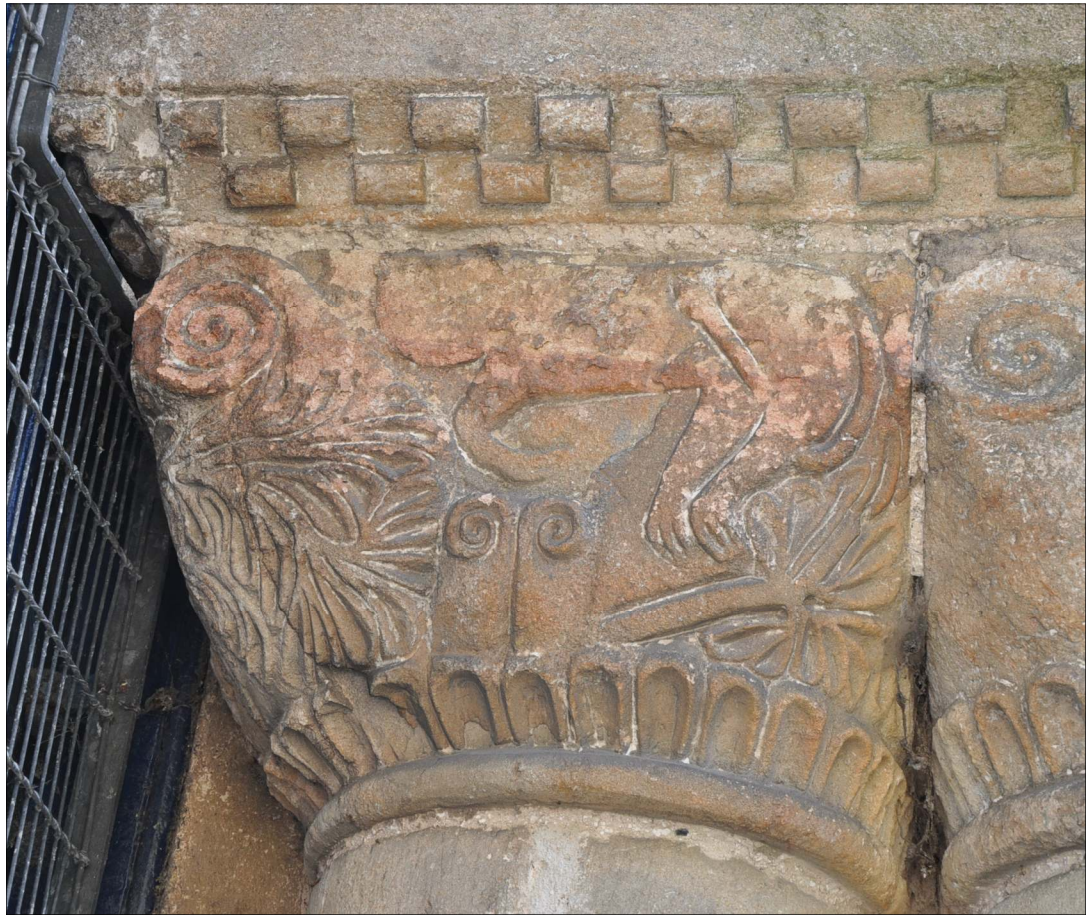
17. The west archway to the tower. Seen here the face of the south jamb and the detail of the best preserved part of the capital, interestingly with a billet ornament above, and in that showing influence from continental Europe and knowledge of the developing Norman Romanesque. Here a beast sits upon foliage which is cushioned below by an accomplished execution of a palmette design. The remainder of the capital is covered by beautiful leaves of flowing foliage. The adjoining capital on the right is badly weathered but the palmette design is repeated here.

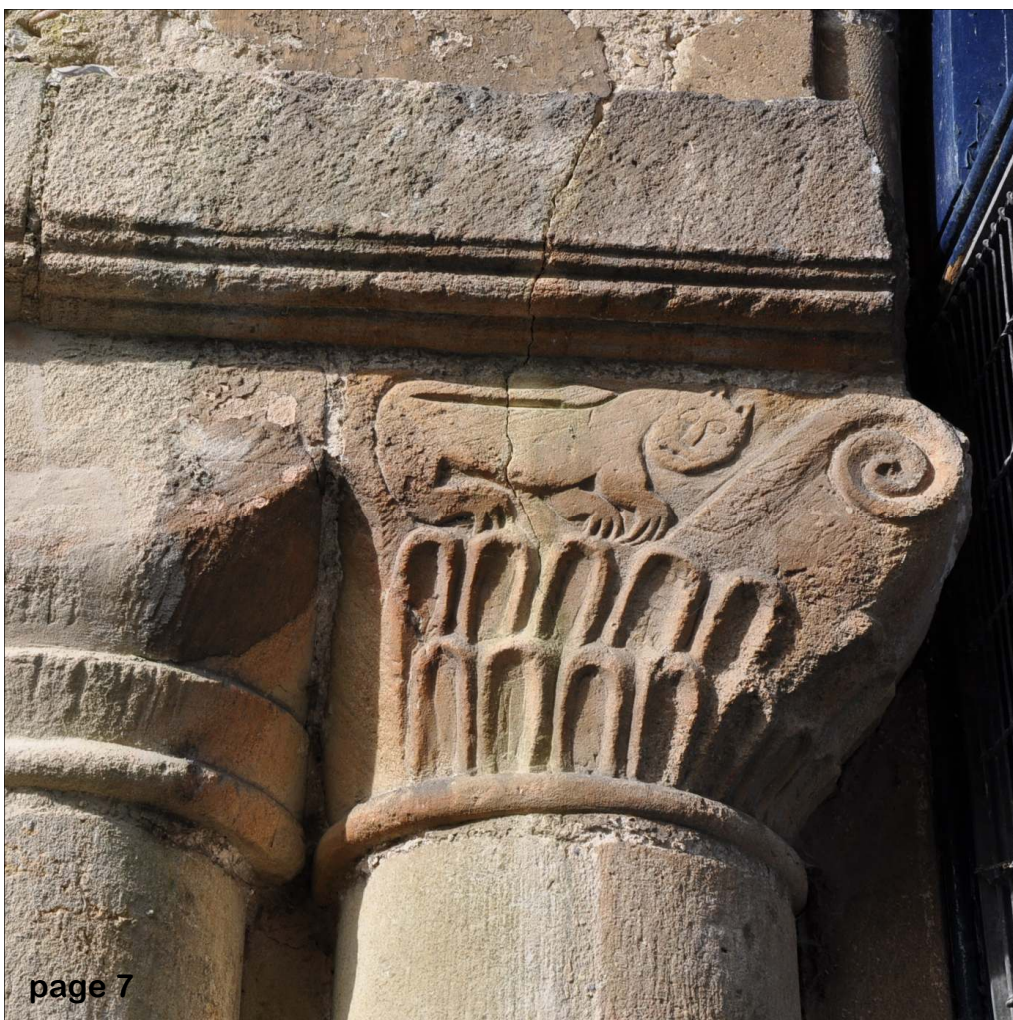
18. Its northern sister with a similar wild beast and with pointed tail, perhaps a lion? The creature sits upon a crude double row of palmette mouldings. The corner of the capital has a bold scroll design and the whole is not so confidently executed and dominates the design, perhaps a less experienced craftsman. Here the impost is not billet decorated but consists of a series of delicate mouldings. Its adjoining capital has lost every detail save a band at the base which stands proud and must have been a palmette leaf design. It is a great pity that the loss of the west adjunct has exposed to the elements this archway with its finely executed and powerfully presented carved capitals.

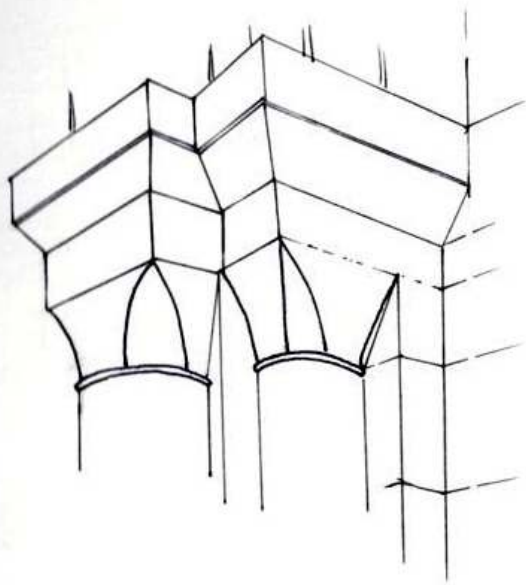
19. Seen here the south capital viewed from within the tower. Note the chamfered and quirked responds here without the existing (applied) mouldings which are constructed of a dark cement or mortar of some form and finished with a stone coloured wash. This can clearly be seen in photo 21 where the 'mouldings' are badly damaged revealing their construction, quite possibly of late 18th or early 19th century date and carried out in the mistaken intention to elaborate and beautify the 'plain' pre-conquest impost. To understand the original form of the imposts here please refer to the photo file of Stoughton church (Sussex) where you will see the chancel archway there is worked in a remarkably similar manner. Indeed the responds, capitals and the bases are to all intents and purposes identical, but here at Netheravon the capitals have not received any carved decoration. The bases of the half-round attached shafts here have a cement mortar applied (in a similar way as the imposts) to mask the original form of concentric 'rings' springing from the base. The lower ring can be seen 'bleeding' through the applied mortar covering (see next page). Of the capitals of the chancel arch at Stoughton church H.Taylor said - *The angle-shafts have capitals with simple cubical tops, which are reduced to meet the circular shafts by the elementary expedient of chamfering each face and then chamfering each angle, an expedient which has many parallels in Anglo-Saxon work. The capitals support quirked and chamfered imposts which are recessed to conform with the recessed form of the jambs.* This description applies perfectly to the capitals and imposts of the east archway here at Netheravon. It is most probable that the work at both churches belong to the same school of masons and was carried out at either the same time or after a short period had elapsed. This leaves us wondering which school worked on the west archway.

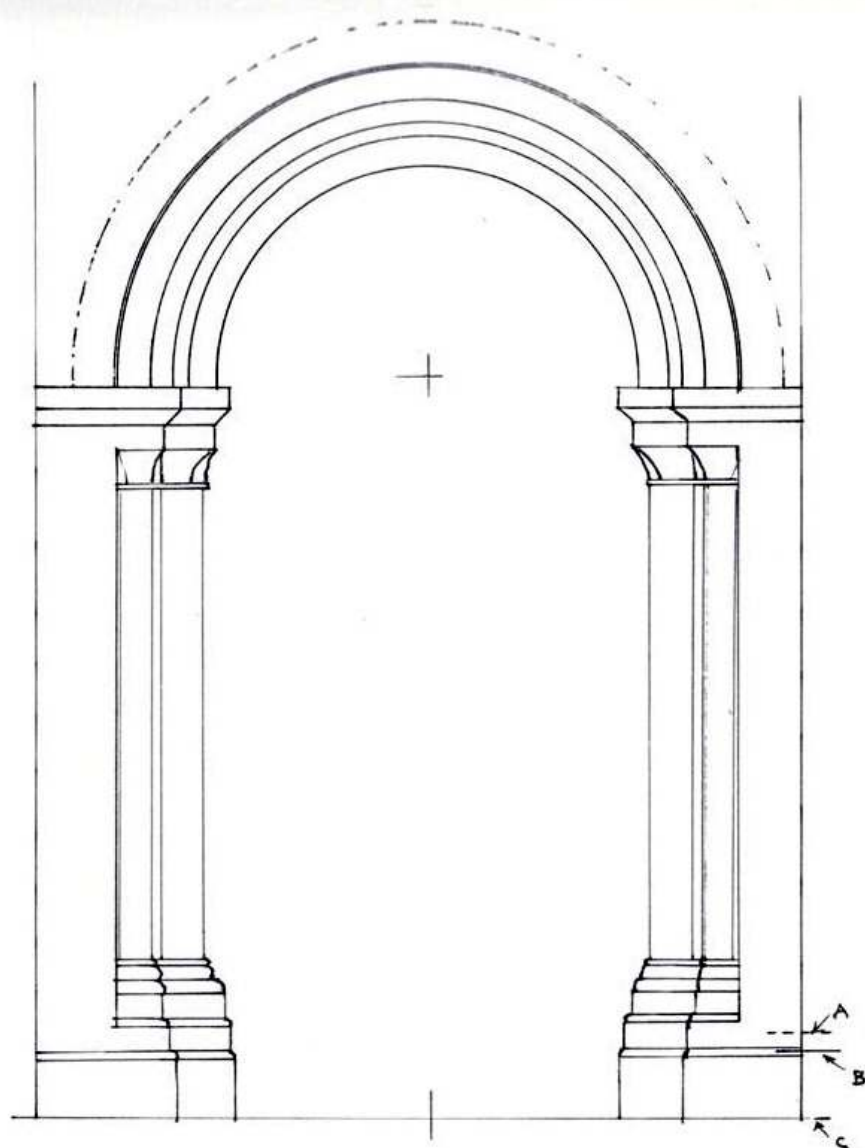
The drawing right (20).

20. The east face of the archway, in its probable original form. At present it exhibits a thin layer of hard plaster which is probably whitewashed, or at least the finish is an off-white to give the effect of stonework, with the result that the joints of the stonework are totally masked. I am of the opinion that this occurred during the later part of the 18th century or early 19th, a Georgian "revamp" and before the screen was removed. The west face of the arch has in some part escaped this 'beautification' or interference (see photo 6), but the east face was originally built to present the 'best' or important face.

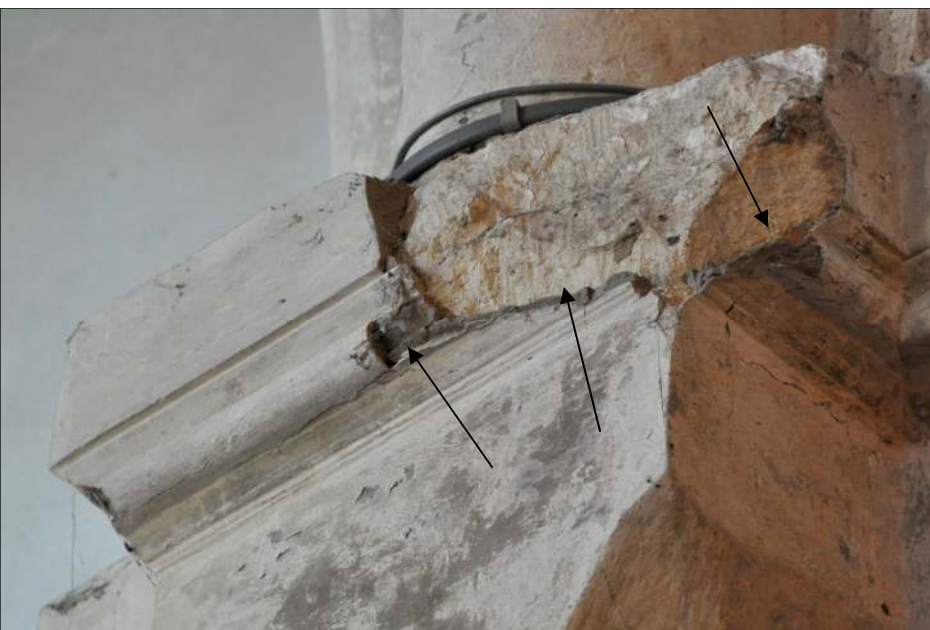
21. The south impost of the east archway (seen in the previous page) where damage has revealed the darker cement/mortar build up (arrowed) of the construction of the mouldings applied to the surface of the original stonework. There is clear evidence of where a (wooden or metal) screen was attached to the north shaft of the archway and it is possible that the damage was done by careless removal of the screen (which would have partitioned off the tower). There once existed a north porch accessing the north aisle (seen in a drawing/painting from the Buckler Collection) and perhaps its demolition necessitated the opening up the tower for easier access to its south doorway (which may have once been blocked).
