# The church of St. Peter-on-the-Wall, Bradwell-on-Sea, Essex.

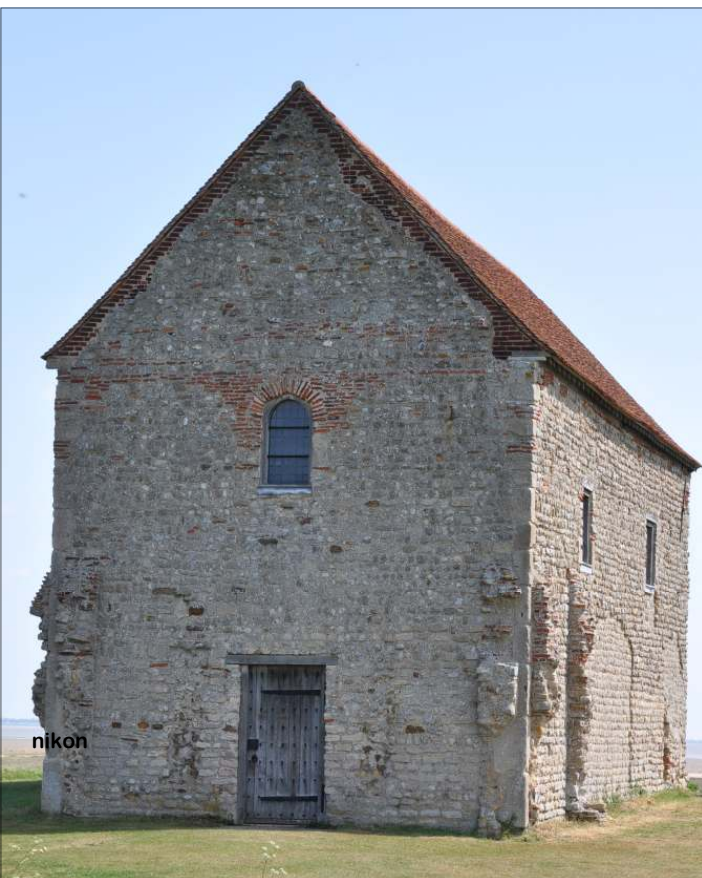
1. The church seen from the west with the south wall of the nave to the right. The nave dimensions are 50 feet x 22 feet.
2. A closer view of the SW quoin, and one of the original windows of the nave which near to one of the buttresses (partly robbed away).

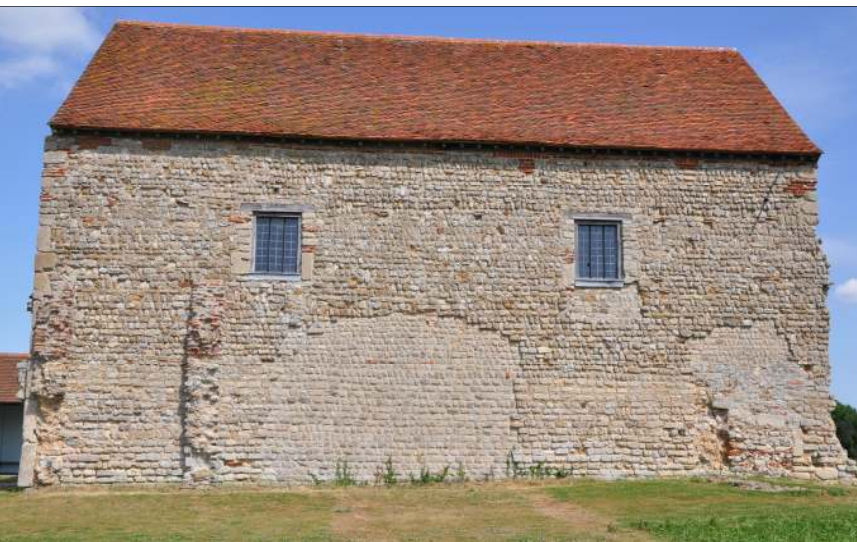
3. The south wall of the nave with the two square-headed windows. The large 'scar' in the walling was for many years an access doorway for farm vehicles!
4. Seen from the south-east, the semi-circular outline on the ground is the apse and with that to the left the south porticus.
5. The simple but imposing interior of the nave looking eastwards. The remains of the end jambs of the triple arcade, which gave access to the apse, may be clearly seen upon the 'dividing' wall.

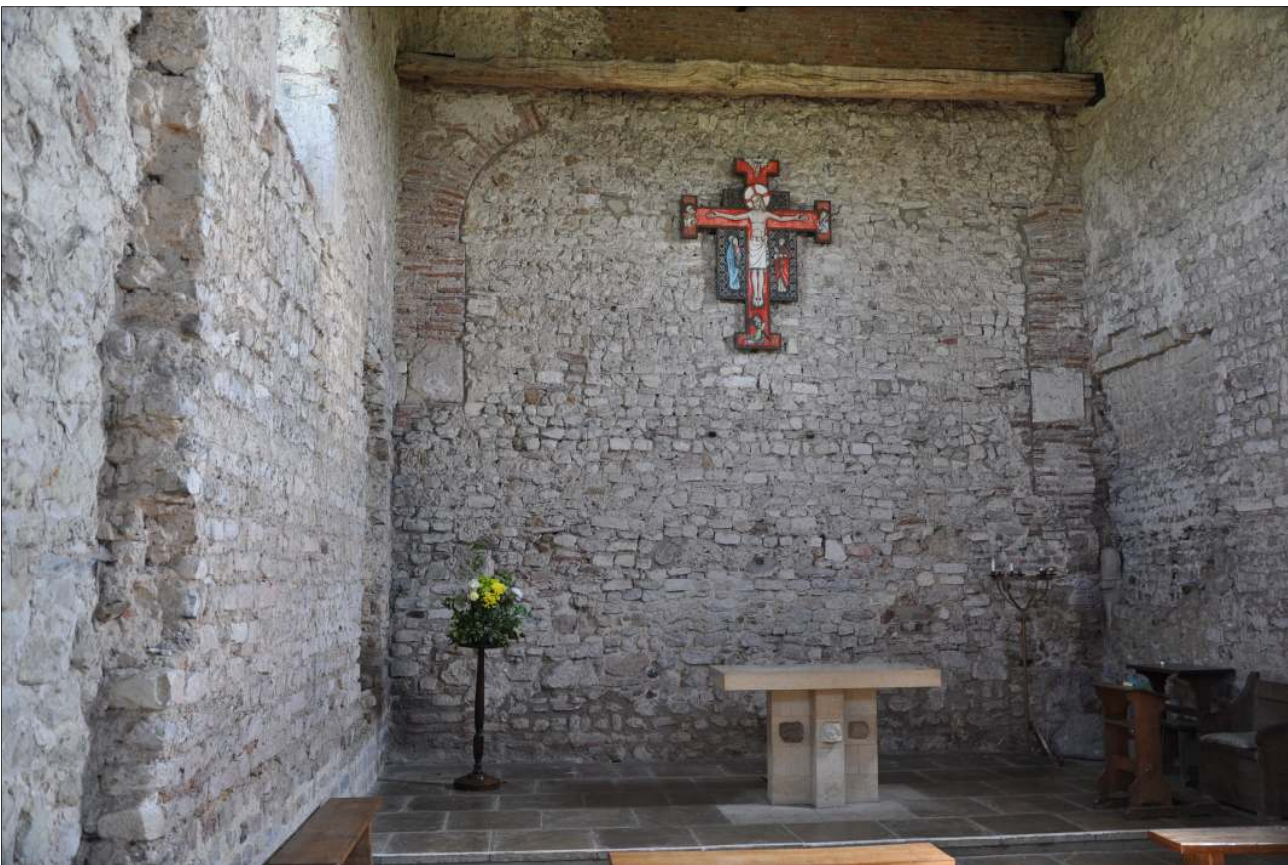
6. The east wall of the nave with a closer view of the remaining jambs (seen in picture 5).
