Church of St Mary, Breamore, Hampshire (updated 2013)

Breamore church.

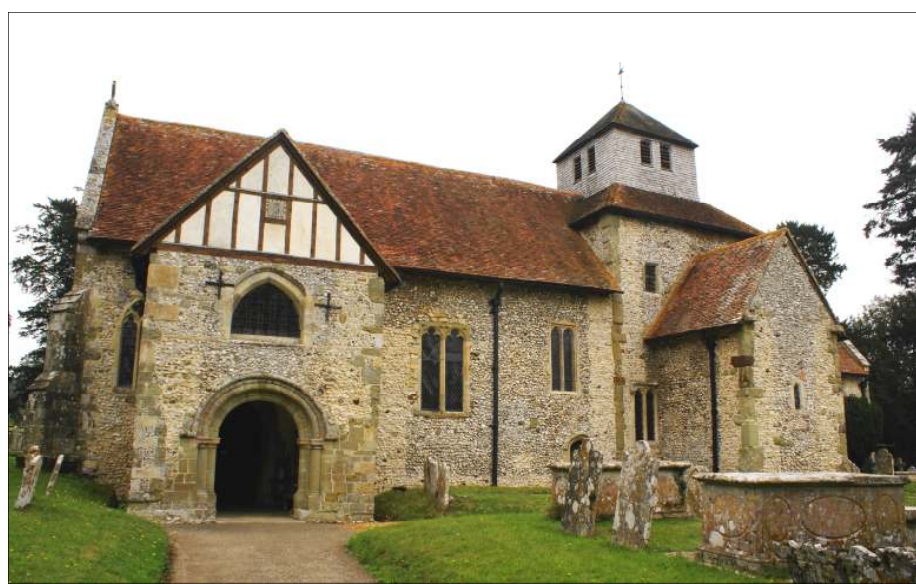
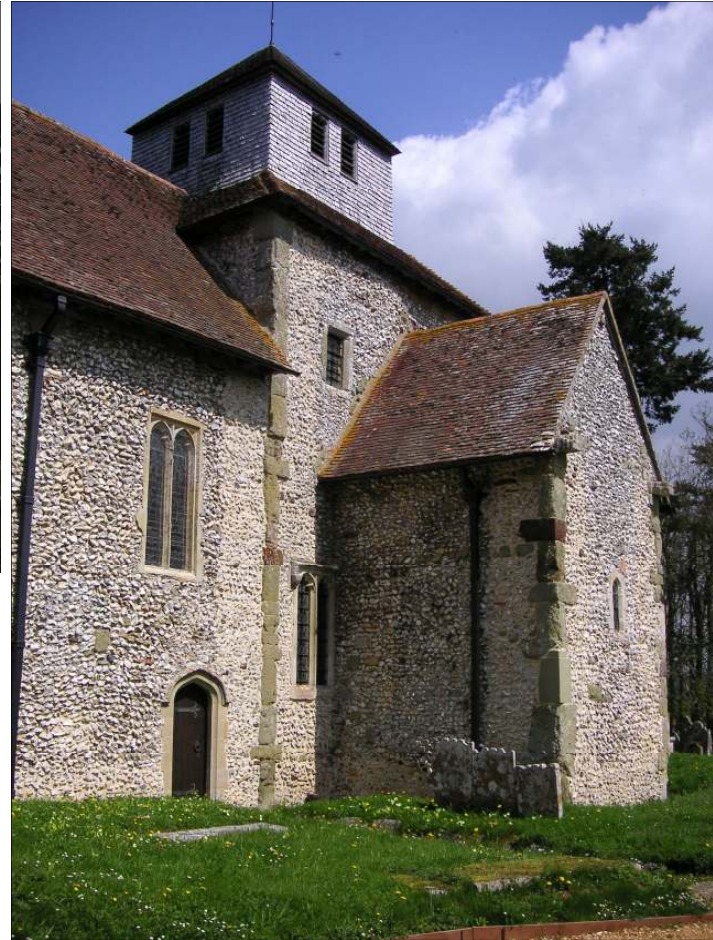
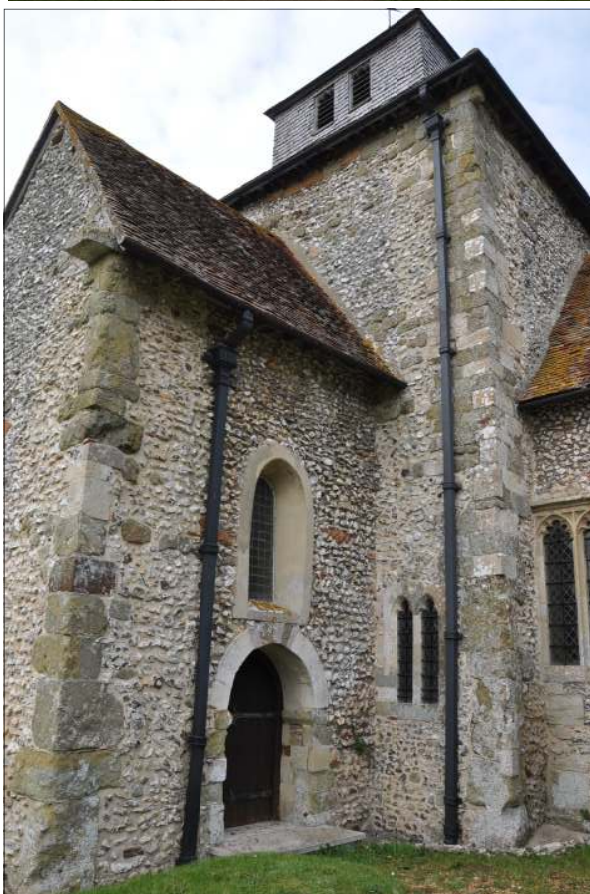
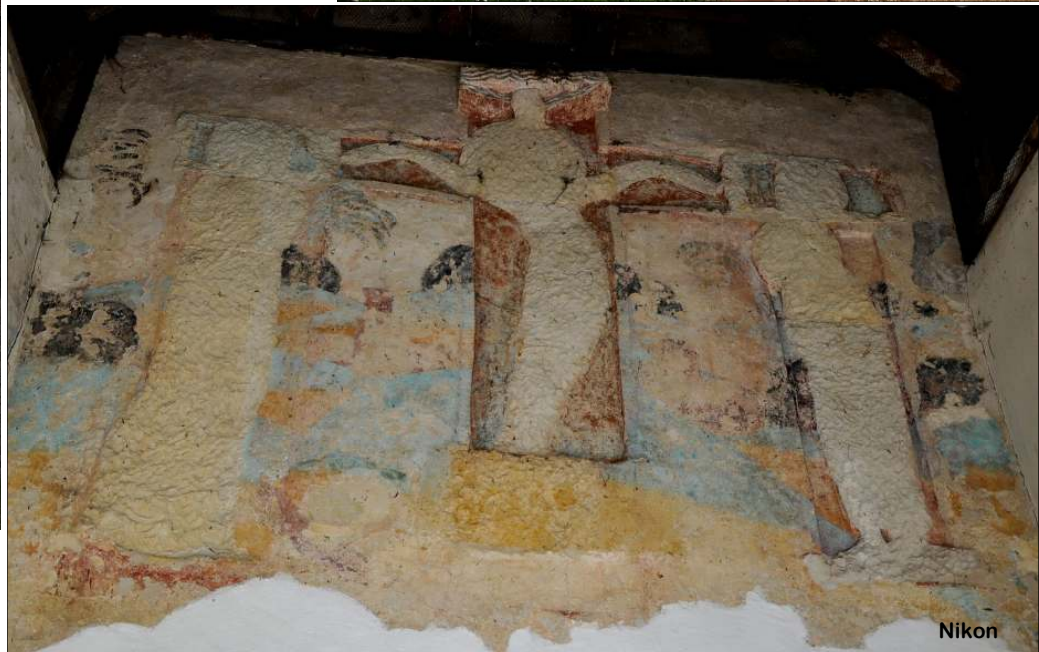
1. General view from south, showing part timbered S porch.
2. Tower, part of nave and south 'porticus' from the south. Note how the porticus is less than the width of the tower, the corner of the tower walls seen rising clear of the adjunct. Note also that the tower is the same width as the nave
3. Rood (defaced) on exterior S face of nave wall, seen from within the south porch.
4. E wall, S porticus, doorway with double splay window above. SE quoin of tower seen here which heavily rebuilt.

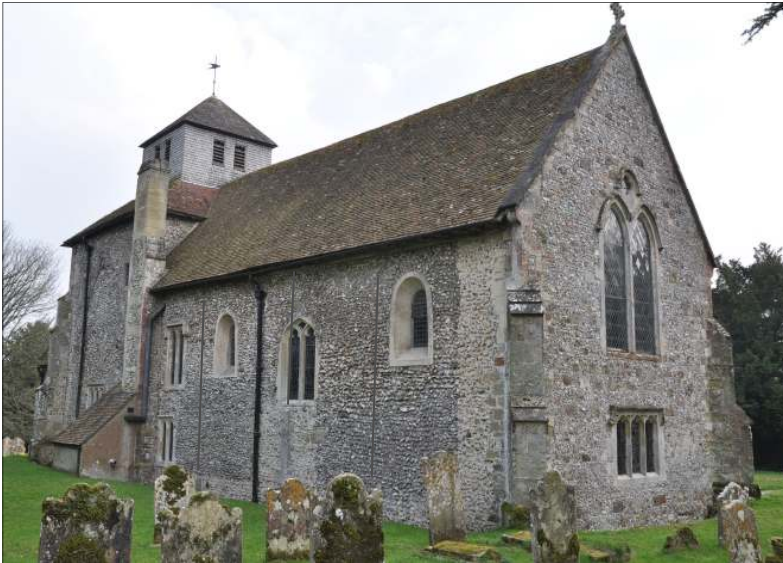
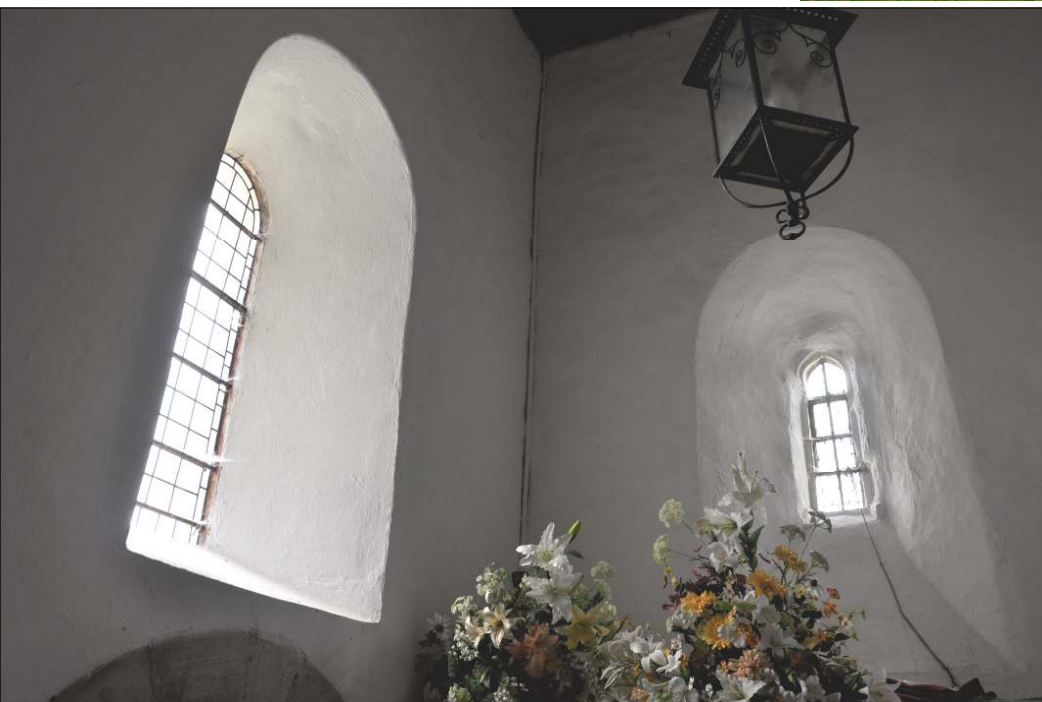
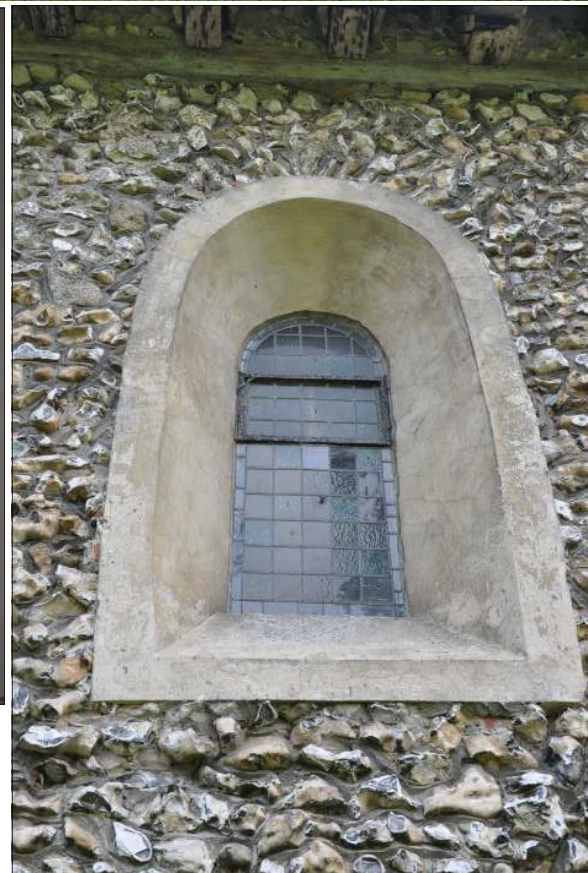
5. The church seen from the NW. Note the remaining two double splayed windows in the N wall of nave. The possible west porch has vanished, however the two stones which were the foot of the west archway to the porch still remain (see next photo). The positions of the three pilaster strips (where some of the stones have vanished over time/rebuilding) are marked in this picture on the north wall by vertical grey lines. These pilasters are (partly) mirrored on the south wall (resize this file to see them more clearly). Those on the south wall are better preserved but the most westerly is missing where the south doorway occurs. Any trace of pilaster strips have vanished where the western buttresses occur.

6. Detail of the west wall with the two remaining archway jamb stones in position, more easily seen on site they are distinguished by being set equidistant from the centre line of the nave, are 'squared' on their 'inner' faces and are a pair, see the 2 blue circles (the intervening space is made up of squared flints at this low level).

7. The westernmost window in the north wall of the nave. The rendering around the windows was re-mortared in 1896-7 when several layers of plaster were removed from the exterior of the walls (revealing the flint construction). It is somewhat unfortunate since the present appearance is not how the original builders intended it! And see picture 20.

8. The 'pair' of double splayed windows in the S porticus seen internally. The right hand window (south wall) has been remodelled by the insertion of a small Early English Lancet window.

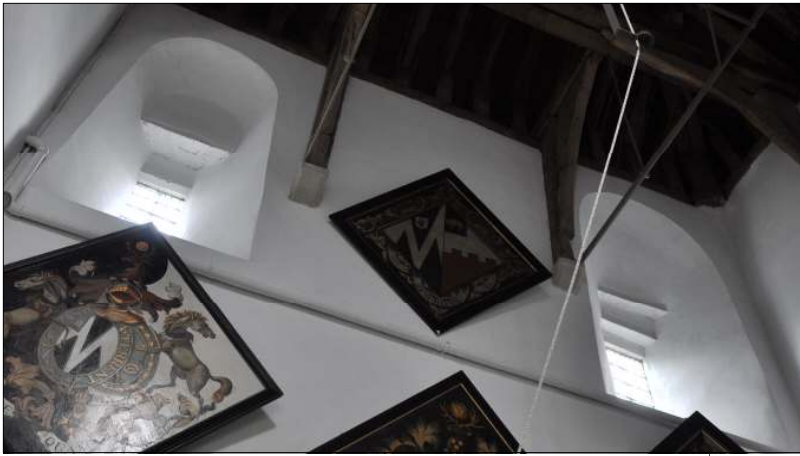
11. The two double splayed windows in the north wall of the tower seen internally. Note the reworking when rectangular medieval windows were inserted.

12. The pitch of the roof of the vanished north porticus as seen against the north face of the tower (do not be confused by the more modern stonework to the very right of the photo, this is the Victorian chimney rising from the boiler-house). The NE quoin of the tower has been in large part destroyed due to the medieval buttress. The 2 red arrows indicate the remains of the jambs of the north porticus archway.

13. Western part of N wall of nave, showing truncated pilaster strip below the medieval window, and also a double splayed window which is one of two in this wall.

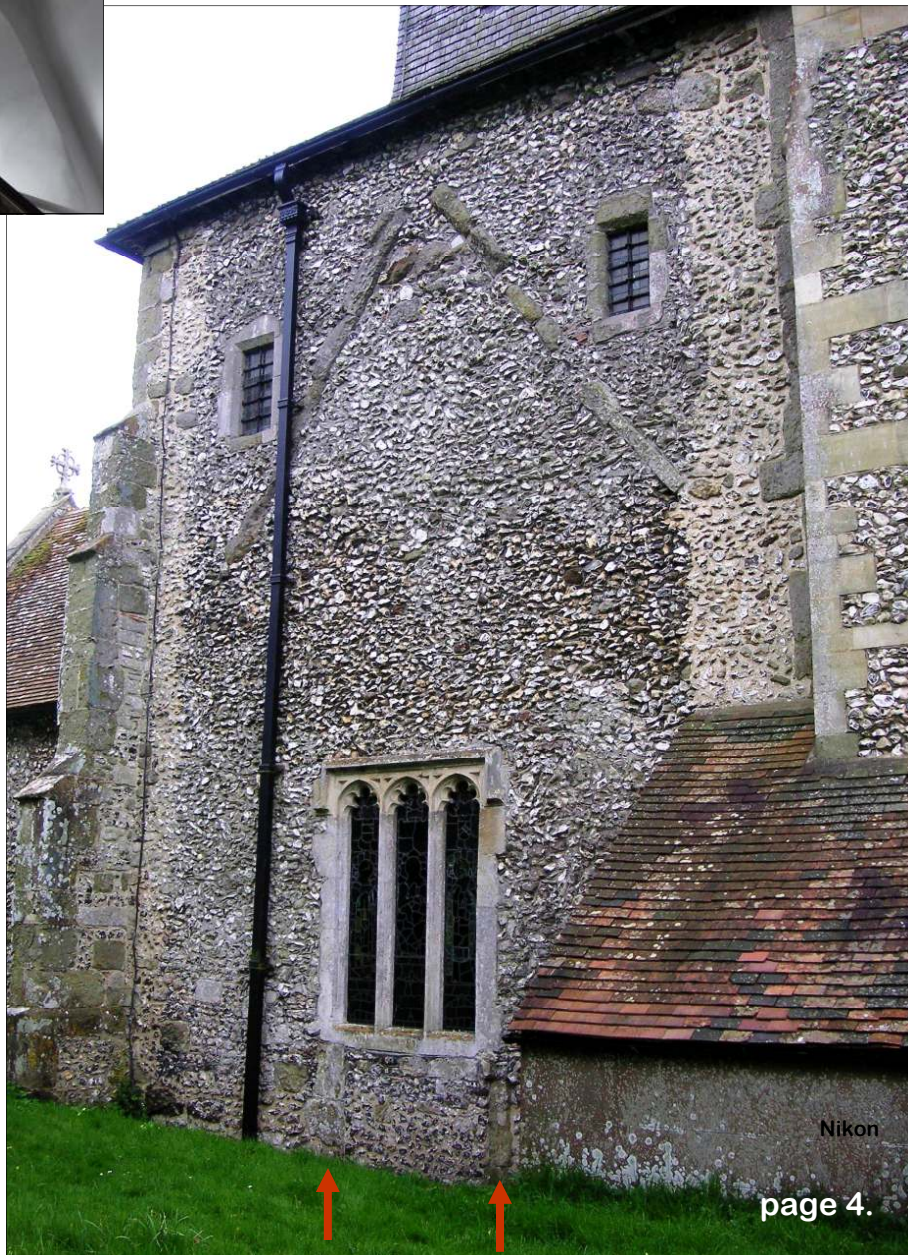
Breamore church. This page; sole surviving (south) archway leading to south porticus from tower (for dimensions see the very last page).

14. Detail of monolithic W impost, with cable decoration. The faces of the imposts seen from inside the tower have sadly been crudely mutilated and are now flush with the other stonework of the arch, whereas seen from within the porticus the cable decoration continues around the western impost only (the eastern impost having been mutilated).

15. The inscription (picked out in red) translated reads "Here is manifest the Word to thee." Note the defaced imposts. From the form of the letters a date in the latter part of the reign of Ethelred II (978-1016) has been suggested. It may be the lettering is an addition to the arches but at least this fixes the latest date for their construction to the second decade of the 11th century.

16. The north face of this archway seen from the tower, the only remaining of the original five archways.

17. Detail of the commencement of the inscription.

18. A fragment of lettering on a voussoir from a now vanished archway reads "DES" (and is situate above the medieval chancel arch). It is not in its original position (see page 10).

The south tower archway (which was the smallest), with its incised text, has six massive voussoirs which are through-stones and are non-radial. The jambs are not through-stones.

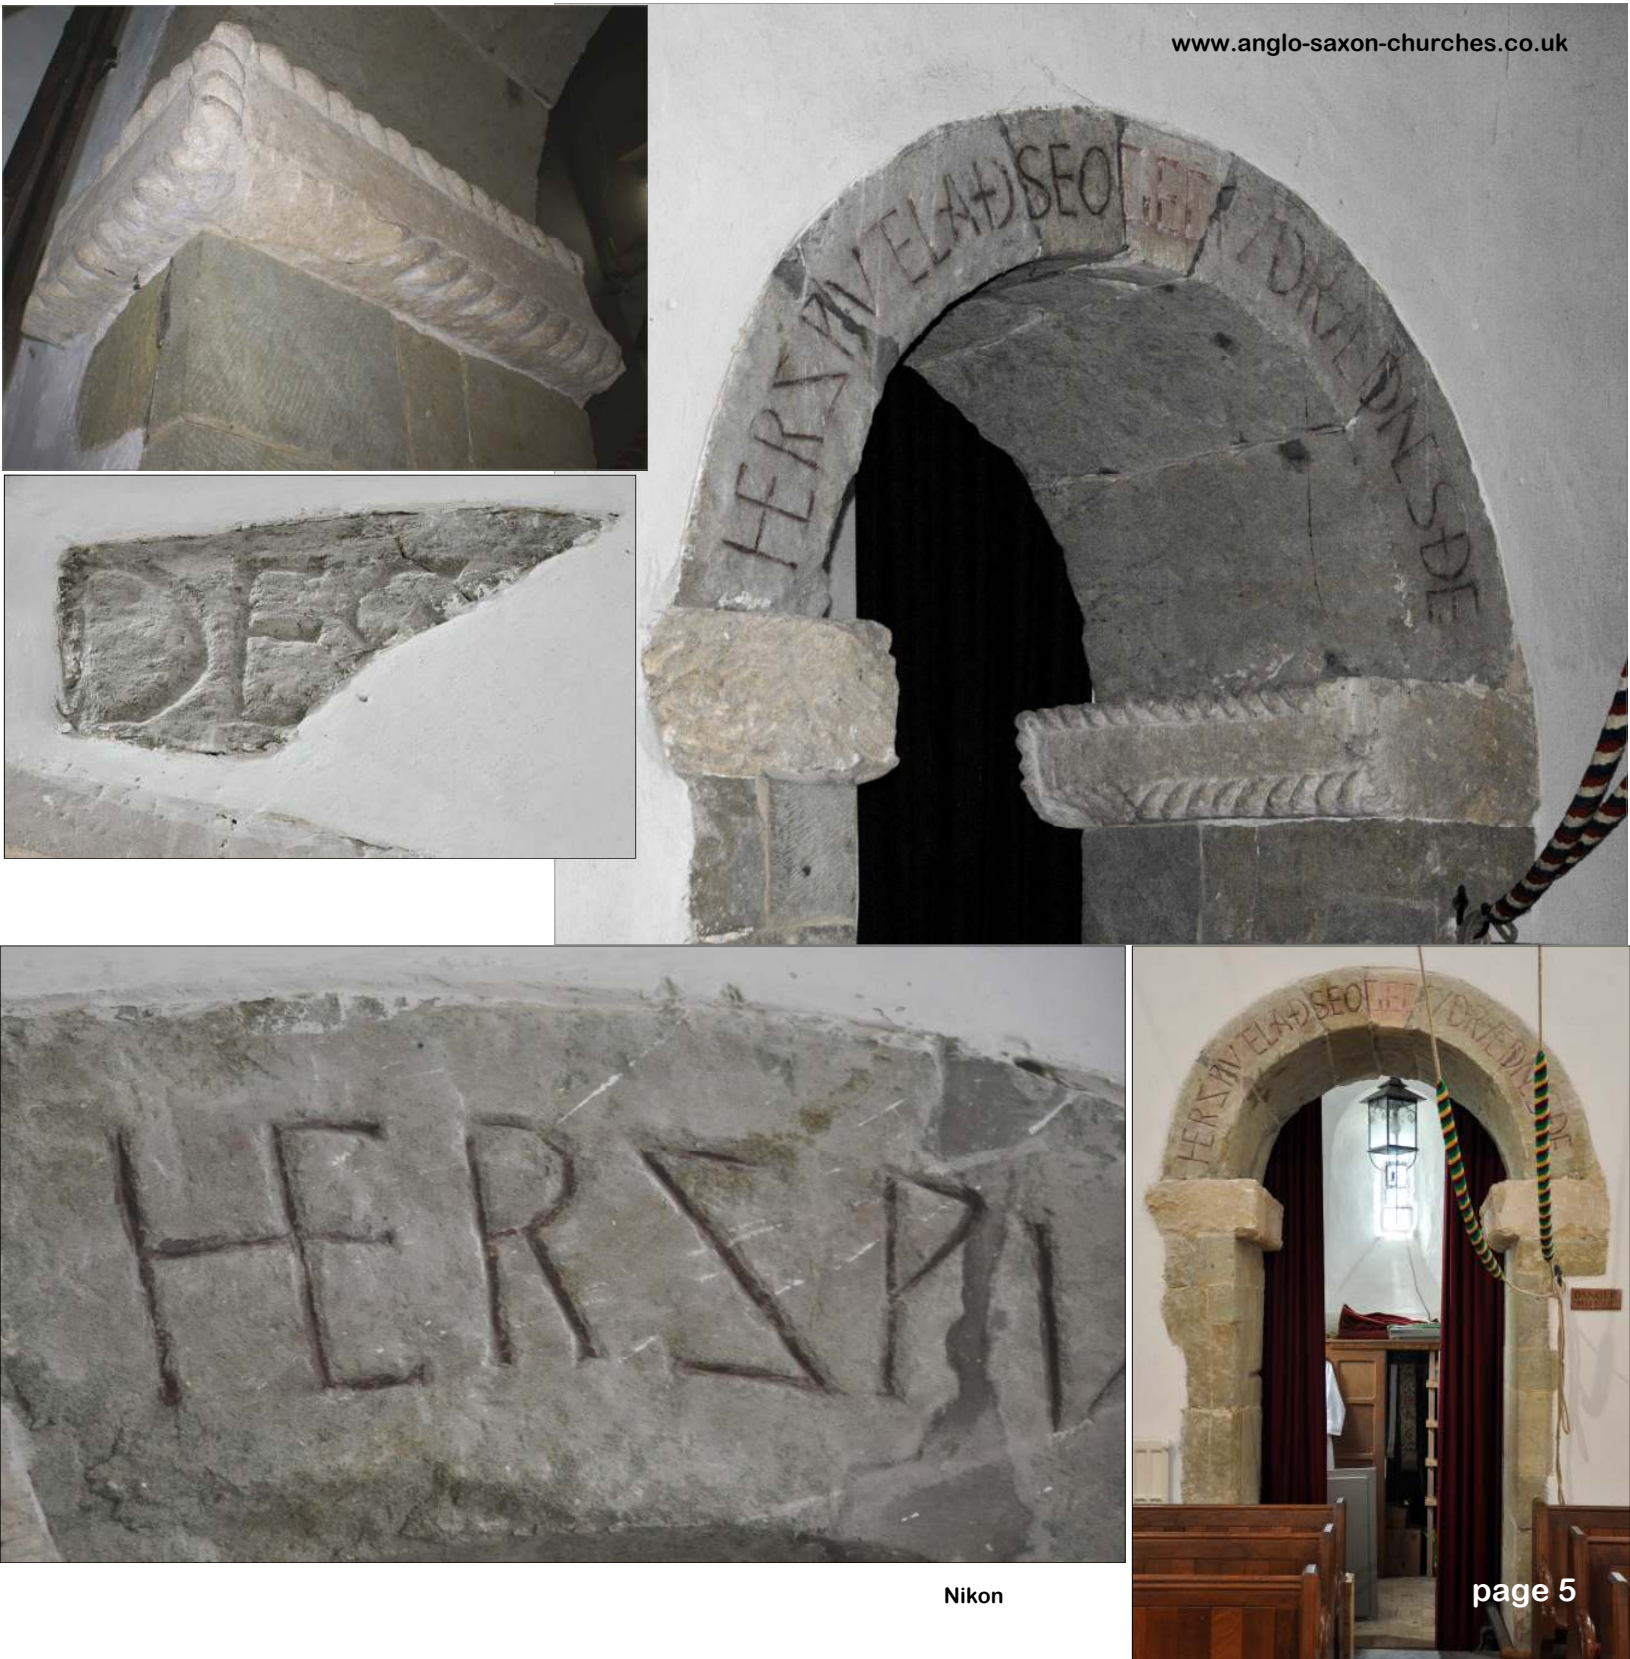
This page; pilaster strips -

18. Cut back pilaster strip at south wall of nave and a little to east of E wall of porch.

19. SW quoin (cut back) where tower adjoins the nave (tower to right).

20. Seen here, to the left, again, the SW quoin to the tower and to the right the SW quoin of the S porticus. The topmost stone of the quoin projects (ringed in blue) and which see also the drawing on page 7. The black arrow indicates a recent new stone, which unfortunately sticks out like a sore thumb (it will take some 300 years to weather down!).

Note: the pilasters and quoins, laid in irregular long-and-short technique, are of the type where the finished pilaster appears as a raised rib cut on the face of stones which are otherwise only roughly dressed, and are appreciably wider than the pilaster itself. Undoubtedly the walls were originally rendered in the traditional way and this rendering was carried up to the raised, or proud edge, of the pilaster strips, so that the stones showed as a vertical strip. The original rendering was unfortunately removed in alterations in 1896-7. I have attempted to recreate the effect where the tower quoin rises; compare pic 20 (rendered) to pic 19 as seen today. The colour is a matter of conjecture, Winchester Minster was called the white church due to its whitewashed colour. Breamore church was evidently plastered in a 'pale ginger' daub (or 'natural'). So on the left it is shown whitewashed, and on the right 'natural'.

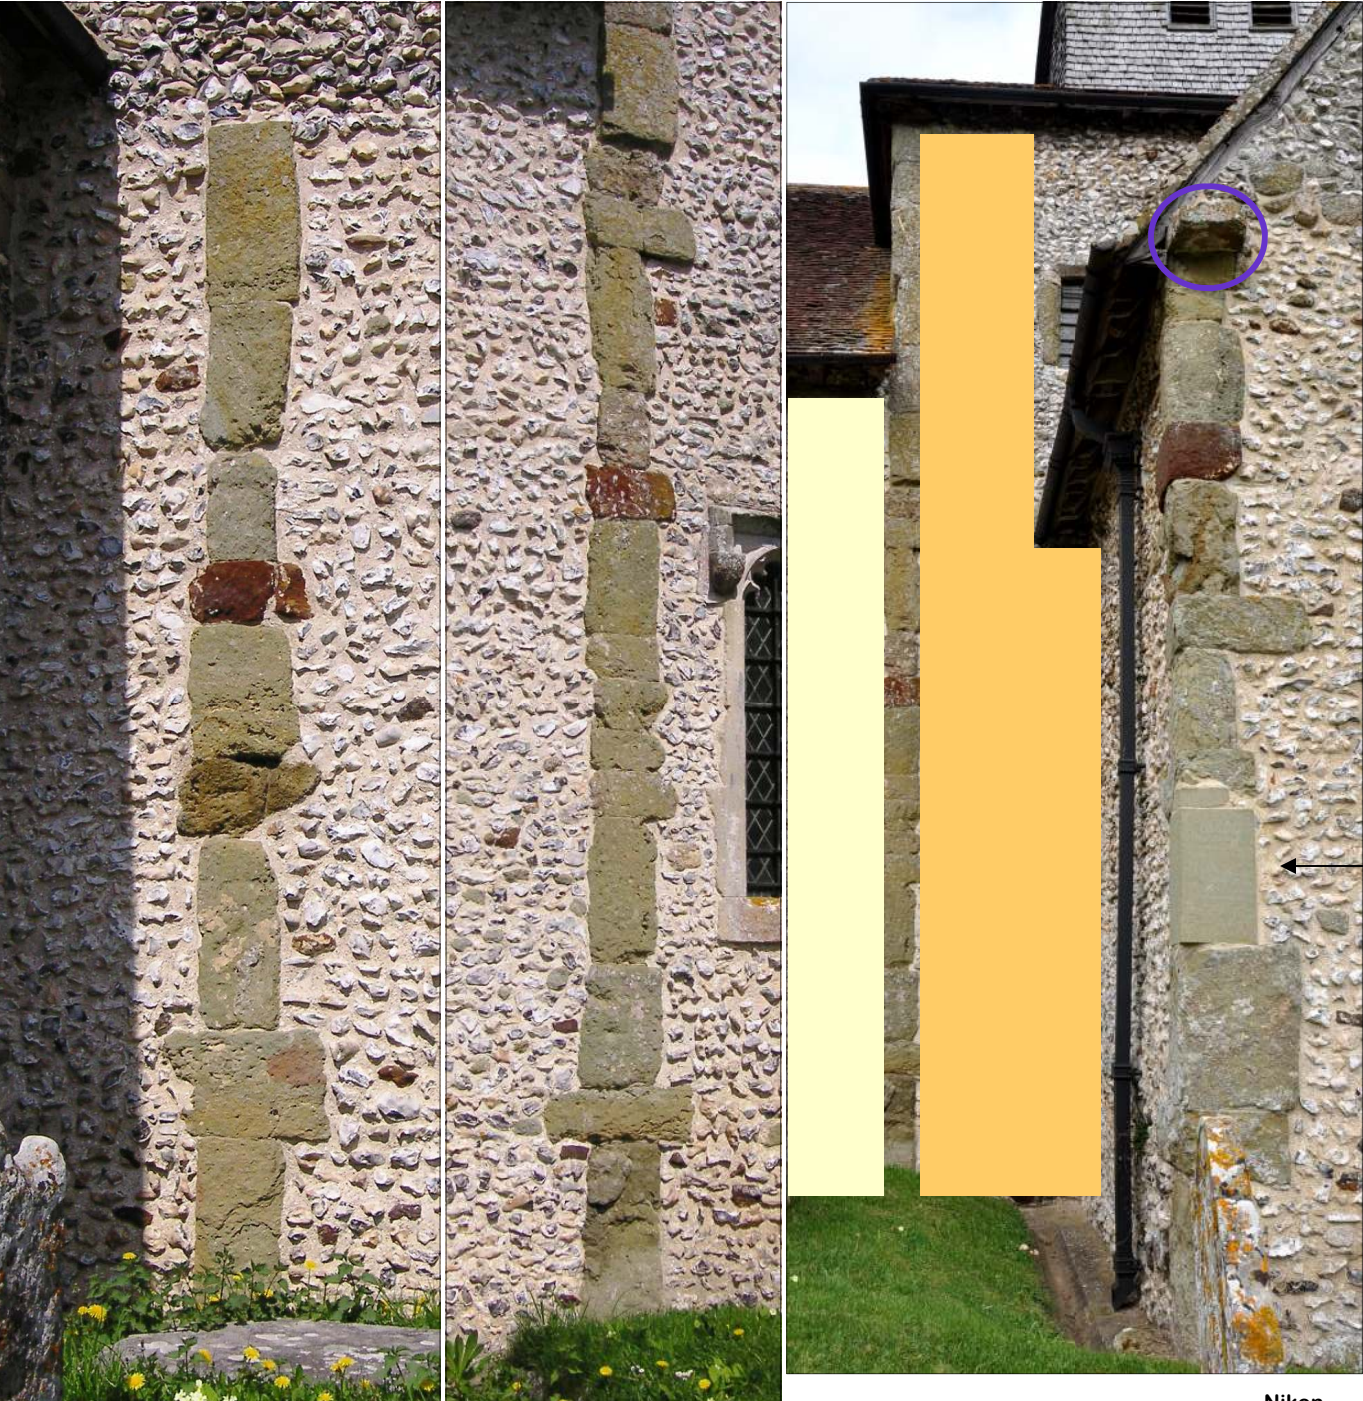
Detail of 'cut back' pilaster strip (quoin) at the meeting of nave and tower (south wall), and seen to the right the SW quoin of the transept or porticus, illustrating the random long & short work. The pilaster strips spring from a large rectangular base stone which protrudes beyond the face of the strip and exceeds its width by a factor of two or more.

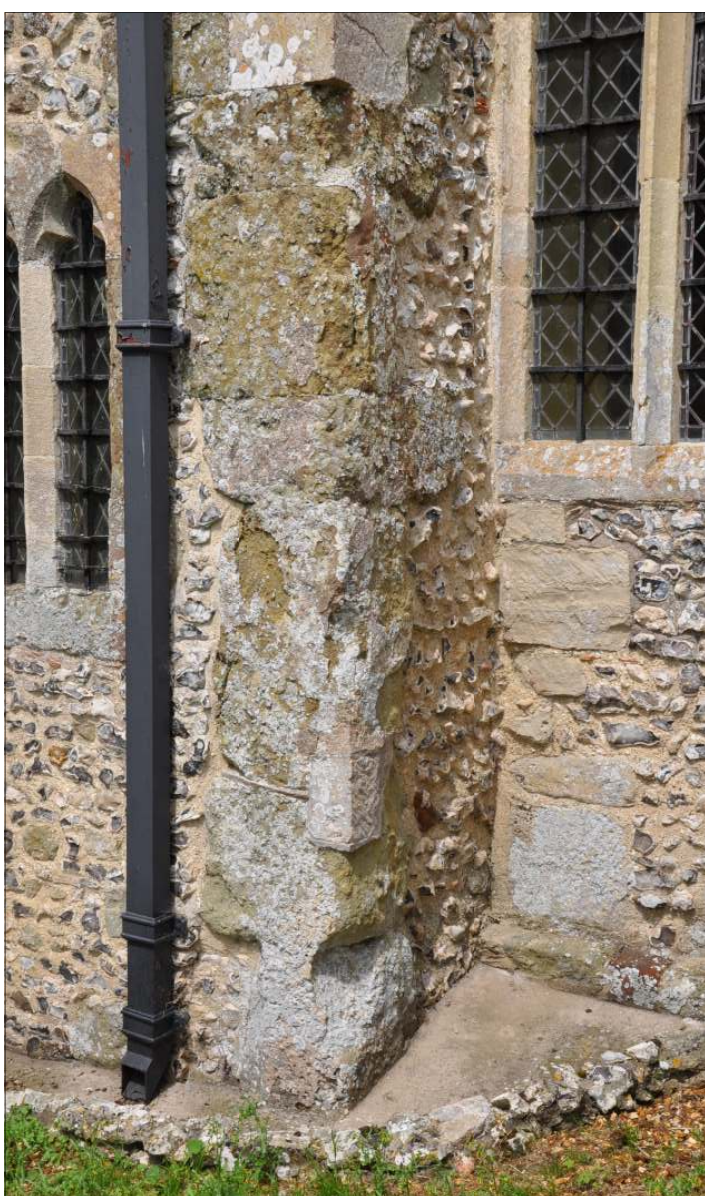
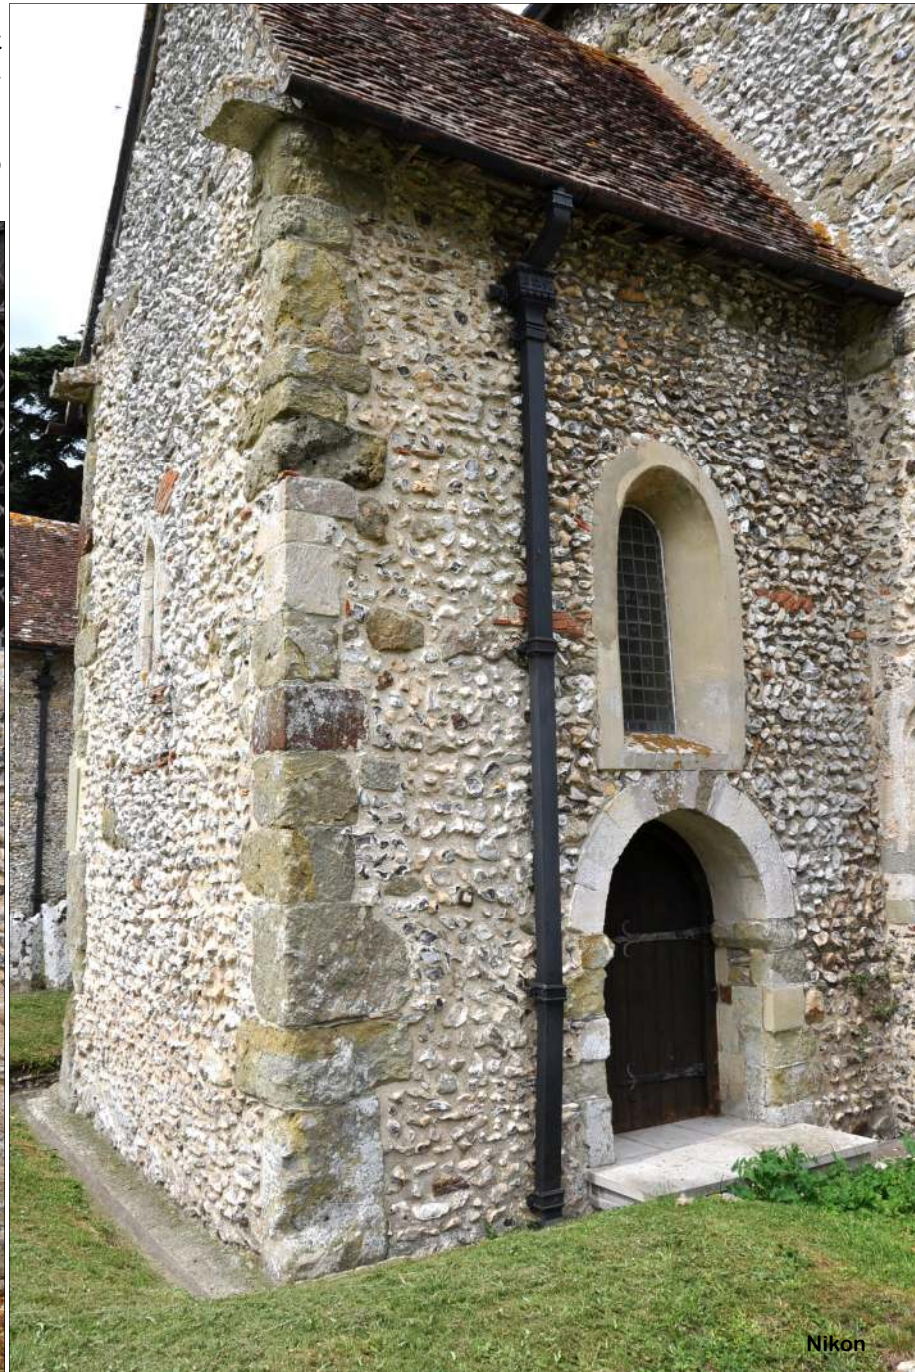
21. The remaining original (lower) portion of the SE quoin of the tower. This is a particularly important part of the fabric since it is the only remaining 'freestanding' corner quoin belonging to the tower/nave build which survives; however the topmost stone (in this photo) and those above, include medieval restorations/replacements. This portion of quoin stones remains (thankfully) un-restored to date. To the right runs the pre-conquest walling of the chancel (which note is not 'full width' as is the nave).

22. I include this photograph of the south porticus to show the similar type of (cut back) quoin seen in picture 21, but also to illustrate the repairs recently carried out and certainly dating to after 1962 (when I first knew this building). They do not seem to match either the greensand, or the ironstone used in the original build, and if restoration of this type were to continue then we are to lose the important story that the stones tell us here. Note the projecting stone at the head of both quoins. I wonder if this arrangement supported a timber beam/gable?

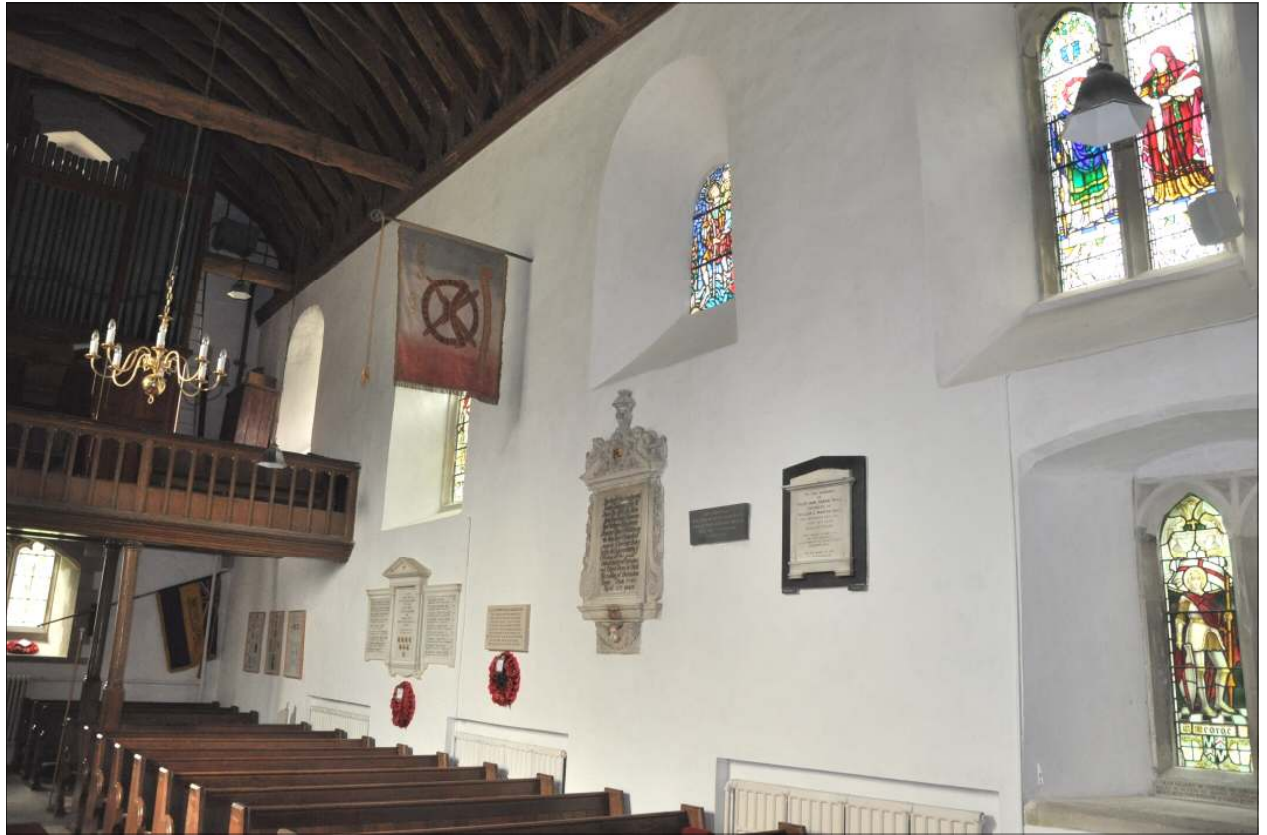
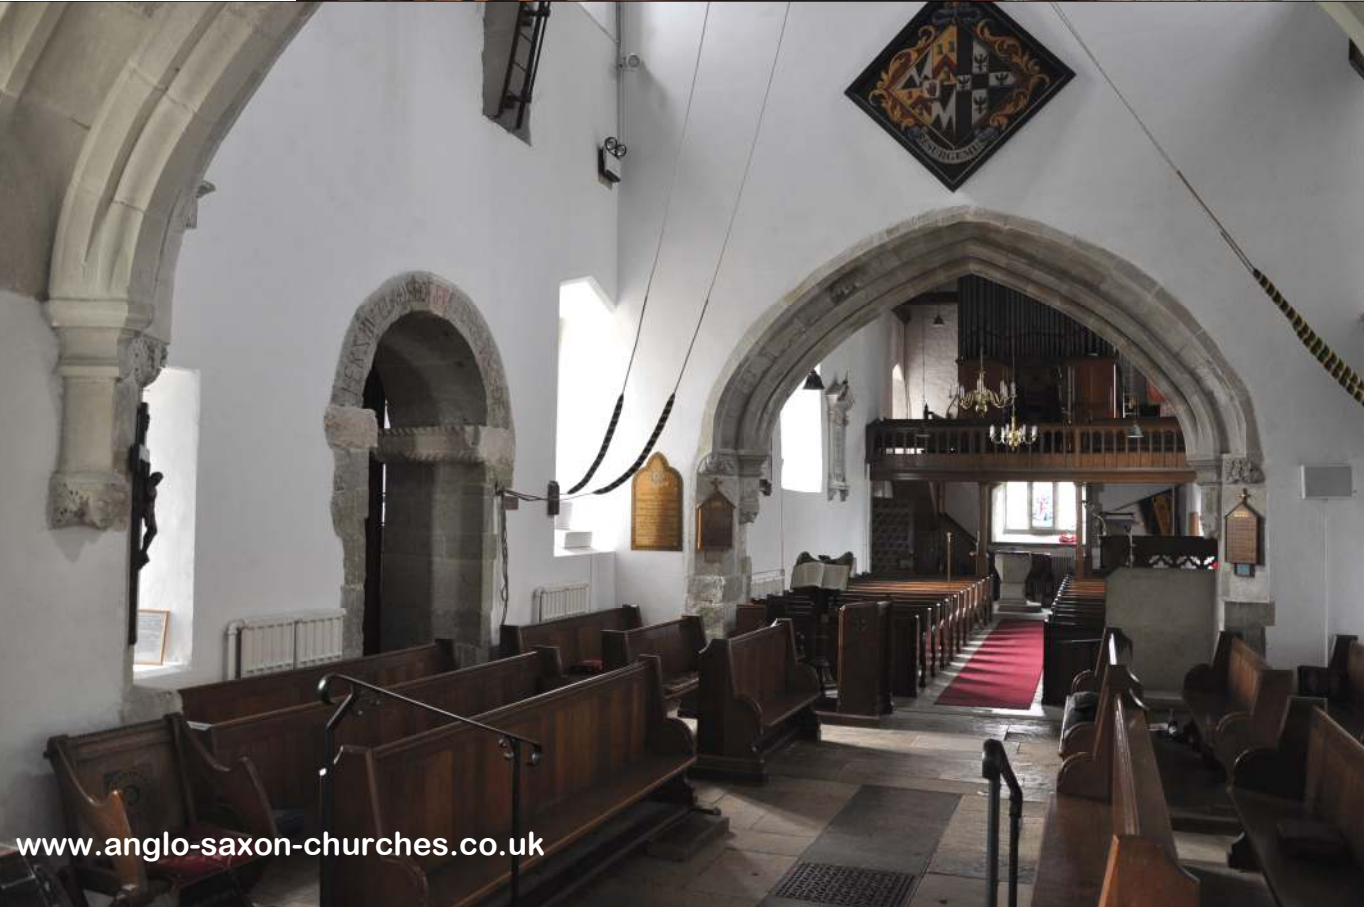
This page; interior views.

23. The north wall of the nave running away to the west, note the two double splayed windows, the furthest now lighting the west gallery.

24. The space under the tower, seen from the chancel and looking west.

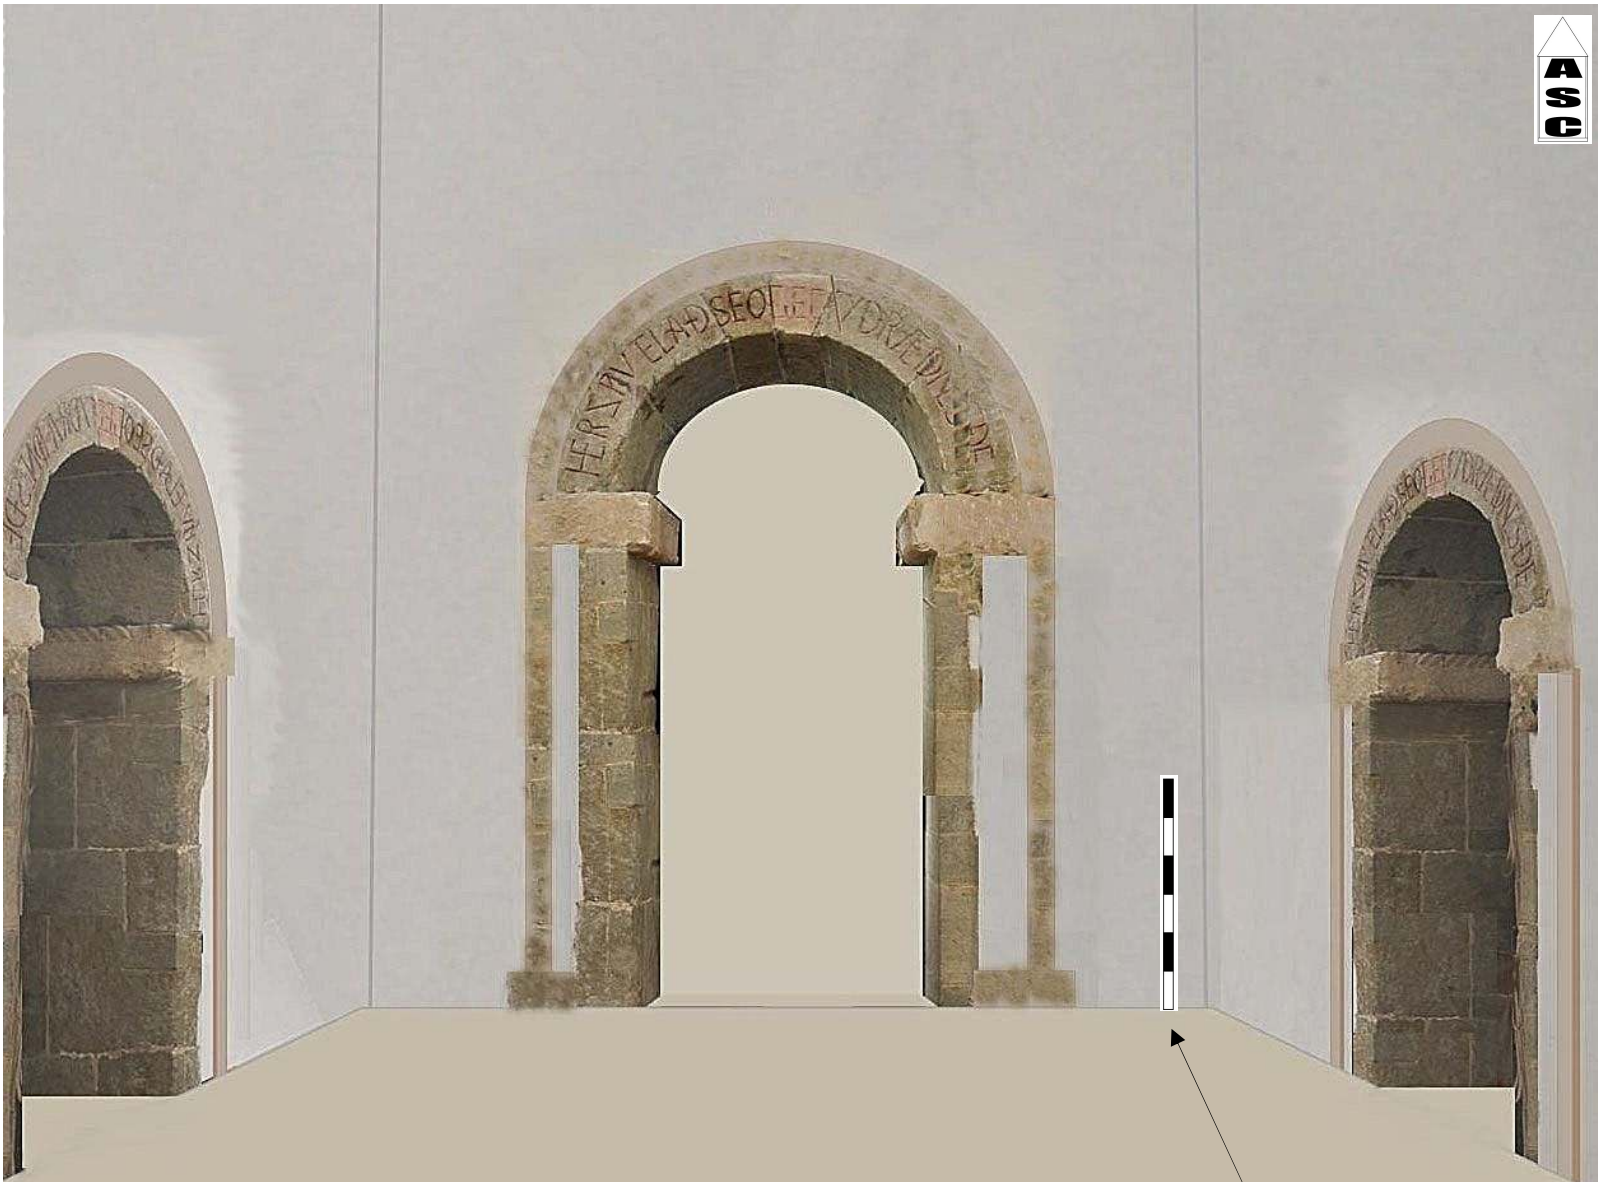
This page; relative sizes of the Anglo-Saxon tower arches (restored).

25. Here are three of the tower arches shown as they would once probably have looked viewed from under the nave archway and looking eastwards. The missing chancel arch is central to the picture, the surviving south arch is on the right and its vanished sister, the north arch, is on the left. You will see that the north arch is larger than its sister on the south, and that the chancel arch is again larger than the other two shown here. Full details of archway dimensions are on the next page.

One must study the remaining archway understanding its currently 'defaced' state. Firstly the face of the impost (seen from within the tower) have been hacked back to the level of the face of the jambs. From within the south porticus the face of the west impost is in pristine condition, it projects forwards and the heavy rope roll moulding is repeated on its edges. This is sadly what is missing now on the north facing aspect. We then realise that the object of the defacing, perhaps belonging to a 13th or 14th century date, was to remove the projections which did not fit the then current thinking. However, this 'tidying' did not stop there. Here, as with the contemporary remaining doorway in Sherborne Abbey, and in a similar manner as at Britford church (Wilts), rectangular pilaster strips framing the archway were removed together with the square bases from which they sprung. Understanding this we now realise how 'undressed' the surviving archway now appears. With the traditional pilaster strips and continuing hood mould 'restored' the archways look 'finished'. As at St. Peter's, Barton-on-Humber, it may be that here at Breamore the pilaster strip and hood mould decoration was only provided on the more important inward face of the tower (see also chancel arch at Wittering, Northants), but perhaps with the exception of both faces of the nave archway which probably would have received pilaster strips (see Stow-in-Lindsey). A little judicious removal of plaster from a small area surrounding the surviving arched opening on its northern face would easily determine whether there are any remnants of surviving pilaster strip embedded in the wall (pilaster strip-work was not a surface ornament, the stonework was embedded deeply in the wall and it formed very much a part of the structure of the archway). So here we see a representation of how impressive the interior of the tower must have looked before the medieval mind came to bear upon it. I should add that due to the limitations of my expertise with computer graphics I have not been able to show the imposts restored with the rope moulding on the faces.

1. Western. W. 1.68 metres (66.1 inches).
2. North. W. 1.48 metres (58.25 in).
3. South. W. 1.333 metres (52.5 in).
H1. 3.142 metres (10.3 ft/123.7 inches)
H2. 2.172 metres (7.13 ft/85.5 in)
T. 0.91 metres (36 in).
R. = Ratio of width to height. 1 to 2.357

Western impost of the south arch is a rectangular block 0.266 metres (10.25 in.) high; 0.56 metres (22 in.) measured west east, and would have been 1.092 metres (43 in.) north south (assuming in restored/original condition before being defaced).
