Church of St. Peter, Britford, Wilts.

Taylor's account of this church runs to a good two pages, but visible remains condense down to two side arches which originally led to their individual porticus, or side chapel, parts of the south doorway (much restored), and parts of the walls. Having been reopened in the restoration of 1873 the two nave arches were provided with small annexes into which they now open. Rickman saw the (then) blocked arches and dated them as Anglo-Saxon. Taylor puts a date (one of his standard bracketed dates) of 800-950. I would prefer a (tentative) date of c.850, in part because of the generous width of the nave. There remains part of the fabric of the nave and parts of the east walls of both porticus embedded in the medieval transepts. The south porch was built to protect the pre-conquest nave doorway which was reopened; it is however much altered. The porch dated to the 1873 restoration.

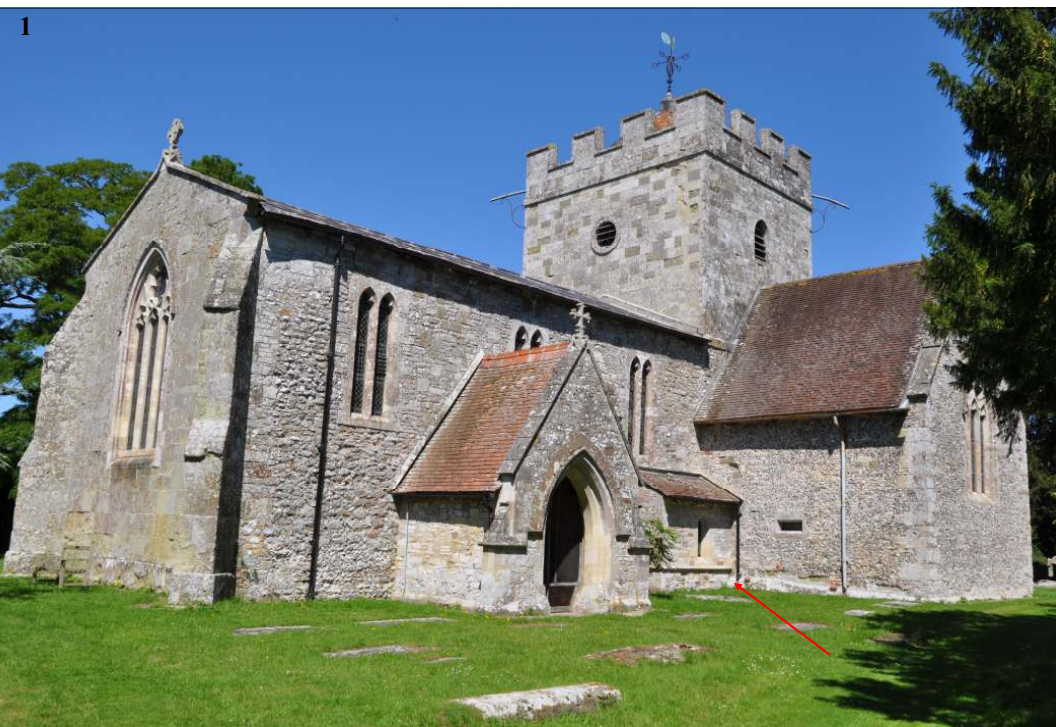
pictures, those on these 2 pages are individually numbered. The topmost picture is of the church from the SW and it shows (red arrow) the south annex built to protect the opened up south archway to its 'lost' porticus. The nave west wall is possibly a Georgian rebuild and with a new and larger west window dating to the Victorian restoration. At that time the west doorway was removed along with its plain porch, probably also Georgian in date.

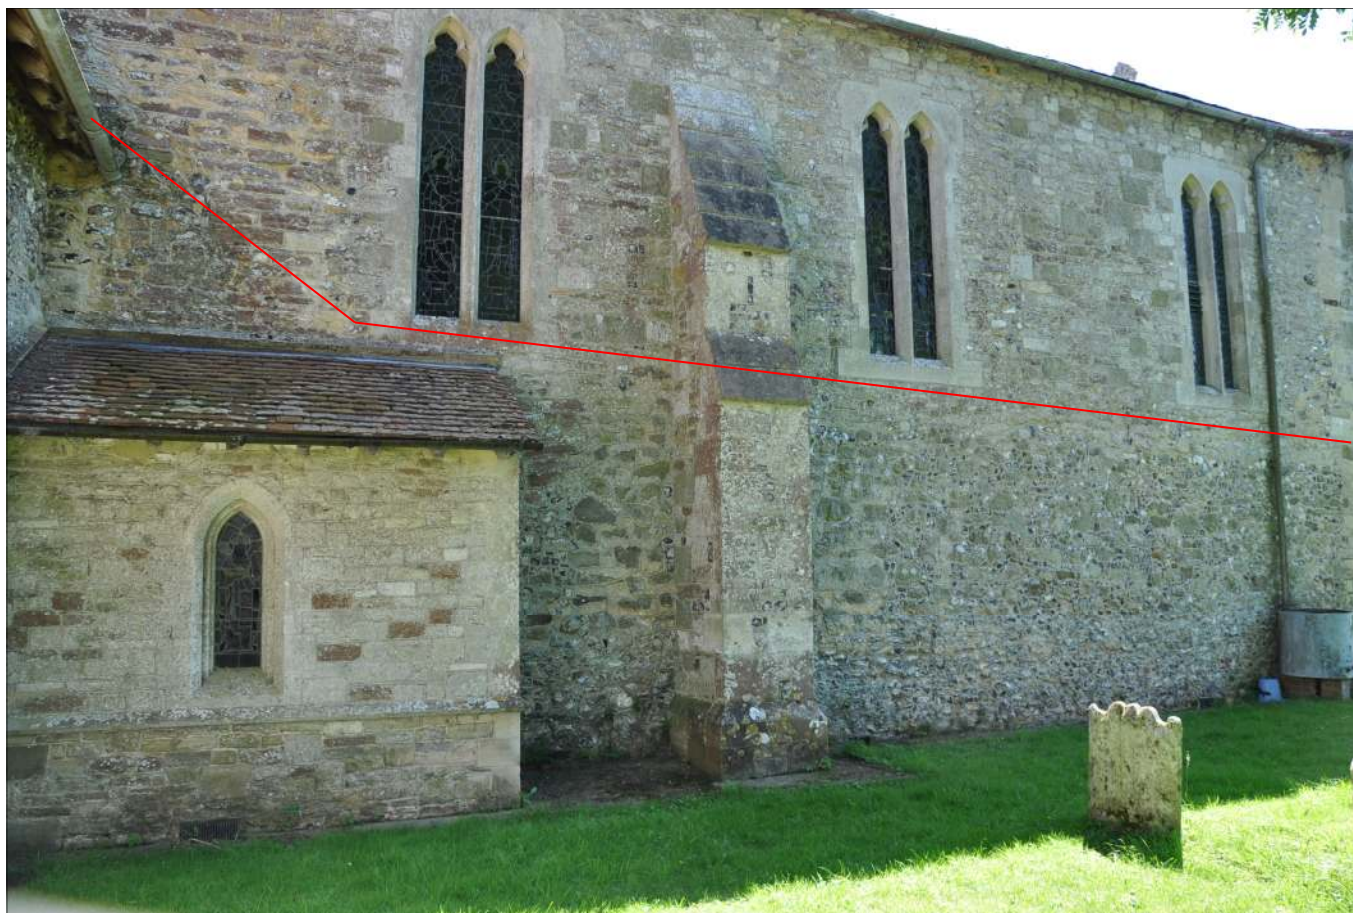
The lower picture is taken from the north and shows the nave wall with annex (to the left) sheltering the north archway. It can be seen that the walling above the red line is of a different makeup to the Anglo-Saxon walling below. Unfortunately this means there are no traces of any pre-conquest windows in the fabric, and the medieval tower and chancel have swept away every trace of any older work. The tower above eave level appears to be a Georgian rebuild.

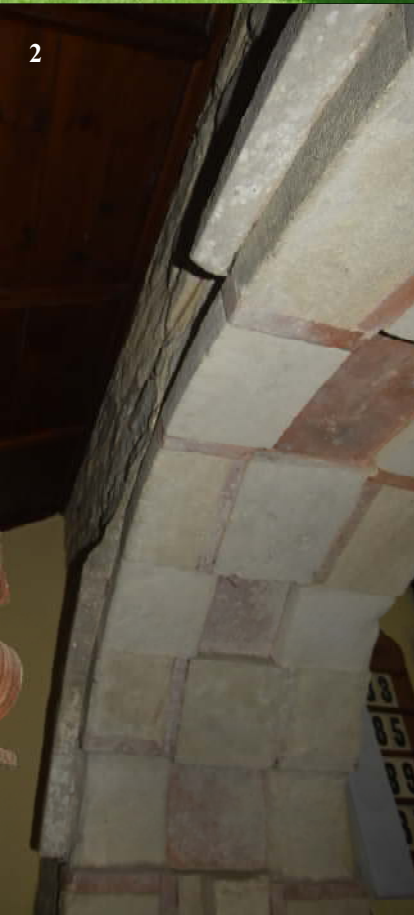
Photo 2 shows a part of the archway of the "external" or porticus face of the north archway and its attendant pilaster strip. It shows well the (almost complete) remains of the pilaster strip which is common to all Anglo-Saxon archways and here it appears to be the same thickness as the Roman stone tiles. It can be seen a little lower down in photo 9 (page 4). The pilaster strips to this archway are closely set to the radius and the internal face of the archway and jambs. BUT this is not so with the south archway where the strips are set at least a foot distant from the inside archway face. It seems quite possible, if we are to assume both porticus were built at the same date then we have two builders each constructing an archway and each with their own ideas on construction details. In fact having a pilaster strip set so close in proximity to the archway face is not usual. As examples see the drawing of Brigstock tower archway and the archway in Sherborne Abbey, both on this website and reproduced here on page 6.

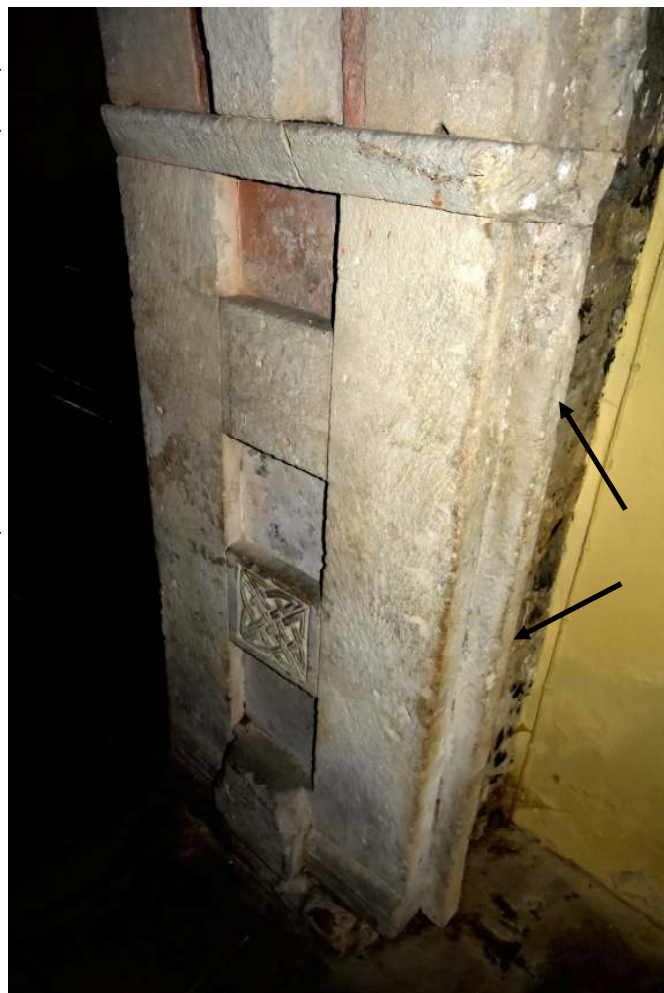
Photo 3. The west face/jamb of the north archway. Here we have plain vertical jambs unlike its sister. The impost is again Roman stone but a plainer moulding. I have included this picture as it shows the pilaster strip intact (black arrows) and not defaced, at least until it reached the impost where both pilaster and impost are hacked back to the wall face. Here in a very similar way to the archway in Sheborne Abbey. It simply reflects the style of perhaps the 13th century where pilaster strips were perceived as archaic and to bring the archway into current thinking pilasters were removed and here completely to the inside faces of the nave but only partially (half-heartedly) to the porticus faces. The same treatment unfortunately was meted out to the archway remaining in nearby Breamore church, but there it was total removal.

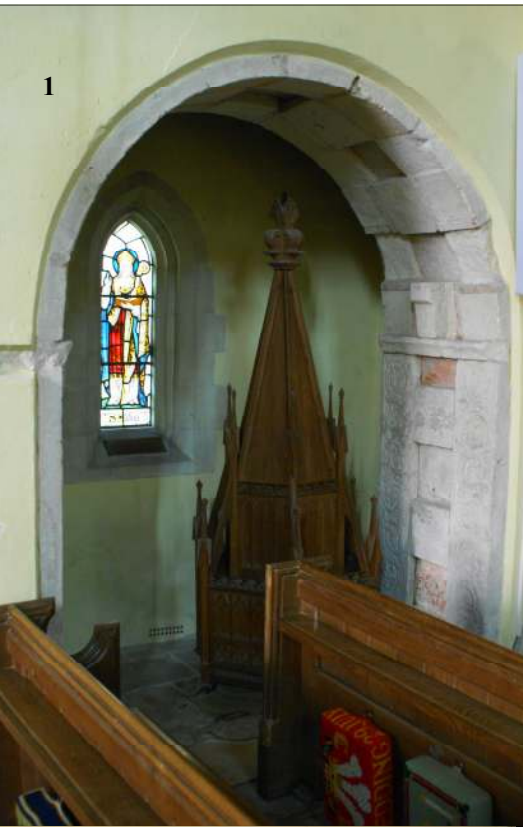
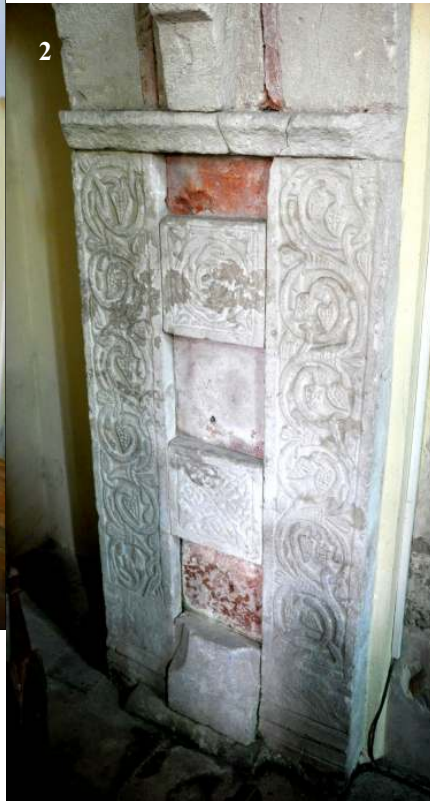
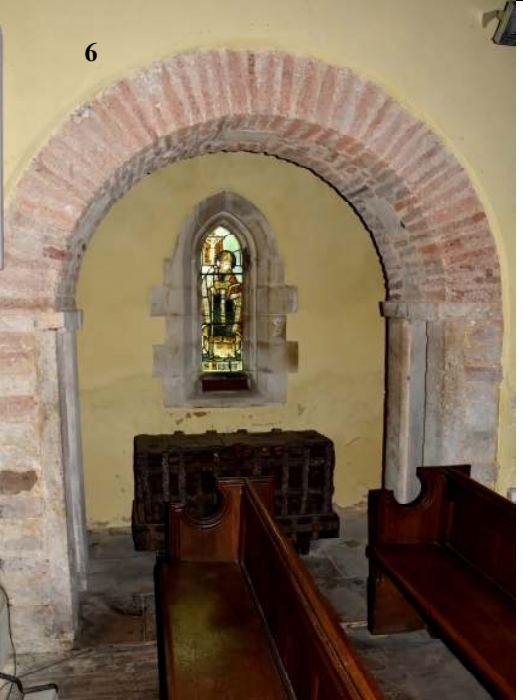
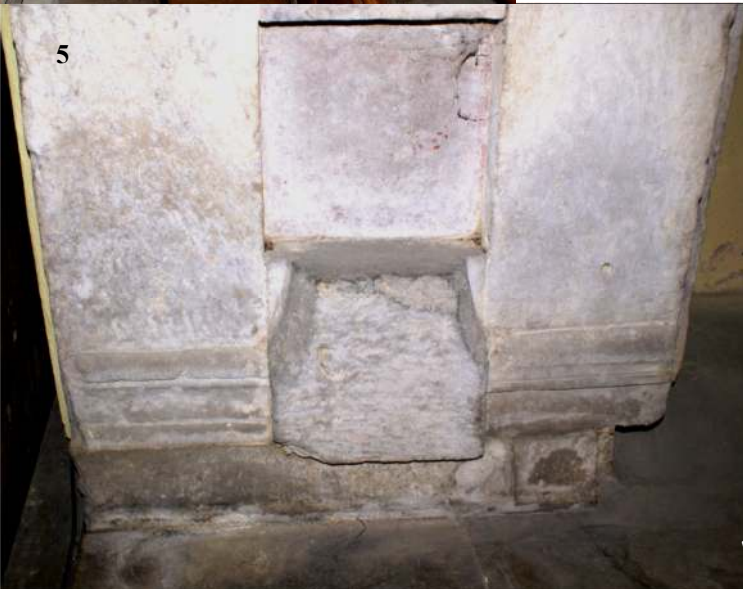
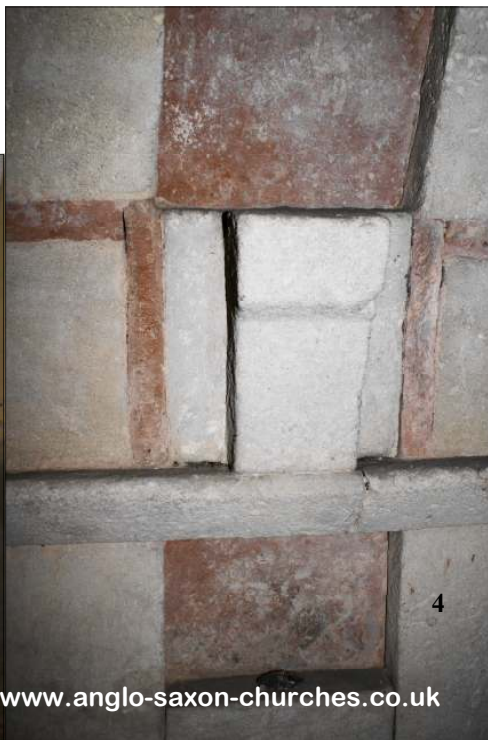
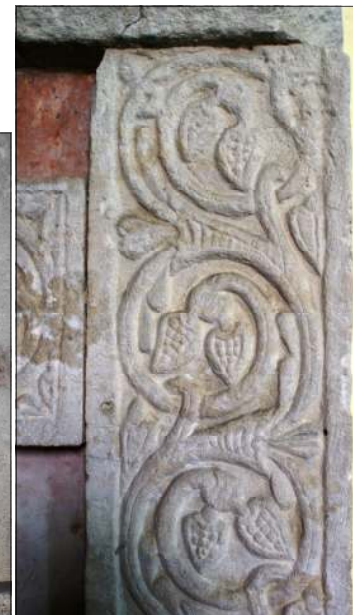
Pictures viewed clockwise from top left.

1. North archway.

2. East jamb of same; note that the vertical stones are of one piece, and this 'design' of grapes, or a vine, is found illustrated, albeit in more elaborate form, in Prof. Banister Fletcher's book "A History of Architecture" pg 67 illus. F. under the heading "Roman Ornament. 1."

3. Detail of Roman mouldings of the east jamb (southernmost of the pair). Note this stone has been truncated/sawn off at the top to 'fit' its new site. Taylor gives both stones as being 4ft 1in high and 8 inches wide. In both cases the Roman base moulding is integral to the whole piece of the worked stone and not a separate piece.

4. A detail of impost of north arch and its make up. Above the impost is an undecorated (unfinished) animal 'head' and is Anglo-Saxon work.

5. Base of the west jamb of the north archway, note the Roman mouldings, used like a skirting board; they are common to both jambs and are a part of that single stone. Note the "old" floor level some few inches above the present floor.

6. South archway, which comprises an archway of Roman (baked) tile rather than stone.

The arches are comprised, in my opinion, in the greater part of reused Roman pieces of stone, stone 'tiles', and baked/fired tiles, all put together as if in some strange jigsaw. The base mouldings (north archway) especially are pure Roman.

It appears as if the builder has been presented with a pile of stone and asked to make two archways. An interesting assemblage all things considered! Both these archways, on both faces were originally outlined with traditional square pilaster strips but are now much cut away; importantly parts remain visible inside both porticus. The nearest source of Roan stonework it seems would be the Roman Villa discovered years ago at Downton, some 5 miles downriver (R.Avon). The stones would easiest be transported by water.

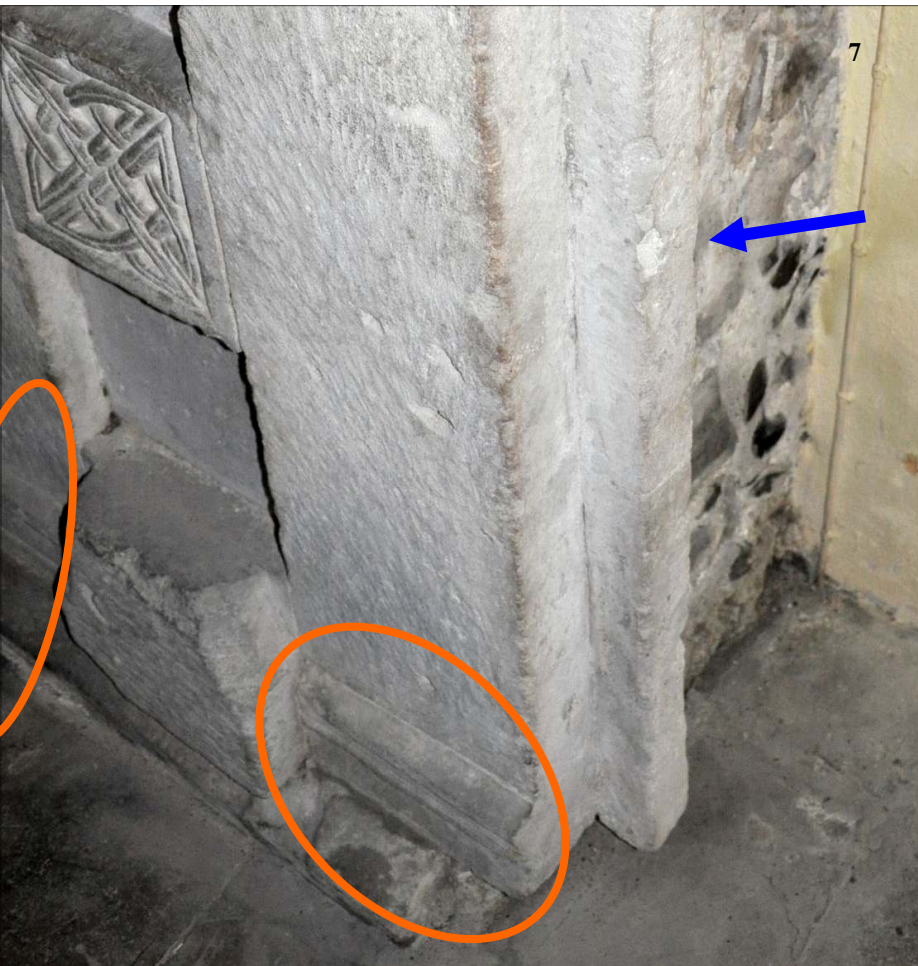
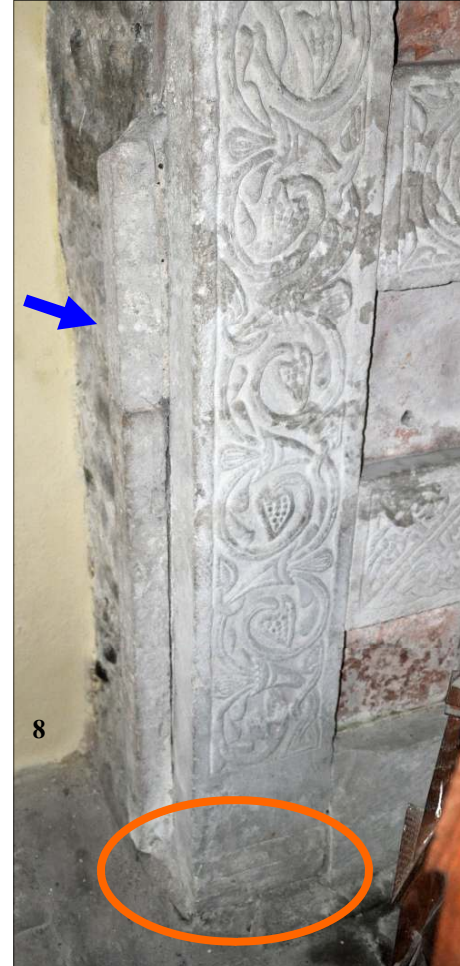
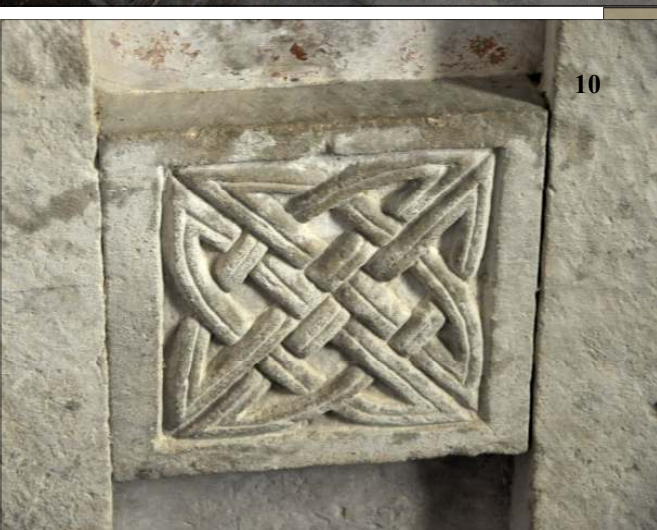
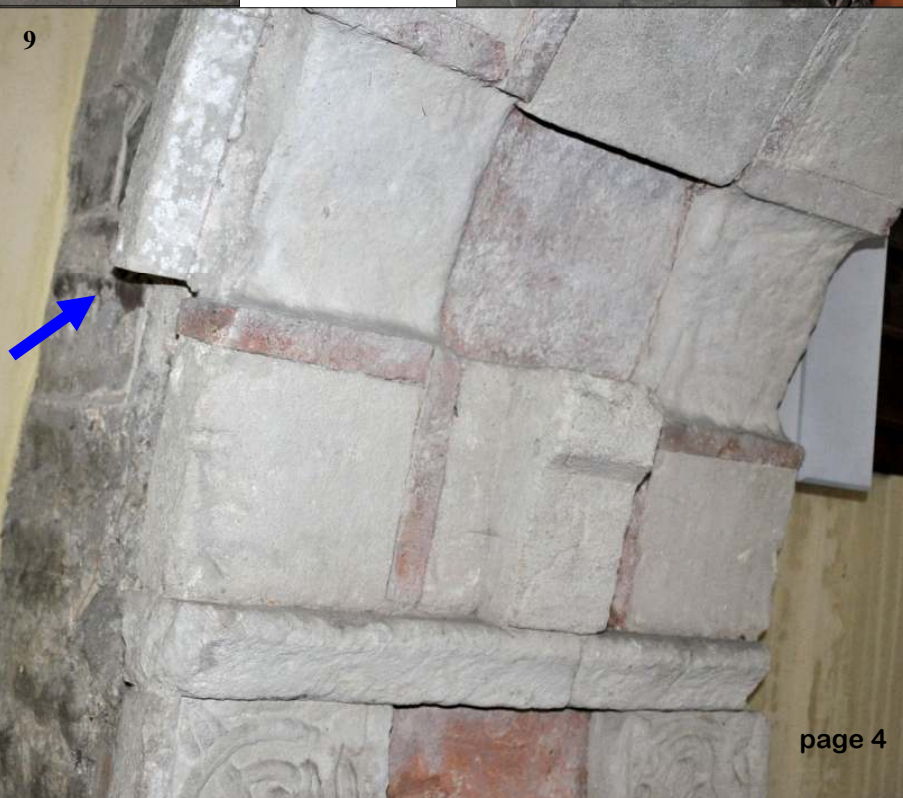
7. Here the west jamb of the north archway; the base mouldings (ringed in orange) are mentioned on page 3. They repeat on the east jamb. H.Taylor described them as being more like a skirting board, they are patently not Saxon, the vertical stones are reused and Roman in date/style. Here on the north face, you will see a traditional square section pilaster strip (blue arrow).

8. On the east jamb the Roman moulding seen again, ringed in orange. Note the decorated Roman stone occurs on both 'edges' on the east jamb but the uprights on picture 1 of the west jamb are plain. Perhaps the builders simply didn't have enough decorated stone? Note the square decorated tiles used quite separately. Blue arrow shows the distinctive A-Saxon type pilaster strip.

9. Looking at the north side of the east jambs with the archway springing from the impost, note the delicate square section pilaster strip running up from the blue arrow, it has simply been cut away below this point. Note the undecorated/not sculptured 'head' sitting above the impost (a tooled/moulded Roman stone reused here).

10. Previous page, a beautifully executed Roman decorated stone seen in more detail, seen in its position in pic 7. It is decorated in an intertwined strap work design.

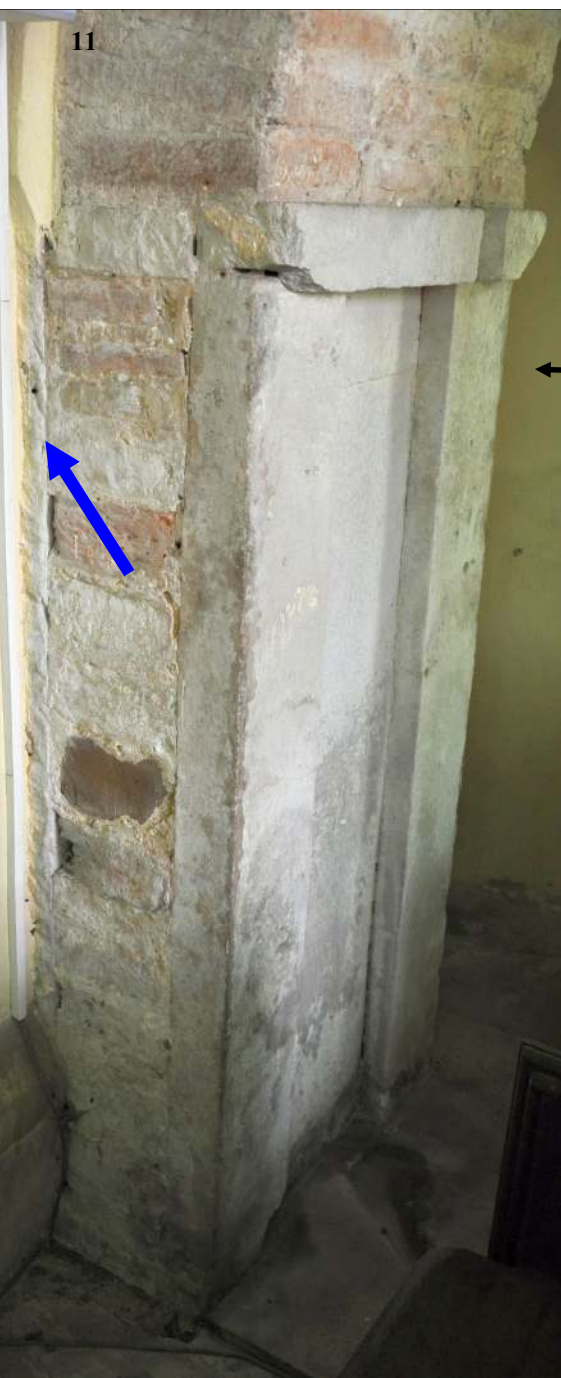
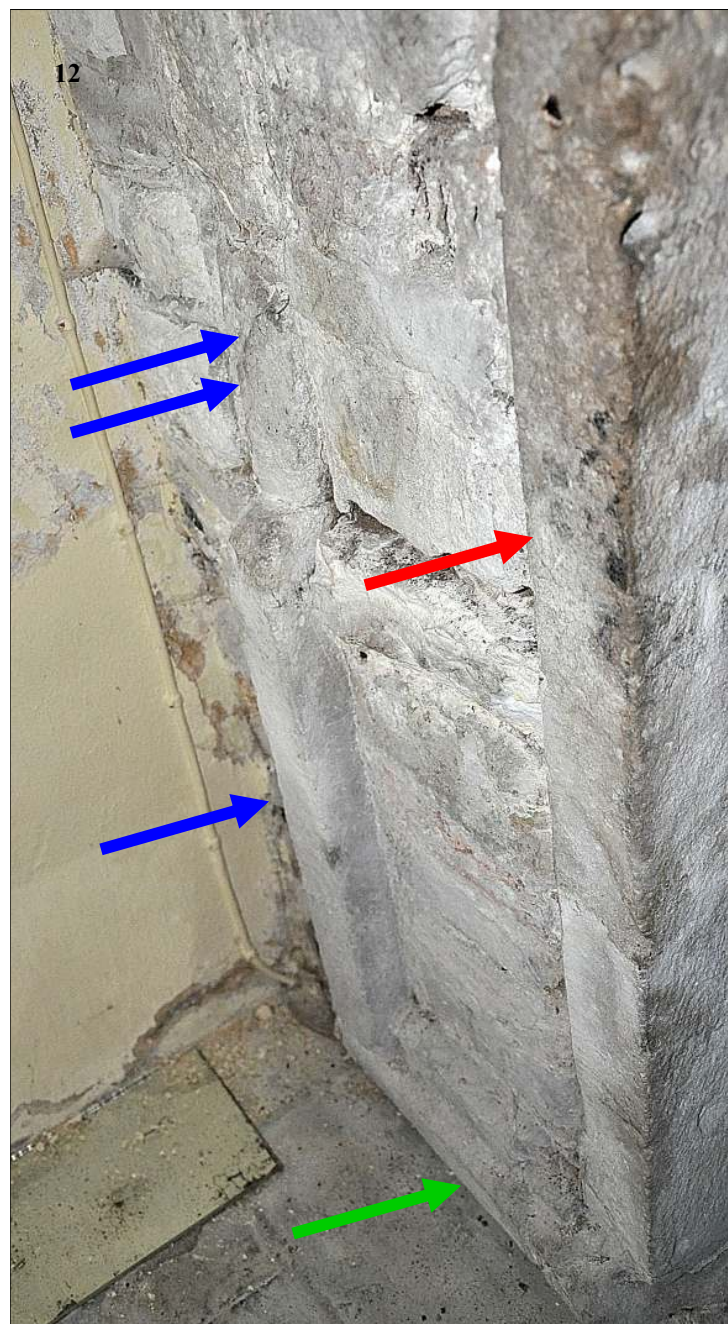
11. The south archway (top left this page) has a very different treatment that sets it apart from the north archway. This is the east jamb seen from the nave (north/interior face). Picked out by the blue arrow is the remains of the easterly pilaster strip which is not extant above the capital/impost. The impost also is hacked away on its north face. See how the east jamb uprights are 'notched/let in' to the impost (a timber technique). And see the coloured drawing illustrating this, where the jamb is in blue the impost in red, and the nave walling behind the impost in green. Observing picture 11, the jamb construction is similar to the

north archway but importantly here all the uprights are plain and devoid of detail, the central part being set back in a similar manner to its sister is devoid of decorated tiles. Compare this to picture 1. The impost is not chamfered but is a square plain section. The archway is constructed wholly of Roman bricks, yet its sister uses stone where each has been carefully shaped to a radius.

12. This shows the west jamb viewed from the south (not easy to photograph as the 19th century annexe built to protect the then newly opened archways is very cramped). The single blue arrow indicates the square pilaster strip and above the double blue arrows show where the pilaster strip has been cut away. The red arrow shows how the jamb protrudes in a vertical plane thus in itself making a pilaster strip. The whole 'assembly' sits on a protruding plinth (green arrow) and in line with the face of the pilaster strip.
