# Church at Corhampton, Hampshire. (no known dedication).

## Church at Corhampton.

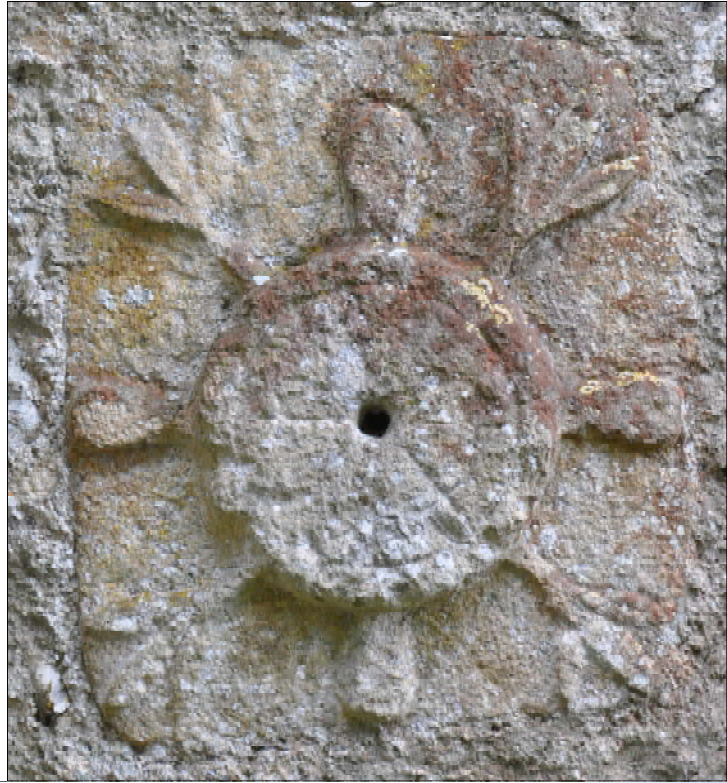
1. Sundial in S wall of nave, about 2 feet high and divided into eight directions marked by objects like the handles of a ship's steering wheel with the diagonal axes marked by branches ending in trefoil leaves, or flowers.

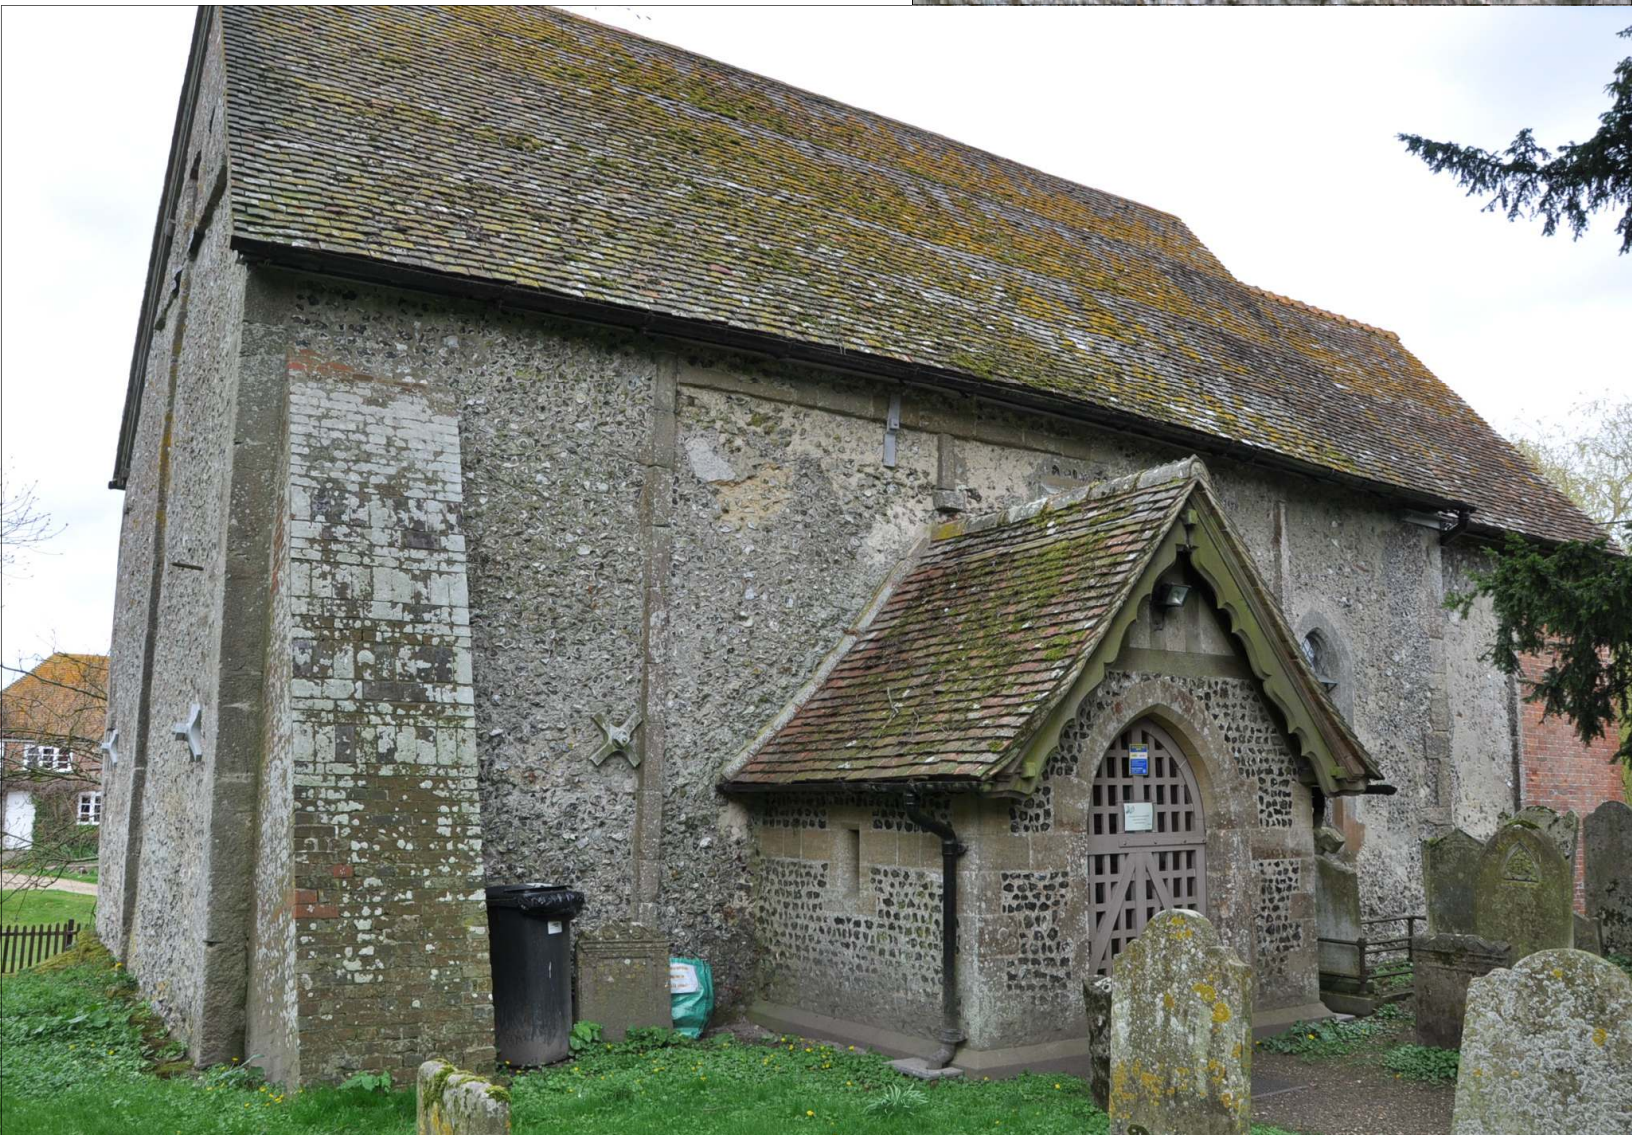
2. The church seen from the south, comprises a nave in substantially its original form and chancel with rebuilt eastern end in brick (1855. When road widening caused subsidence). The main walls are built of whole flints, lightly plastered and dressed stone is used for the long-and-short quoins at all four angles of the nave. The S porch is medieval and the original south doorway accessing the nave much rebuilt to provide a medieval doorway. The N doorway has been blocked and a window inserted in the blocking. The pilaster-strips spring from a well defined square plinth of roughly dressed stone. Note the central pilaster-strip on the west wall which runs up to a horizontal string-course and which may well have been at the base of the original gable, the side walls having been shortened at some date by about three feet. The pilaster-strips are formed of dressed stone laid with closely fitted joints and occur on both north and south nave walls (source H.Taylor).

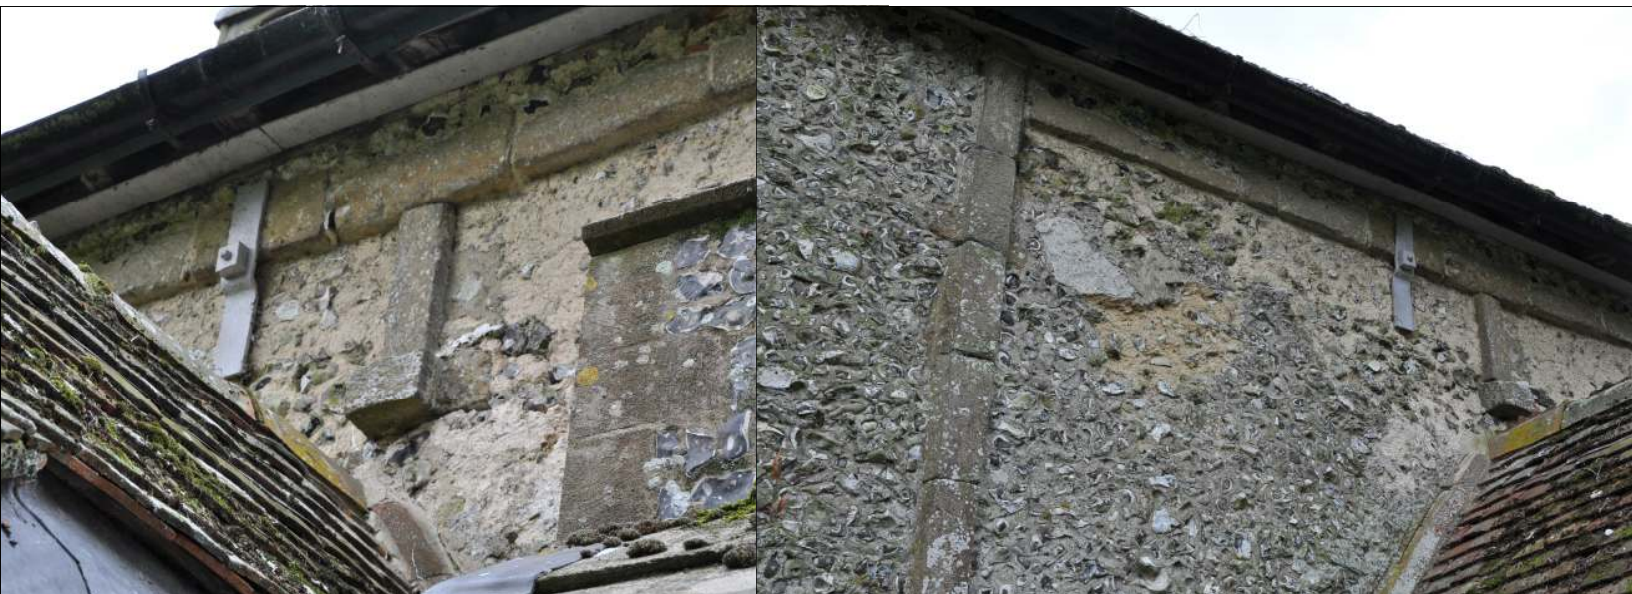
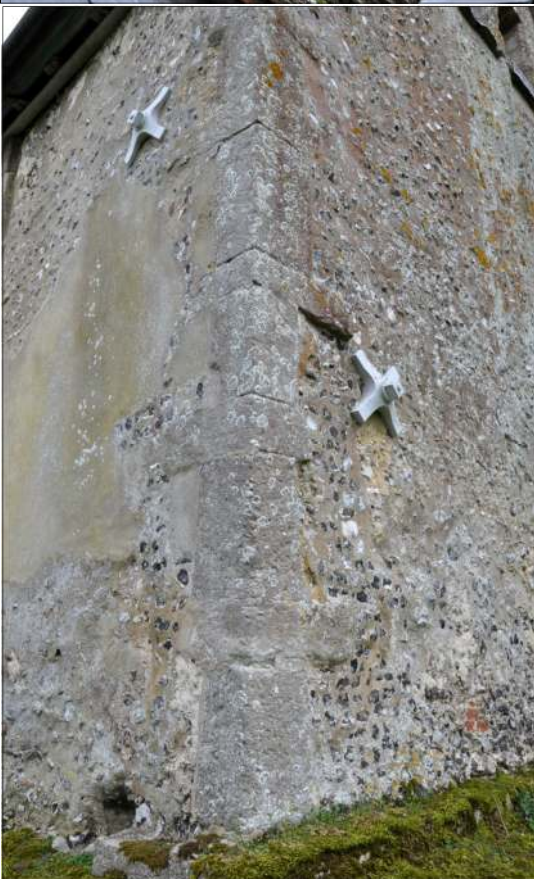
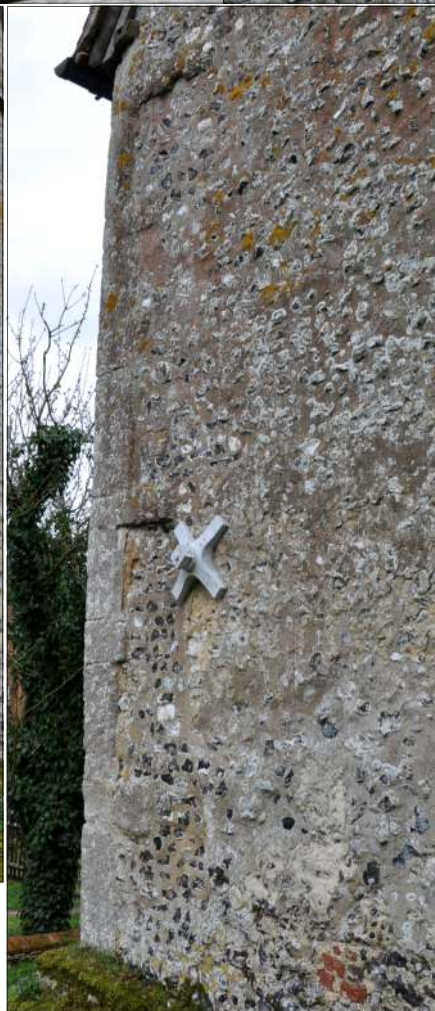
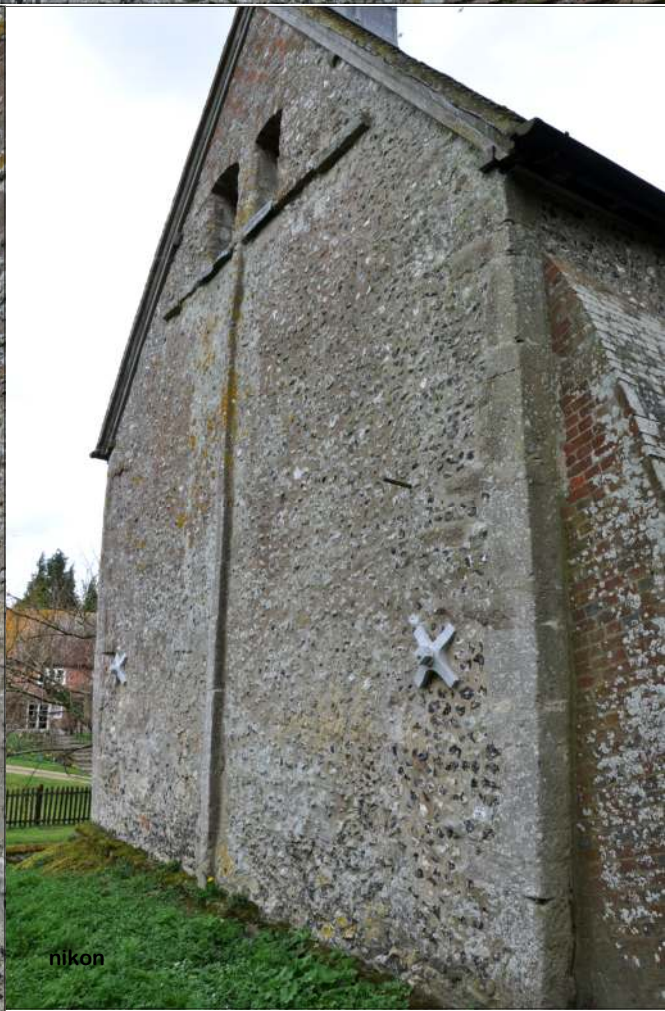
3. Detail of pilaster-strip and horizontal string-course above roof of south porch, note pilaster-strip rising from a stop.
4. Seen again with horizontal stripwork running to the west of the porch with associated pilaster-strip on the left.
5. The west wall, with twin openings under rebuilt brick and stone gable. These were used at some stage as a bell cote and a drawing published in 1846 shows a massive stone lintel forming the head (now rebuilt in segmental form).
6. A closer view of the NW long-and-short quoin and part of the face of the west wall.
7. The NW quoin again but seen from that quarter.

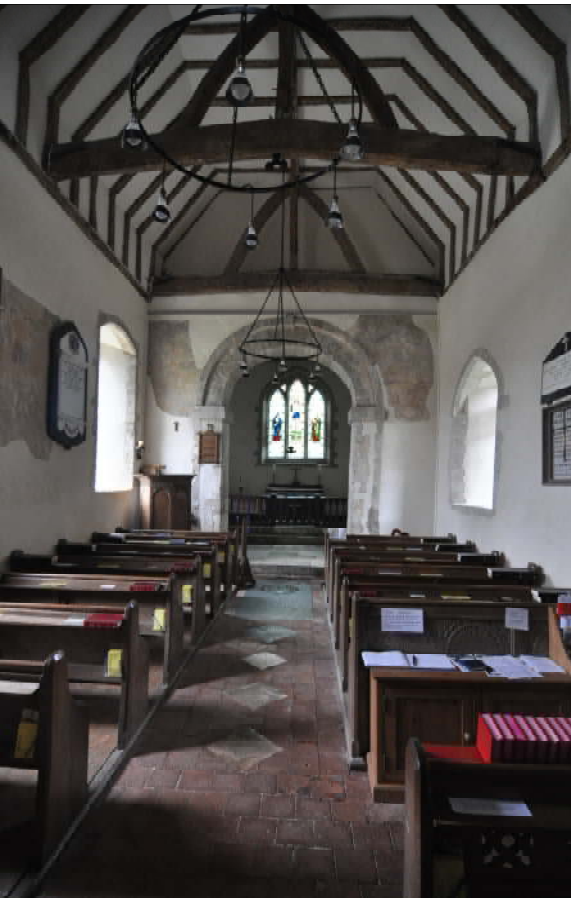
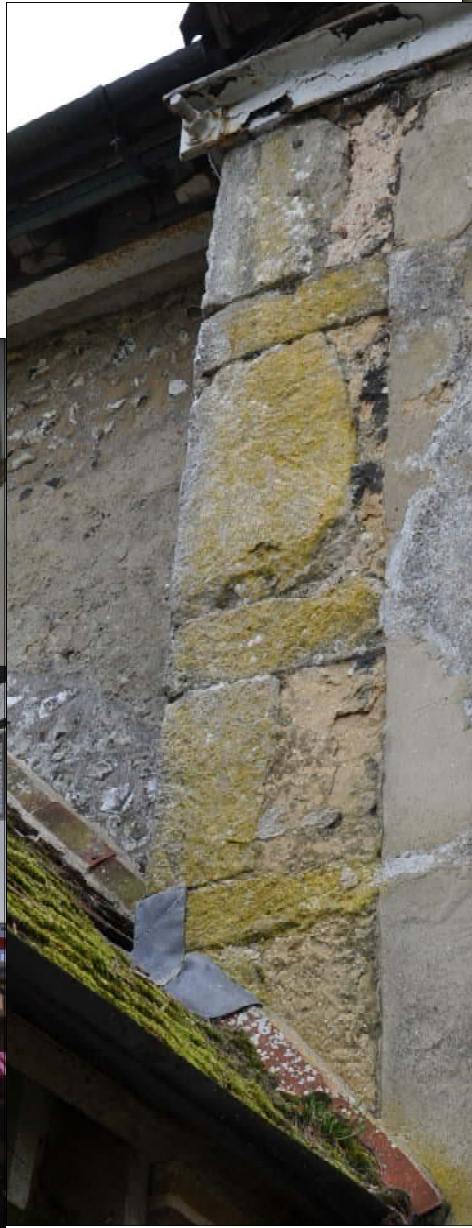
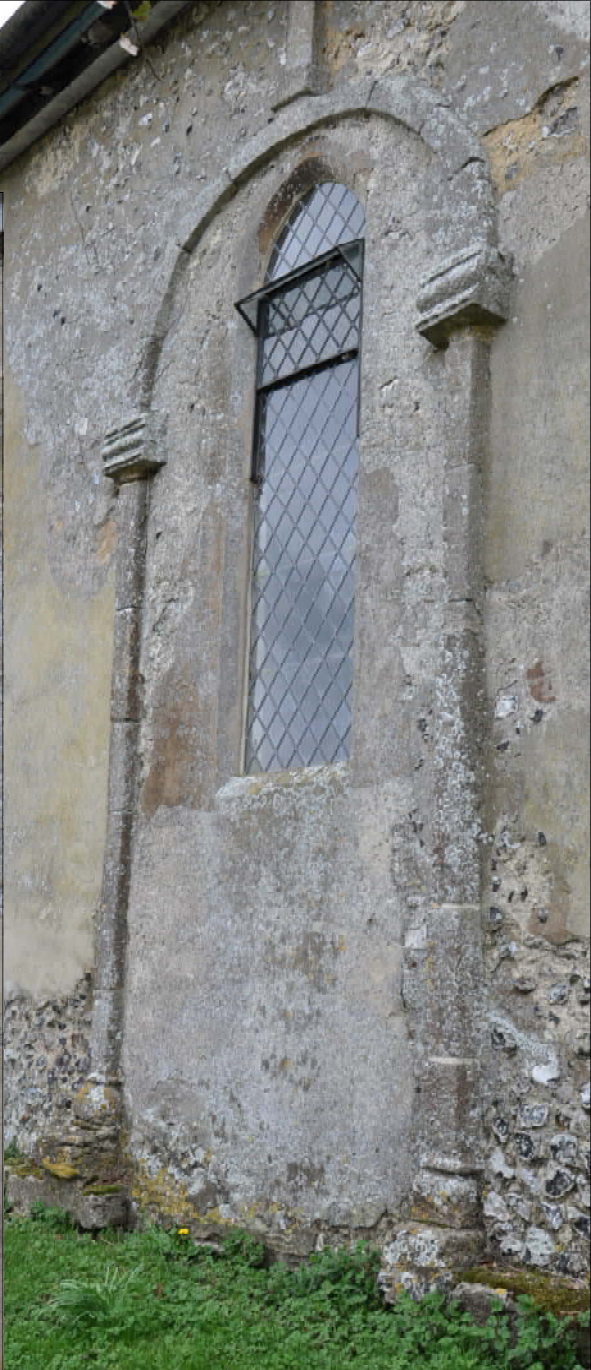
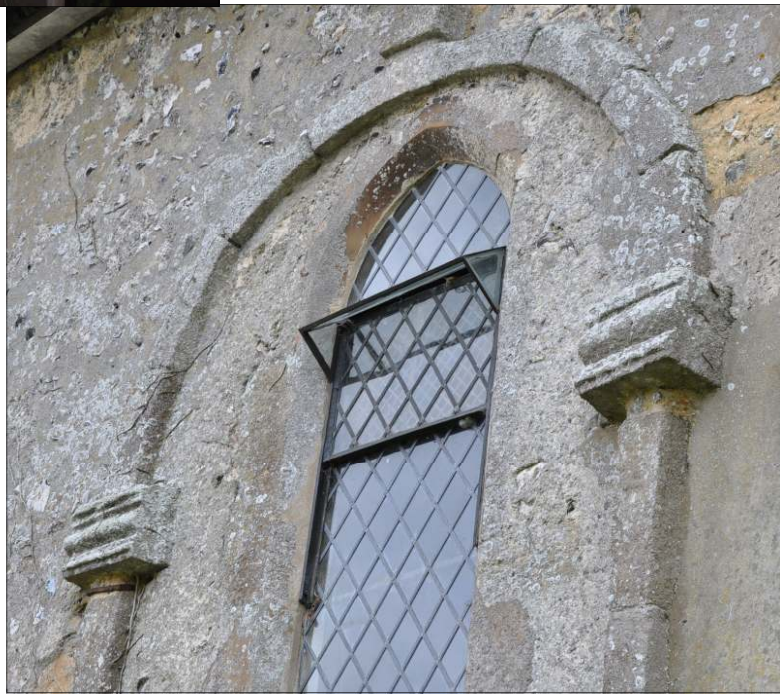
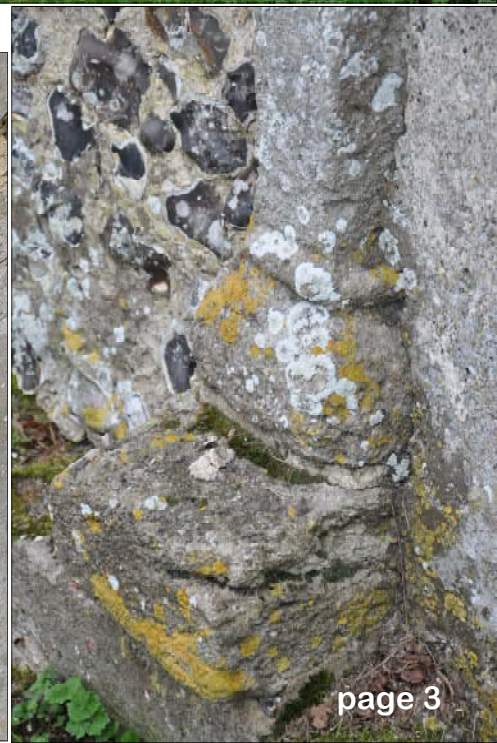
- 8. The interior looking eastwards.
  - 9. The upper part of the NE quoin of the nave.
  - 10. The blocked north doorway.
  - 11. Detail of E base of this doorway.
  - 12. Closer view of the arched head and its imposts.
- At the plinth the pilaster-strips have simple rectangular bases and were decorated with three upright leaves of which one is carried around on the corner and one is set flat in the centre of the face. Weathering in the ensuing 50 years since Taylor saw these features has sadly made such identification extremely difficult.

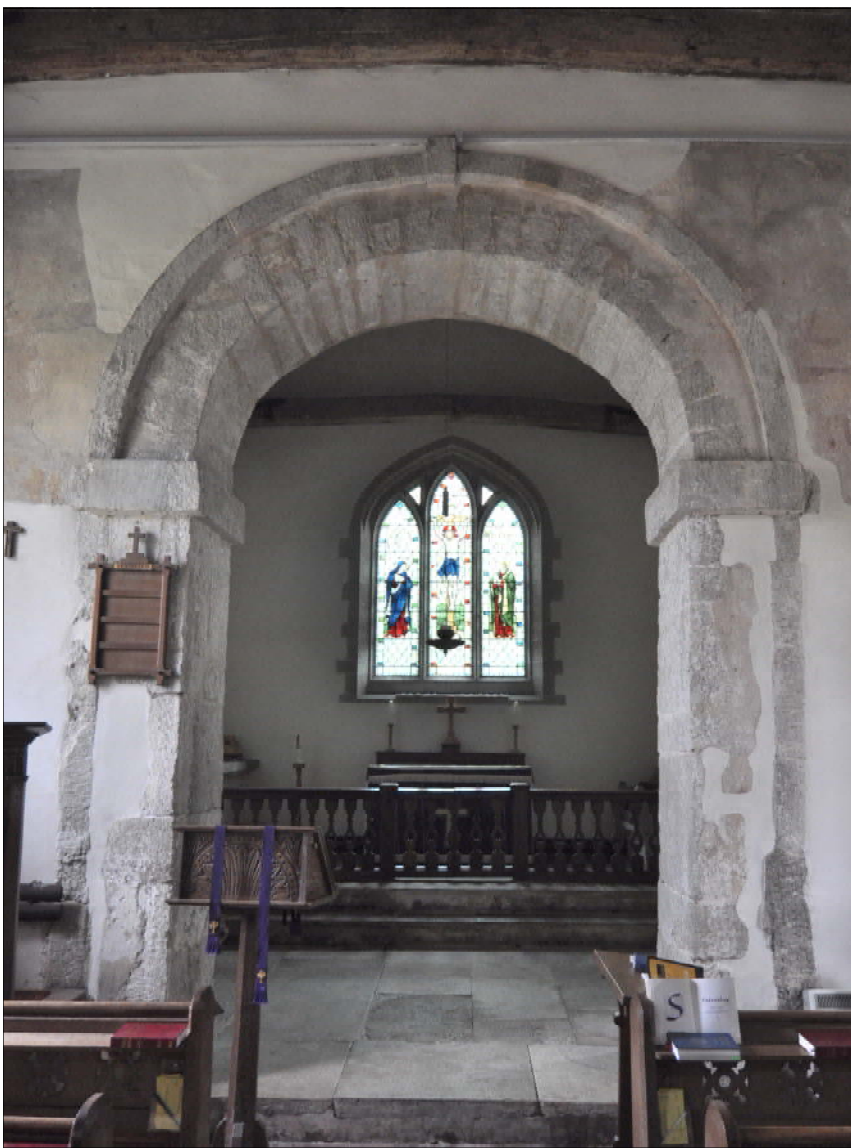
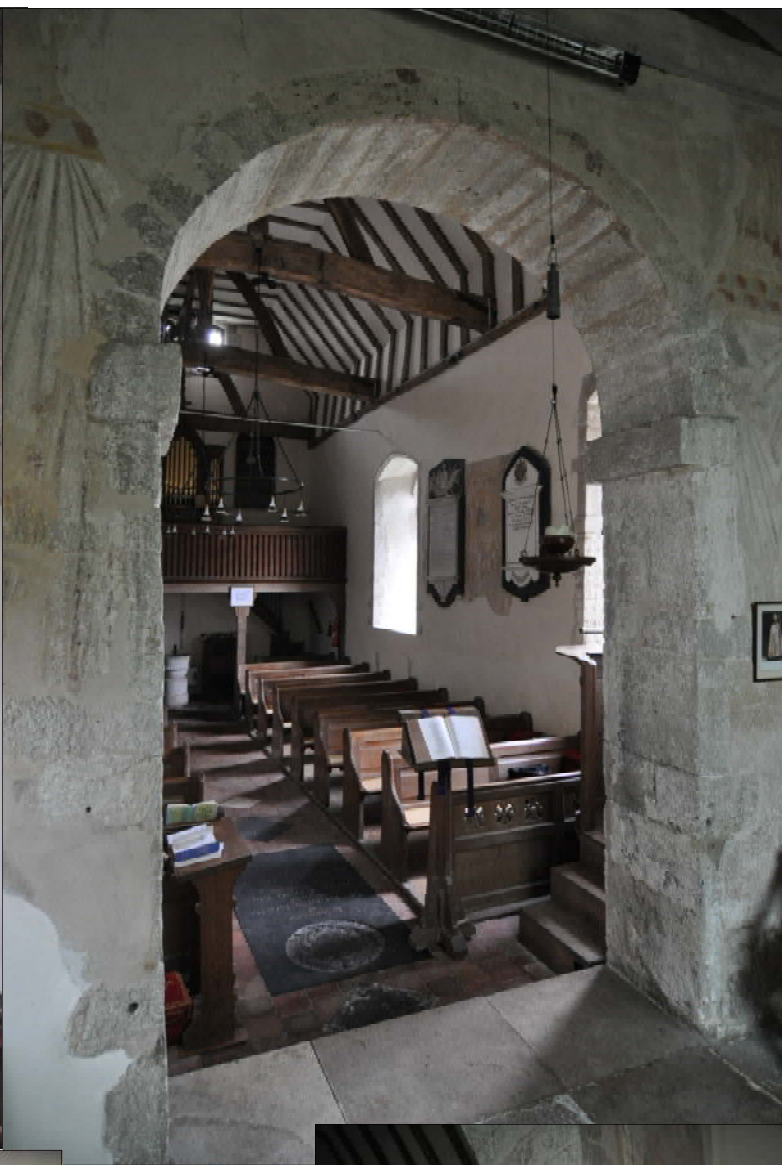
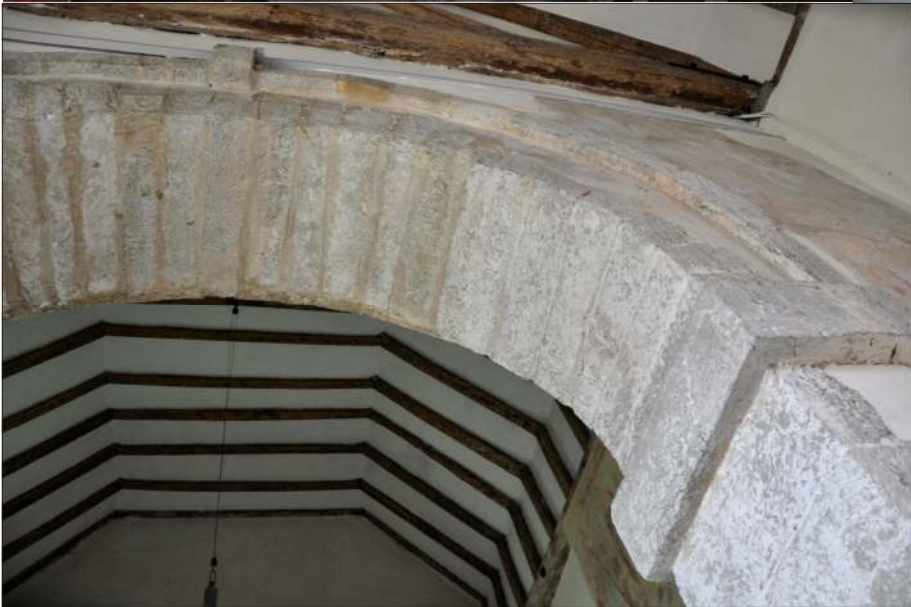
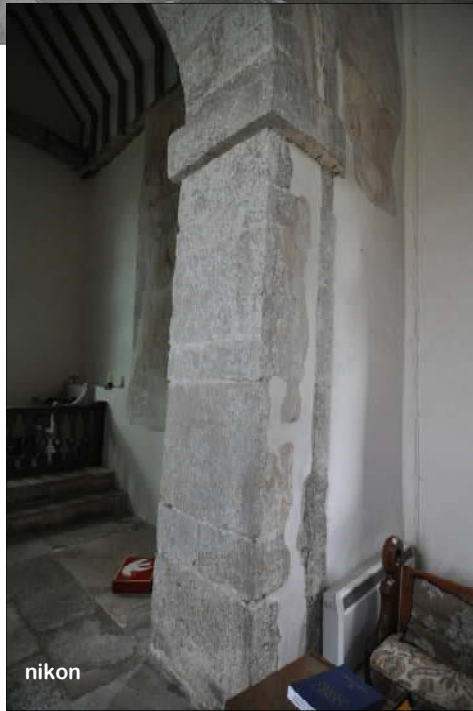
13. Seen from the west, the chancel arch which is of one square order with through-stone voussoirs neatly laid with (nearly) radial joints. The jambs are predominately laid with through-stones, and the imposts are bold rectangular blocks. The western face of the arch was outlined by strip-work carried up the sides as pilasters and round the head as a hood-mould but the vertical pilasters have been hacked away almost flush with the wall face (a medieval “tidying”). An unusual feature is a pronounced keystone at the head of the hood-mould.
14. Chancel arch seen from within the chancel.
15. The southern jamb of the arch seen from the nave.
16. Looking up at the arch from within the nave (note the keystone again).
