Church of St Mary, Deerhurst, Gloucestershire (and also Odda's Chapel of the Holy Trinity, which see page 5).

All pictures viewed clockwise from top left.

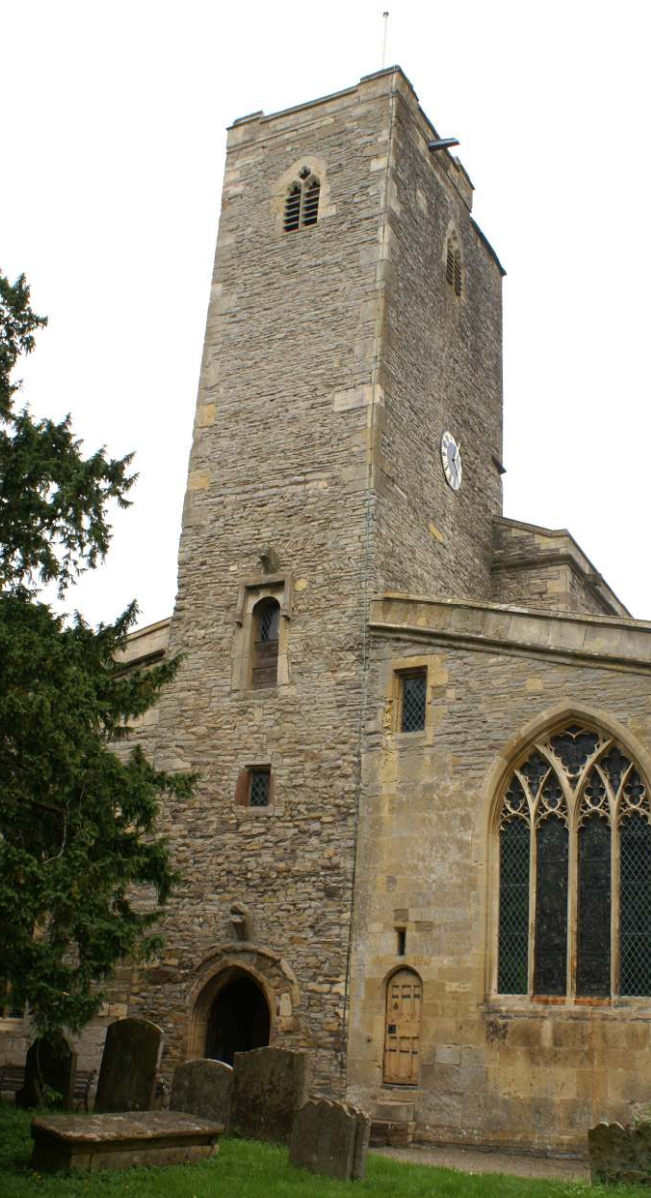
1. West tower, from W.
2. Upper stages of tower from W.
3. W doorway, situate west face of tower. The present doorway is medieval and sits inside the A-Saxon doorway, see the original hood-mould and the carved beast above.

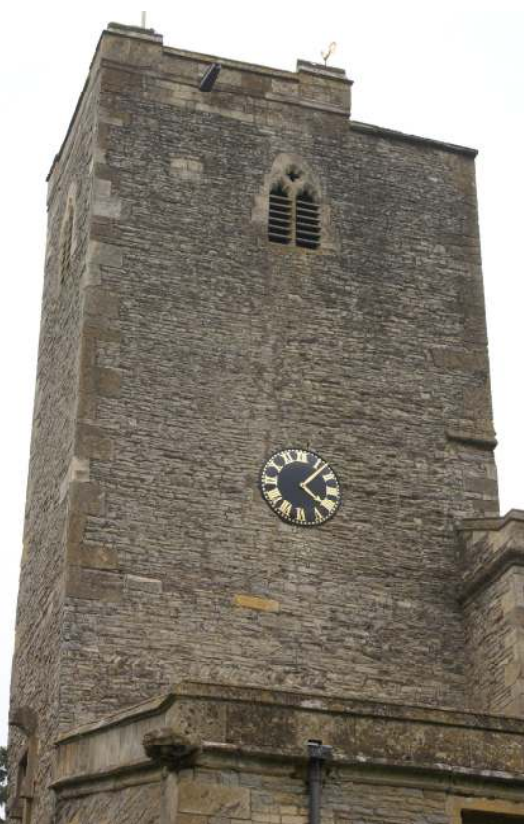
4. Western tower, south face.

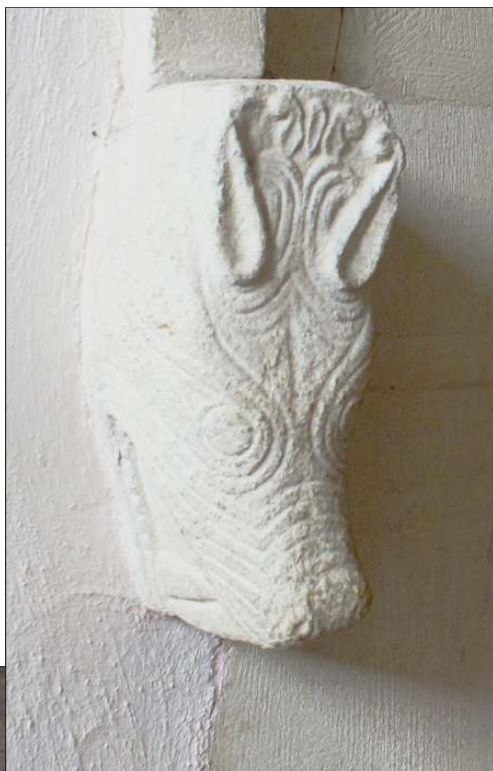
5. Animal head as label stop, internal doorway, gnd floor, tower.

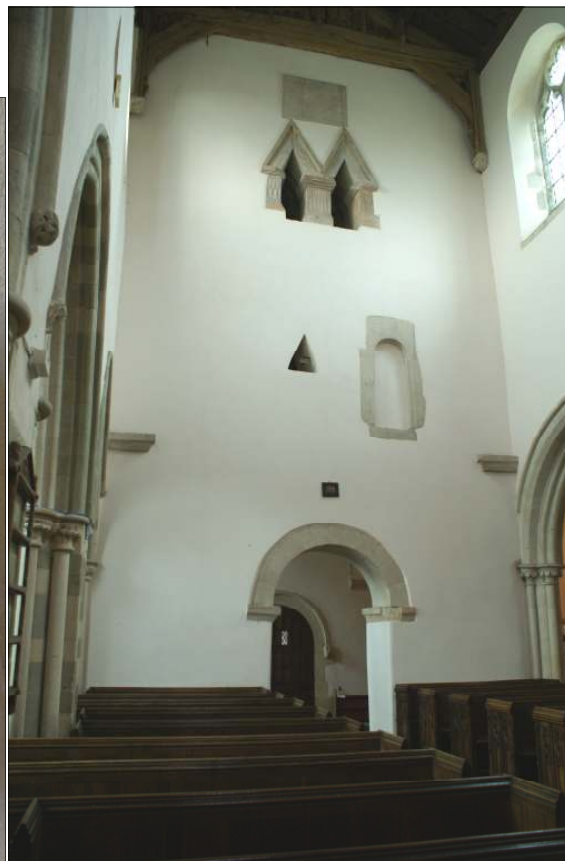
6. Looking towards the west, in nave, showing east face of tower with archways etc.

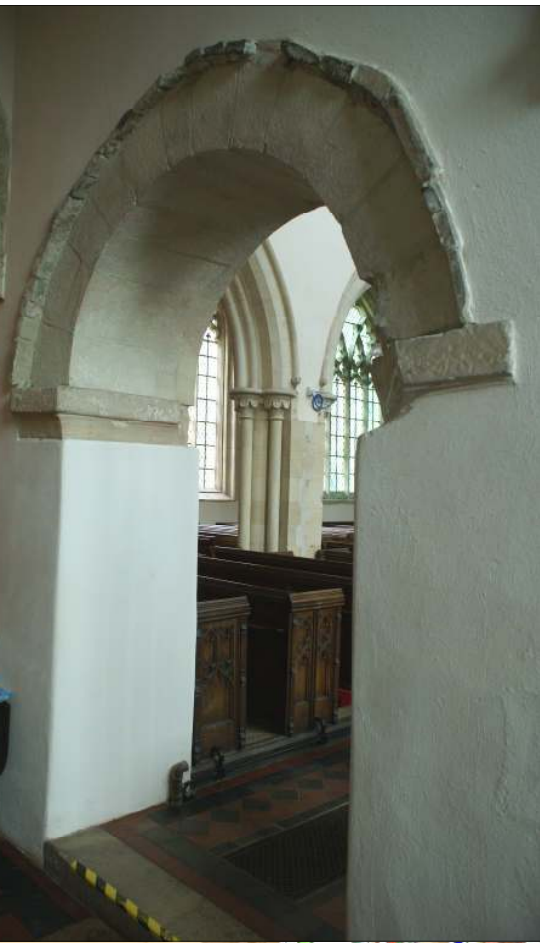
9. Ground floor archway in east face of tower wall, seen from inside the tower, thus its west face seen from the SW.

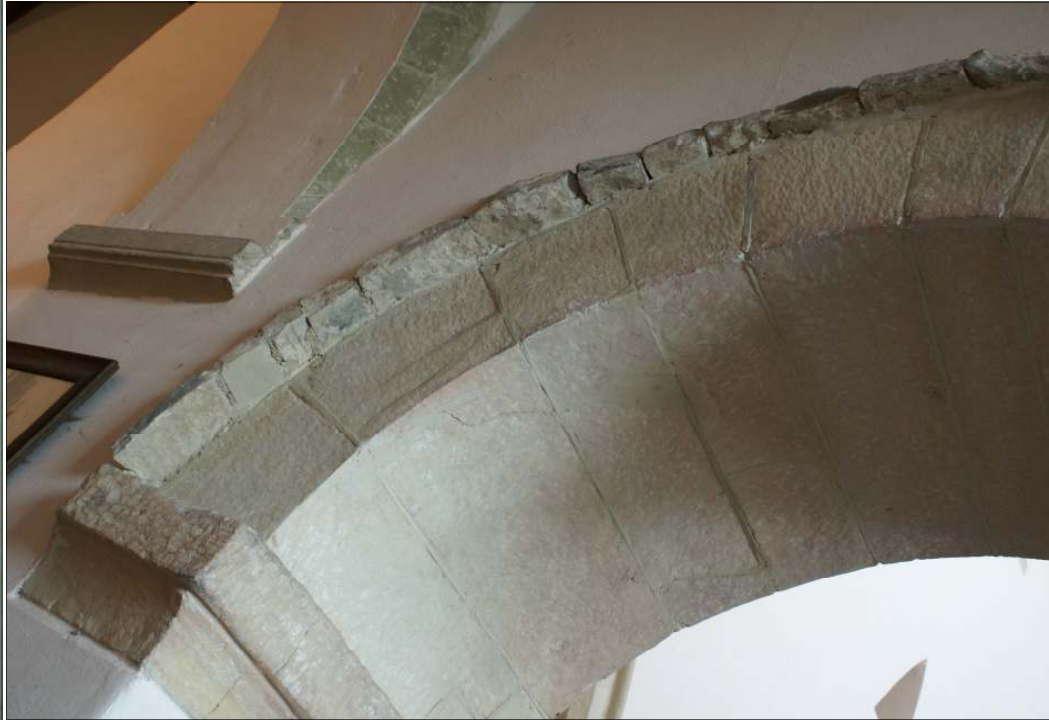
10. A part of the archway, a close-up view, same aspect.

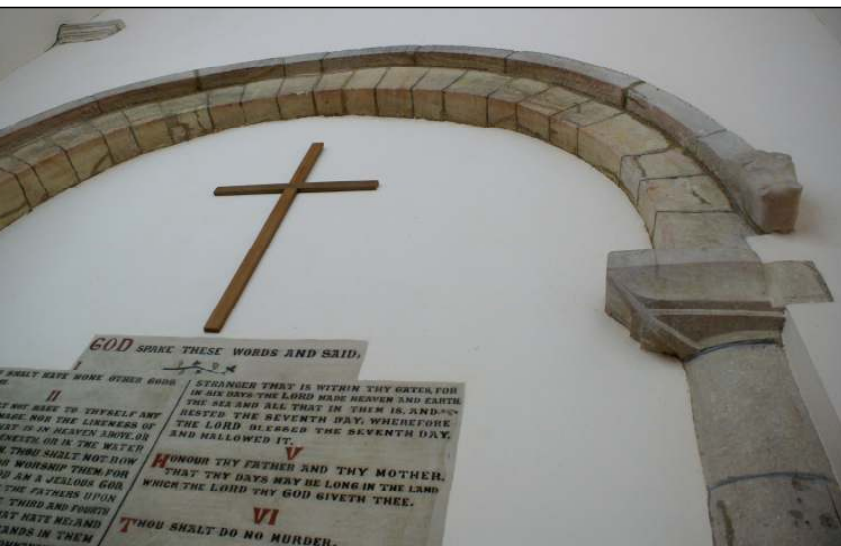
13. The remarkable chancel arch seen from the nave, including the southern capital.

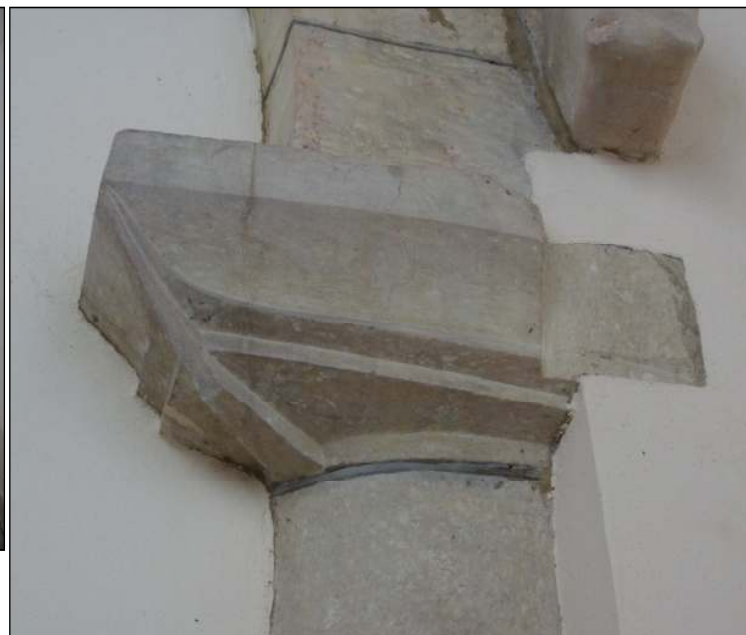
14. The S capital in detail.

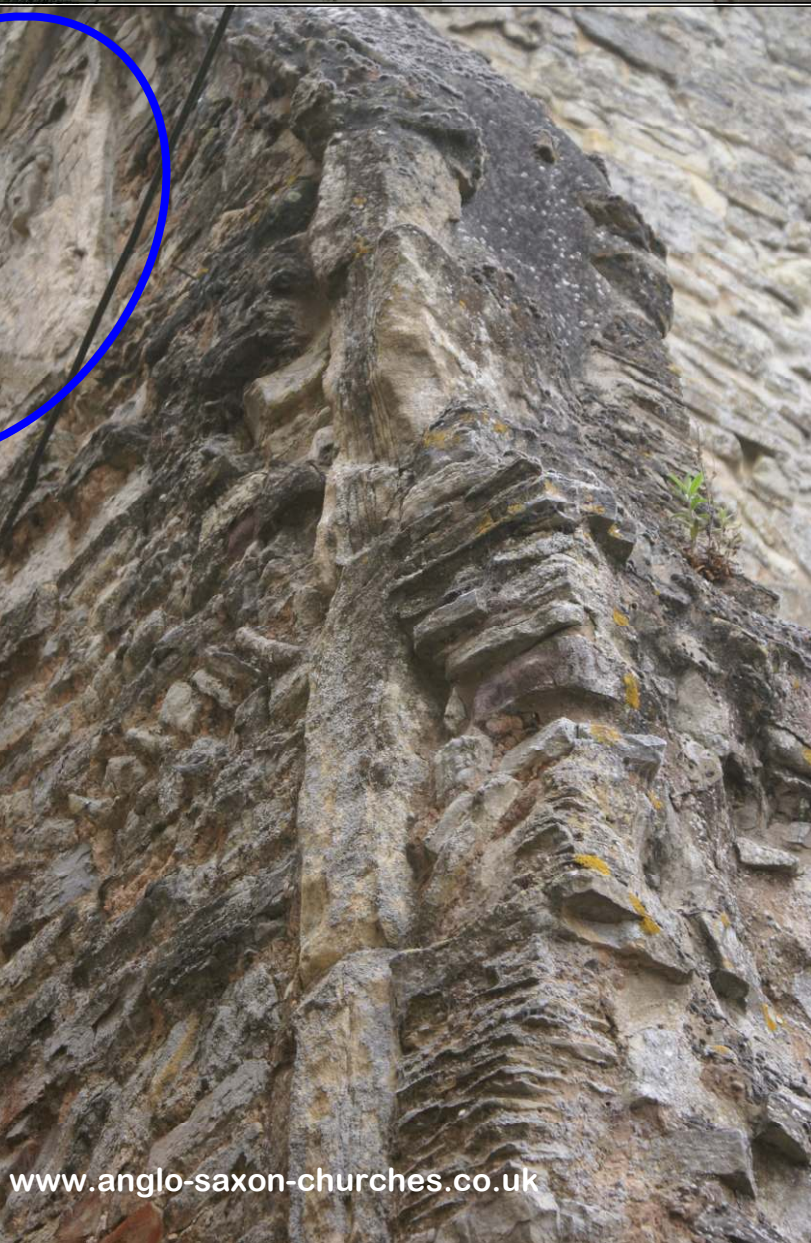
15. Chancel arch seen from site of ruined chancel.

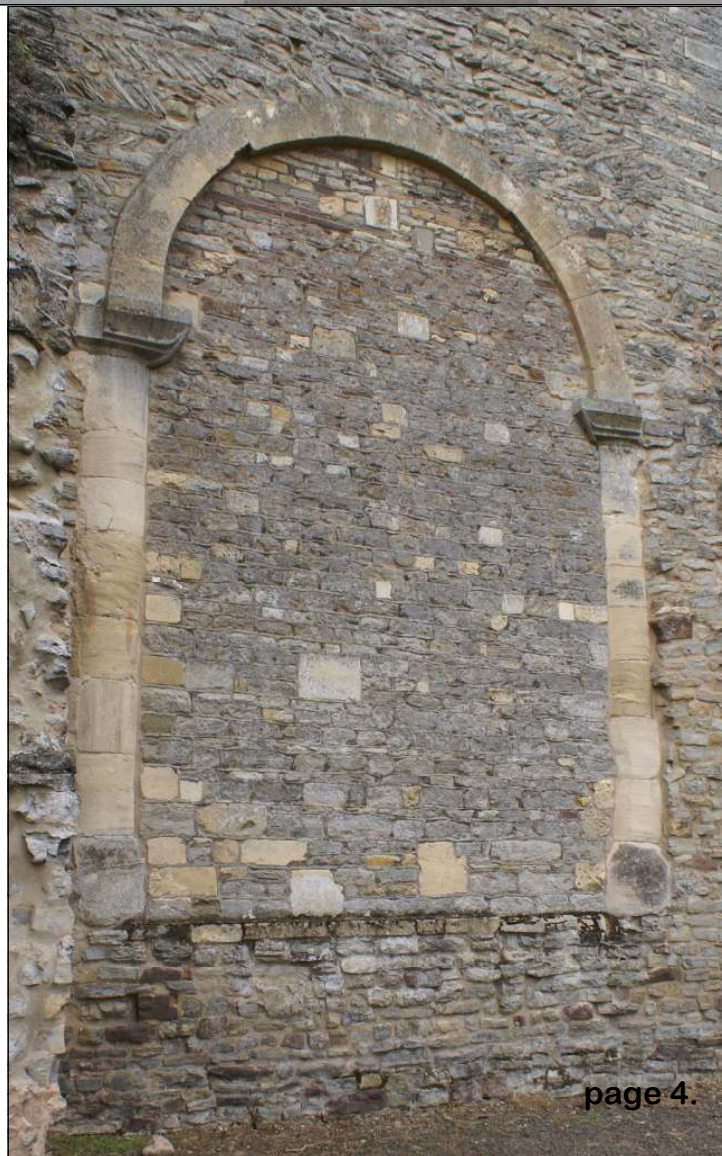
16. The 'Deerhurst Angel', seen at top L of picture (inside the blue line) and under the triangular hood, S wall of chancel; note also the pilaster strip to the right at the break of the wall and the way the stonework of the pilaster is bedded well into the wall thickness (ignore the black line running from underneath the angel towards the top, it is a telephone line!). This particular part of the church is only a few yards away from the adjoining farmhouse/old priory and makes photography very awkward.

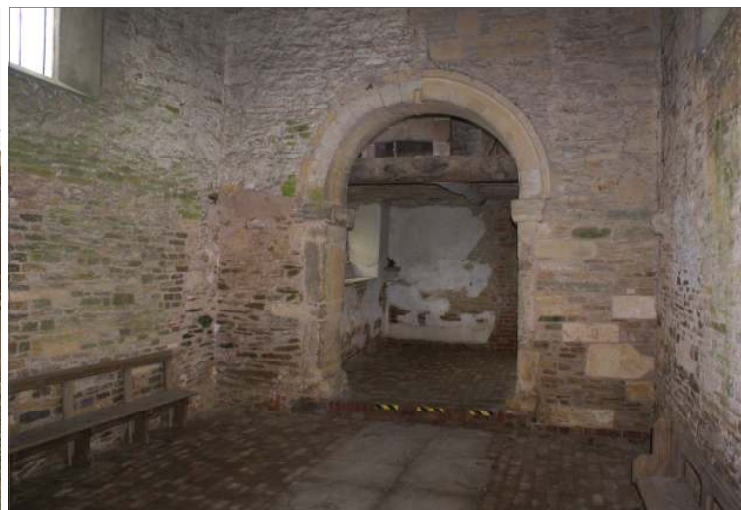
17. The chapel from the SW. 2. The chancel arch from the nave. 3. The S capital of the chancel arch.

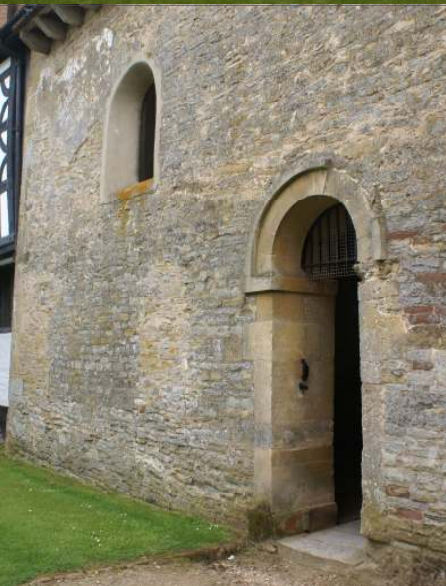
18. Double splayed window in N wall nave, seen from outside; this window has remains of the oak frame in situ.

This fabric is precisely dated by the dedication stone (which was discovered in 1675 discarded in the adjoining orchard and now in the Ashmolean Museum, Oxford) to 12th April 1056.

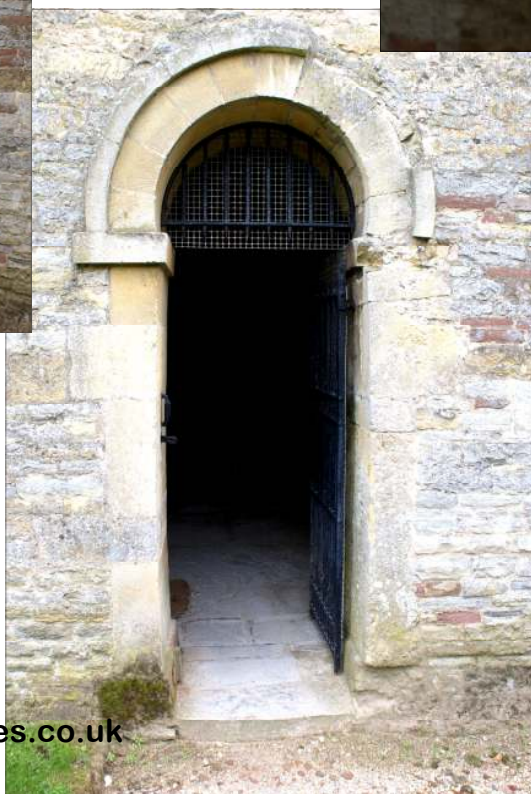
19. Doorway, N wall nave.

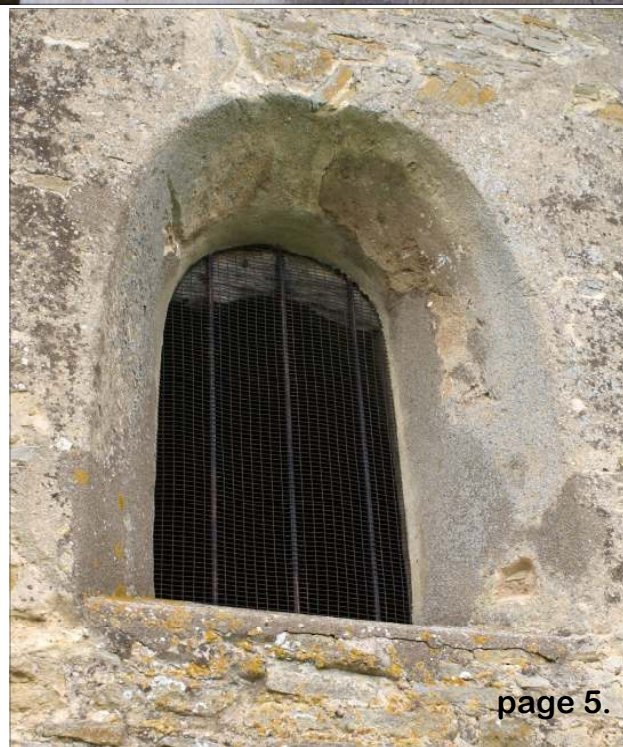
20. The doorway and window in N wall of nave.
