Church of St John, Escomb, Co. Durham.

Escomb, Co. Durham.

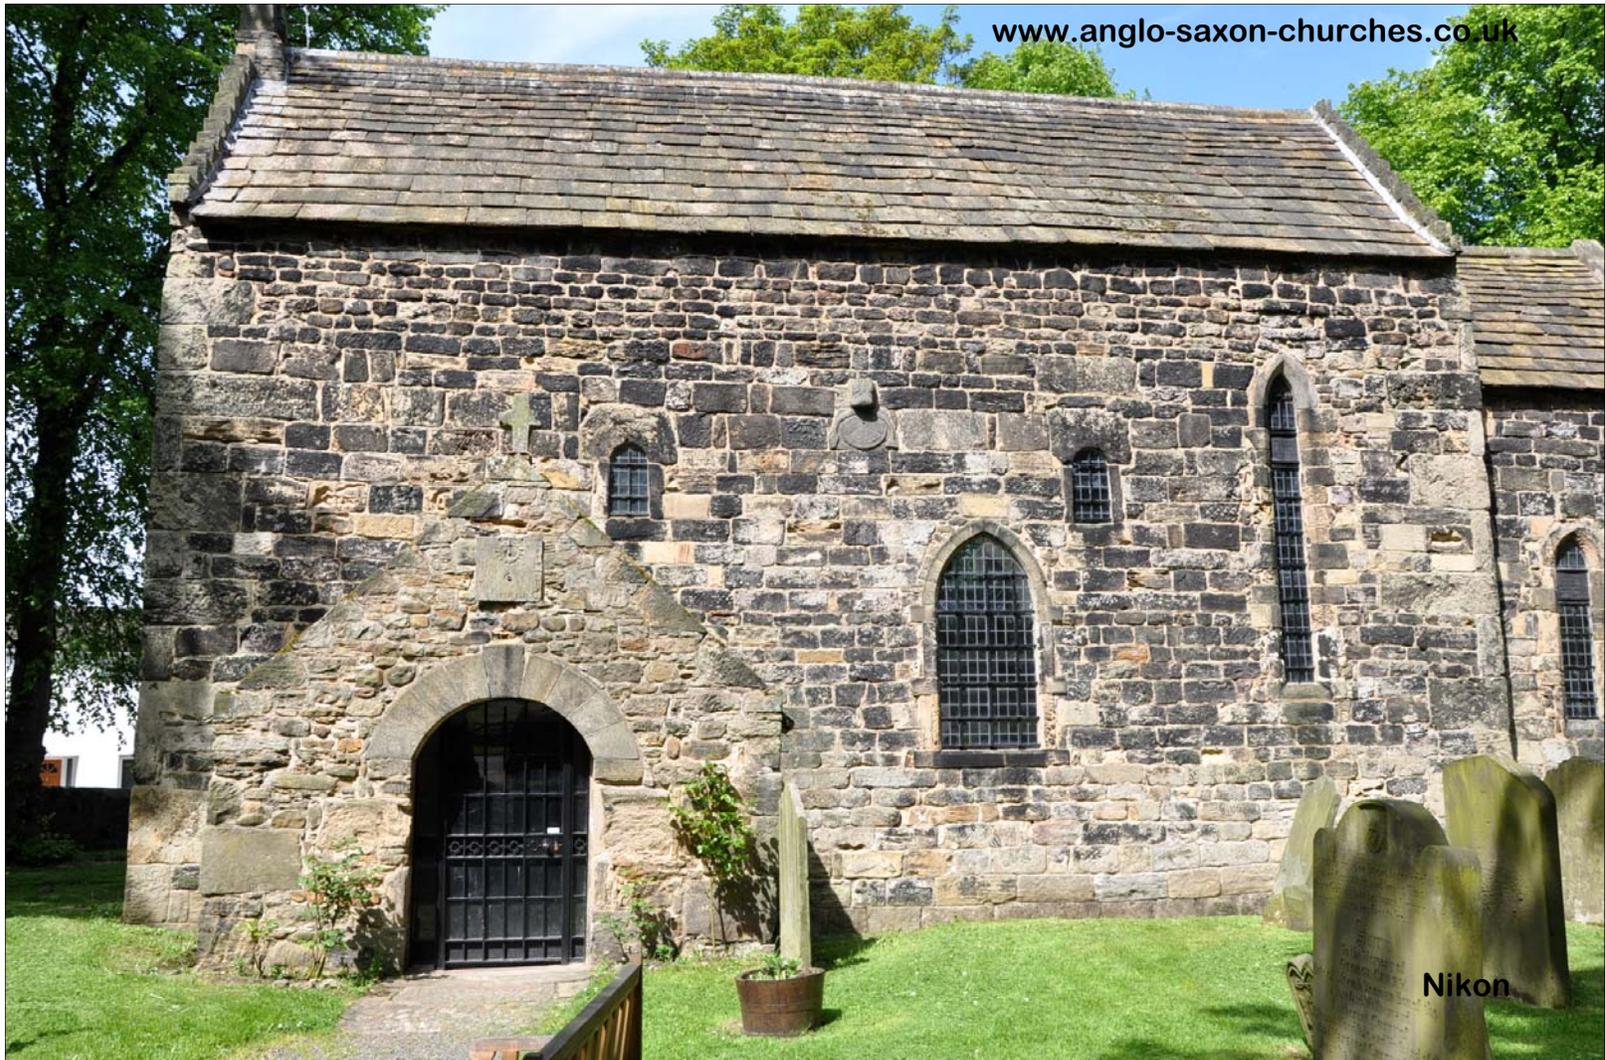
1. General view of the exterior from the south.

H.Taylor gives a date of this church either before Bede's death (735), or after. Bede does not mention this church, and it has been said to date after his death. However, as Taylor points out, Bede only referred to churches where they were linked by an event he was writing about. When Taylor visited the church in the 60's, and I made my first visit in the early 80's, the interior showed the stonework in all its glory. Now, most regrettably, it was been almost entirely lime-washed. This is an exercise in how NOT to treat a church and it illustrates how in supposedly enlightened times a wrong decision can sadly spoil the interior of an ancient and venerable building, a listed and (supposedly) protected building. The stonework and its detail are now very hard to make out, and texture, tooling and colouring has been lost to the eye. I have included the nice black & white photo, by H.Taylor, of the chancel arch as it appeared in his day and how I remember it. Taylor noted how Baldwin Brown pointed out the unusual way the imposts had been treated (and cut), a feature to be found in one of the Roman gateways at Chesters fort (on the wall), and thought the chancel arch probably was removed from the neighbouring Roman fort of Binchester (Vinovia). In the same way as the tower arch at Corbridge church is Roman (moved and reused).

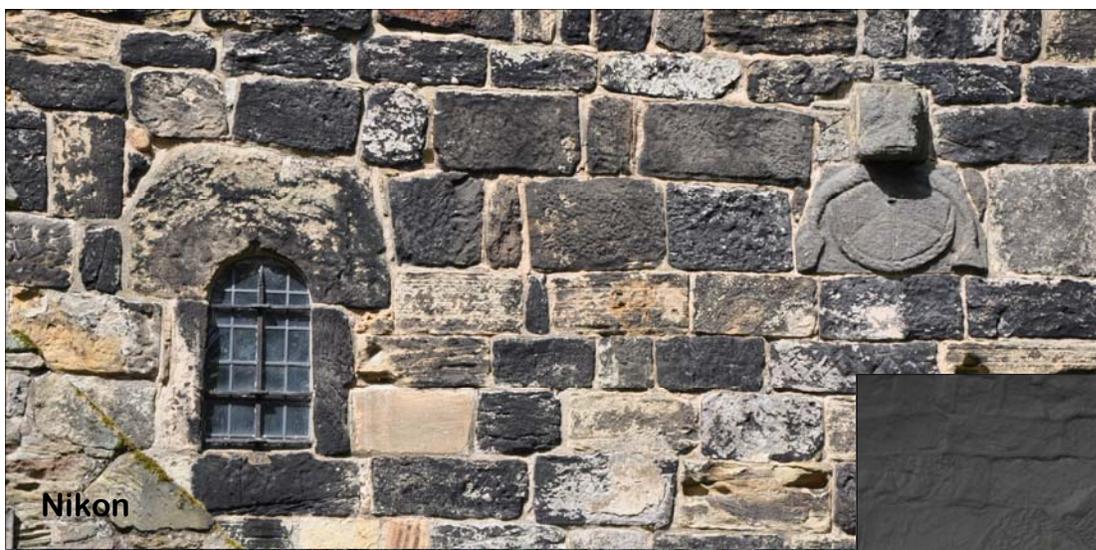
2. Detail of the left hand window and sundial seen in pic 1. (previous page). The sundial is in its original position.
3. The chancel arch, sadly as it now appears, covered in whitewash. Note the medieval painting on the underside of the arch.
4. Harold Taylor's photo of the chancel arch. Note how the original detail of the Roman stonework is easily seen; simply a delight.

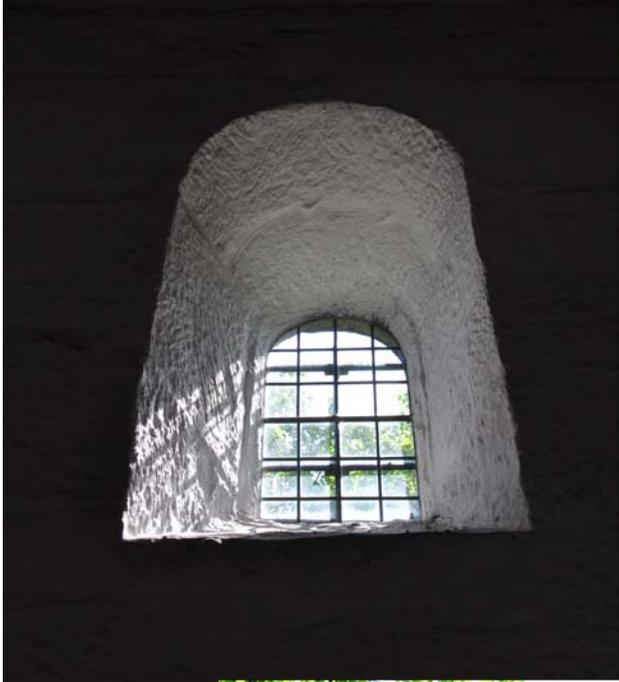
- 5. The chancel from the south.
- 6. North aspect of church and note Saxon north doorway to nave (that in the chancel is now blocked).
- 7. Massive side-alternate quoins at SW corner of nave.
- 8. A nave window viewed from inside.
