Rougemont Castle, Exeter.

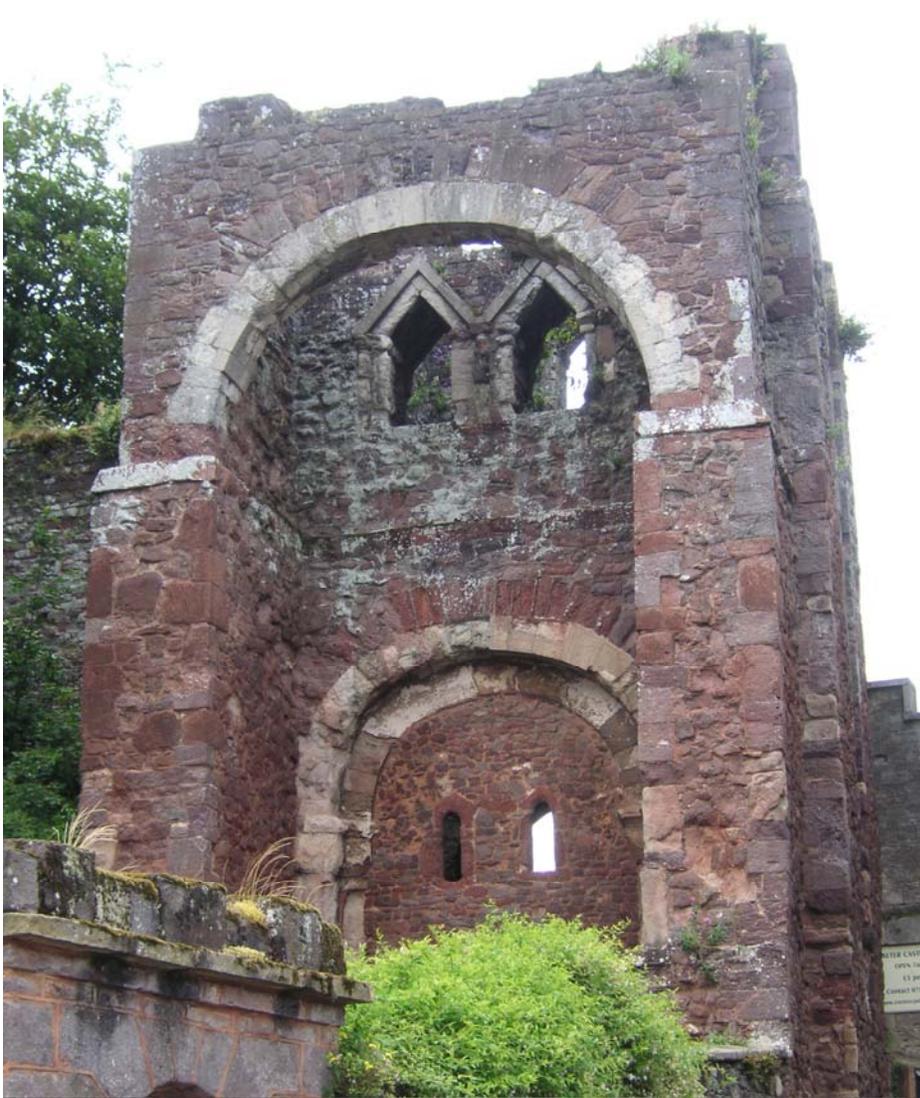
1. The (blocked) gateway from the castle exterior.
2. From the interior, the left "buttress" exhibiting substantial long & short work.
3. The blocked archway from the inside, note the non-radial voussoirs.
4. The twin triangular headed openings (partially restored), and also seen in picture 1.

The prevailing Saxon features are: random rubble walling; long & short work; triangular headed openings with typical Saxon treatment; non-radial voussoirs. The Roman defences were thought to have been rebuilt by King Athelstan (circa 925), and later withstood William The Conqueror for 18 days before Exeter was finally taken.
