Church of St Botolph, Hadstock, Essex.

Described in Vol I in H.Taylor's "Anglo-saxon Architecture" (see pages 272 to 275), this church comprises a pre-conquest nave and with openings to transepts. The chancel has been totally rebuilt in Victorian times (1884) and with a pseudo Saxon chancel arch to 'match' the transeptual arches. Both these arches are not complete however. The north of which opens to the pre-conquest transept, but the south transept has been replaced in medieval times. The picture becomes more complicated, as I will detail further (see text belonging to archway photos), and as Warwick Rodwell so ably expounded in his book "The Archaeology of the English Church" and which see pages 128 to 130. The pre-conquest tower at the crossing has now gone, local tradition has it that it was the tempests of 1440 that carried it off. Taylor thinks that the crossing was probably low and the walls continuous with the nave, similar to Breamore (Hants).

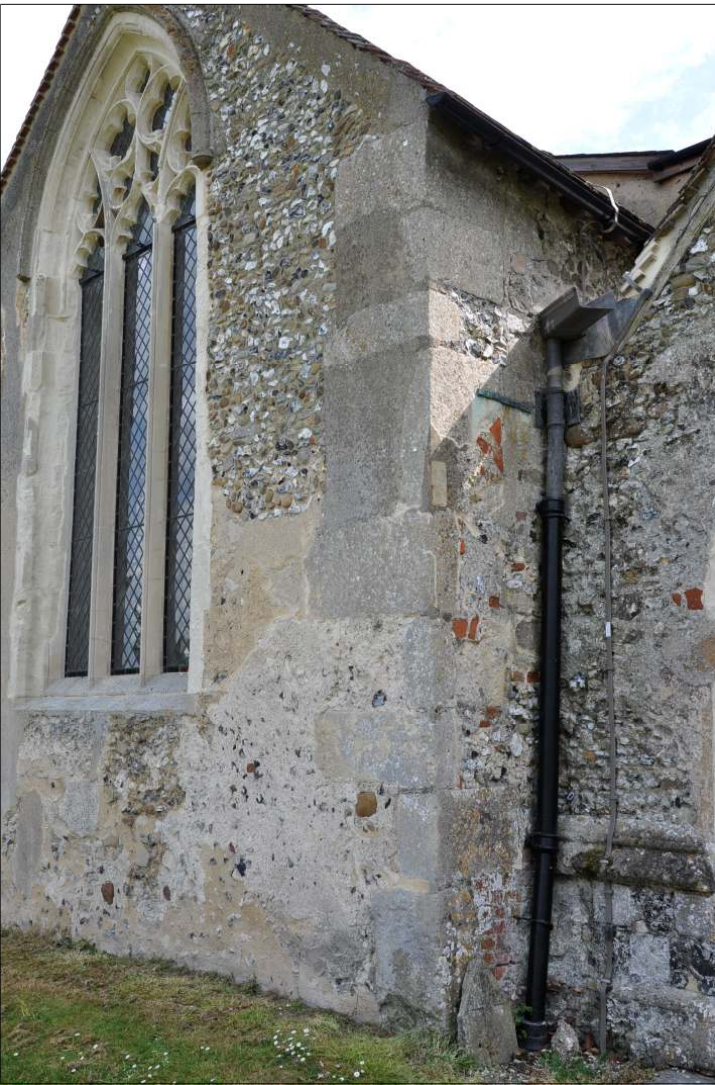
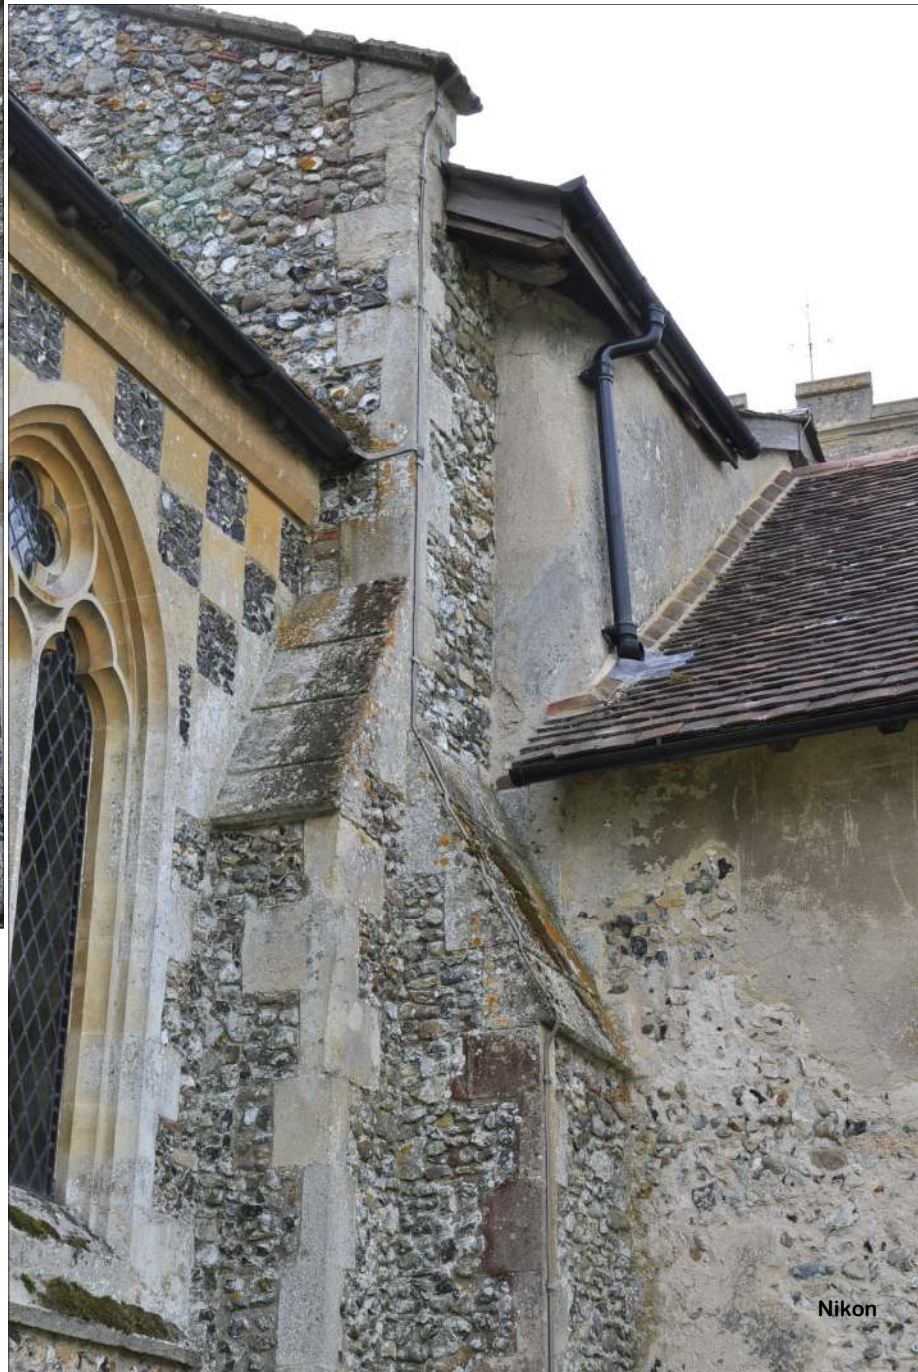
1. A view from the NW of the north transept, note the massive (random) side-alternate quoins. The medieval porch lies, and abuts, immediately its west wall.
2. The east wall of the transept and where it makes a join with the easterly end of the north wall of the nave. You will see running to the left the 'new' west end of the Victorian nave (violently different in character). The east wall of the nave has been built up against but any trace of the original chancel arch has disappeared with its wall.

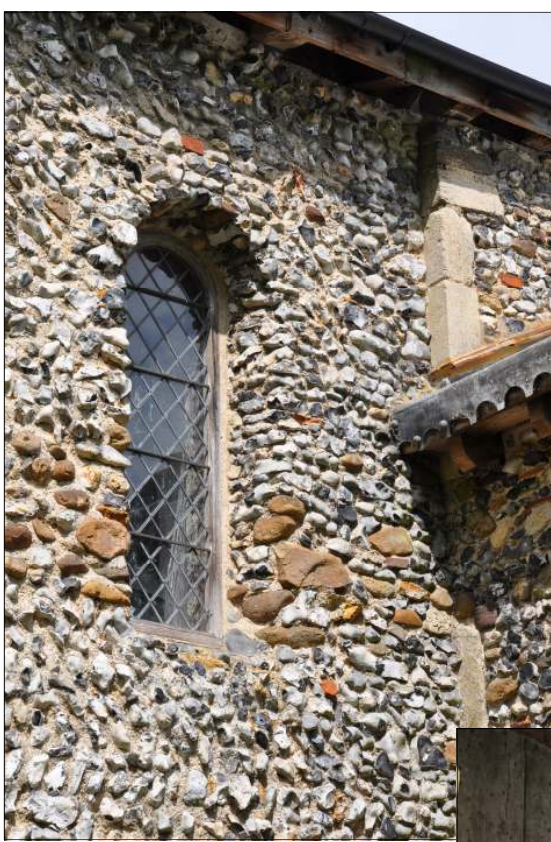
3. One of the six double-splayed windows high in the nave walls. This is the easternmost set in the south wall.
4. Inside the nave looking west towards the medieval tower. A doorway seen to the right exhibits (externally) similar mouldings and decoration to the south transept arch.

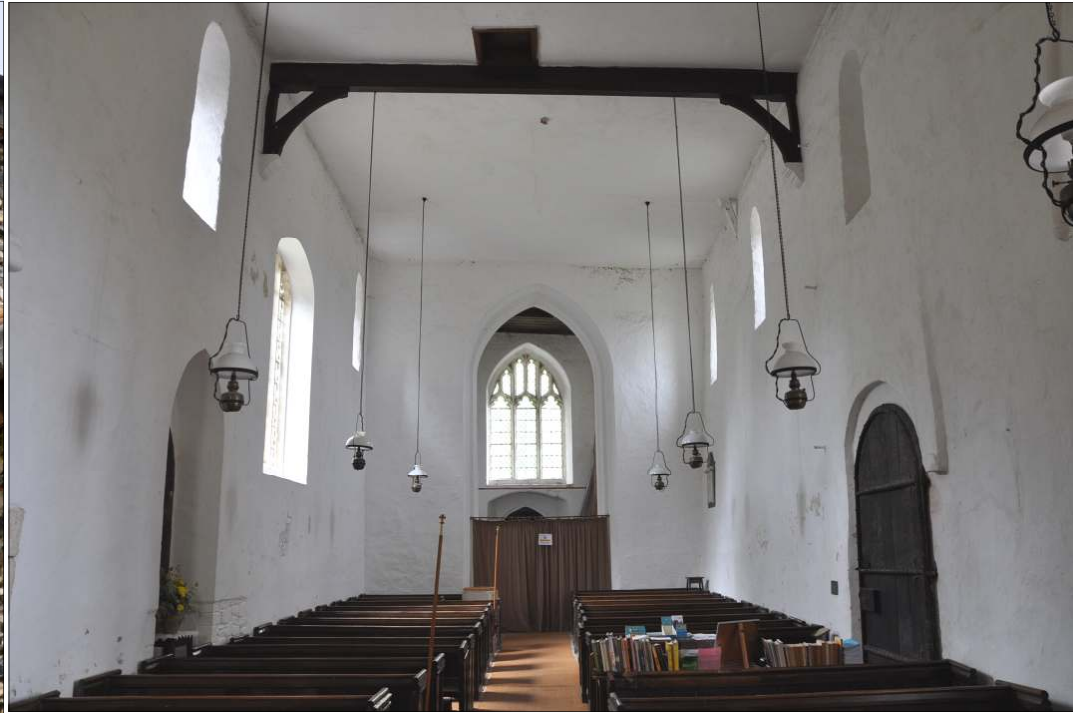
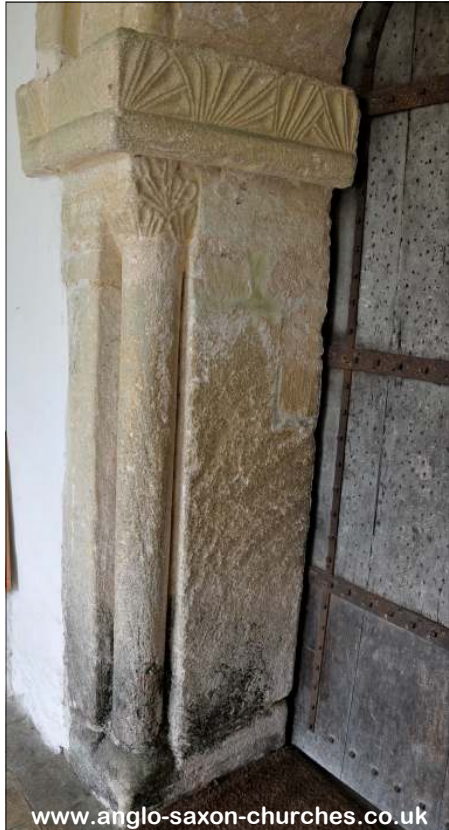
5. The external face of the north doorway.
6. A detail of its west jamb. Taylor notes that the battened door hangs against the inner face of the wall (there is no rebate, this is typical pre-conquest practise). The impost is returned along the exterior wall-face and is roughly square in section but with a roll moulding on the lower angle and a panel of carved ornament along the vertical face. The round head of the doorway is of through-stones of a single order, recessed externally with a roll moulding round the arris.

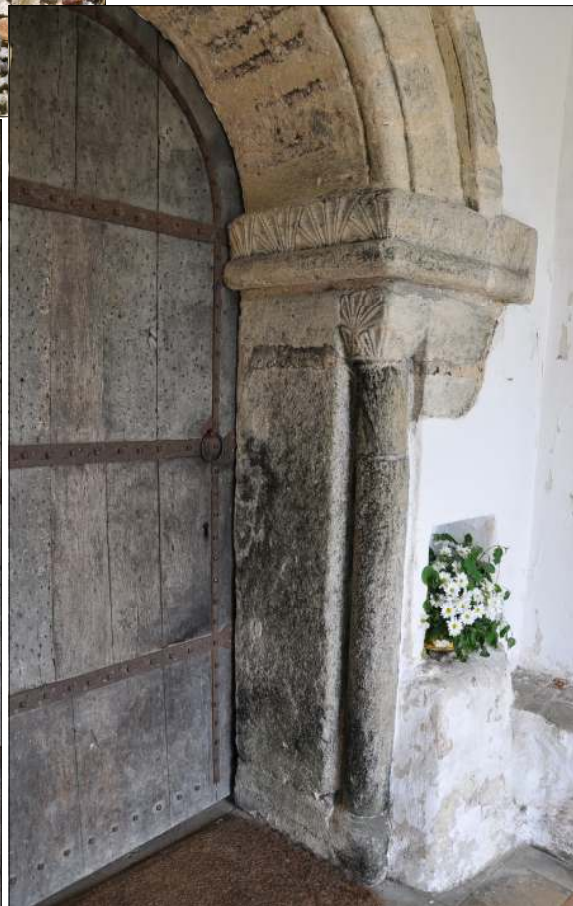
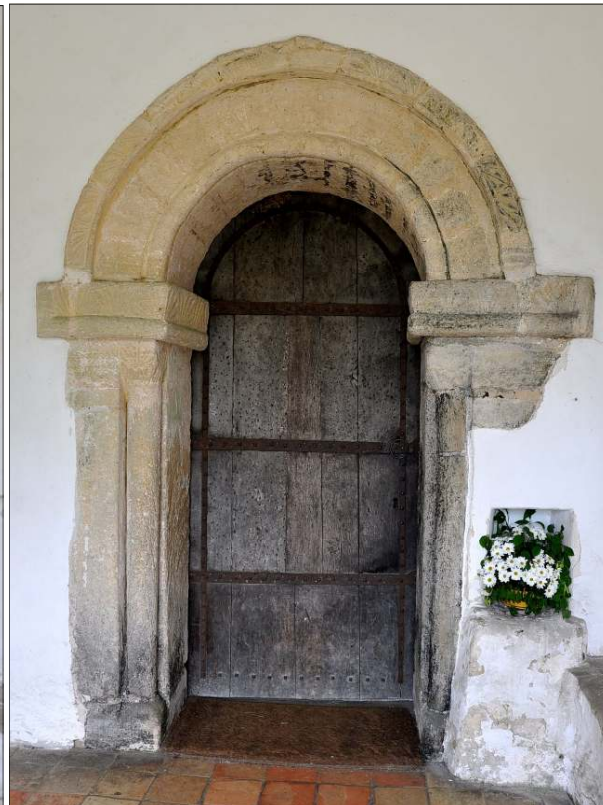
7. The east jamb. The carved ornament which occurs on the capitals of the angle shafts, and the imposts, and less distinctly on the hood-moulding is described by the Royal Commission as 'crude honey suckle ornament'.

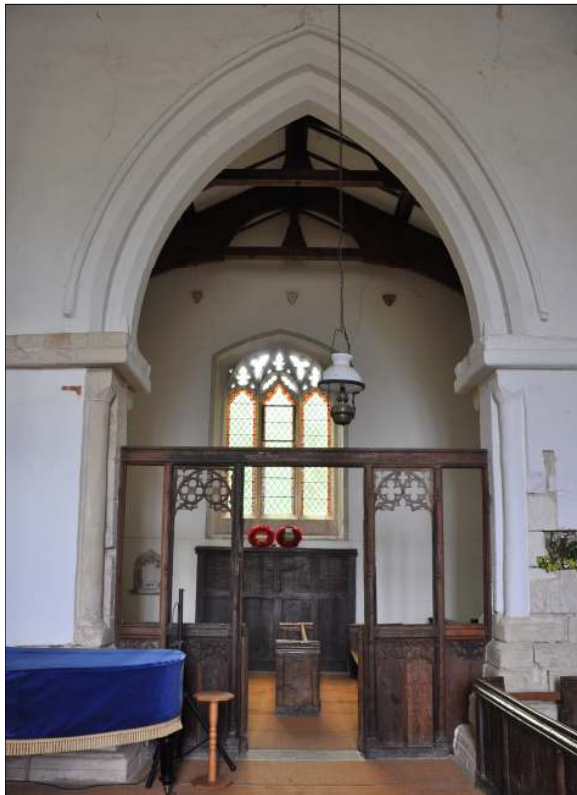
8. The archway to the south transept seen from within the nave. Note the later medieval pointed archway, but the jambs to the arch and their imposts are reminiscent of the north doorway, and here stand on a plinth built up of four orders. And here we have an interesting twist. Warwick Rodwell relates that the fabric excavation yielded unexpected findings. The four-tiered plinths revealed their true form; when the limewash and plaster 'filling' was removed it was discovered that the plinth belonged to two periods, the lower two tiers were re-used Roman stones from a major building and the upper two tiers were jumbled and certainly not in their original position. The whole build of the plinths was a makeshift arrangement made up of battered mouldings and wide joints. It was also clear from a study of the mortar that this entire archway from ground to apex was a reconstruction of the 13th century. The chaotic jointing was disguised by generous pointing and the coating of limewash was marked with red paint outlining the false joints.

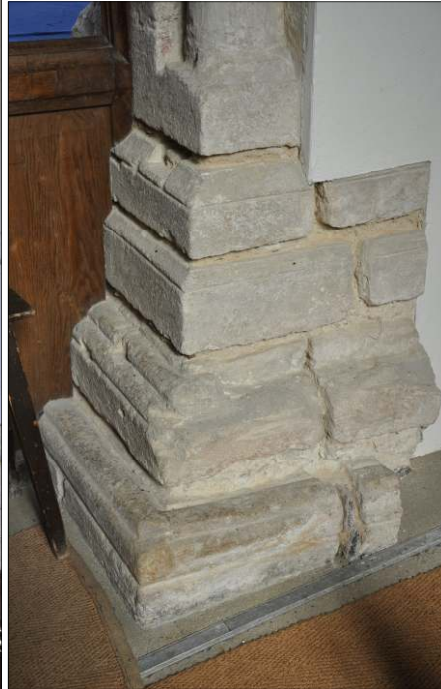
9. The east plinth belonging to the south archway (the timber screen is mid way of the full width of the walling).

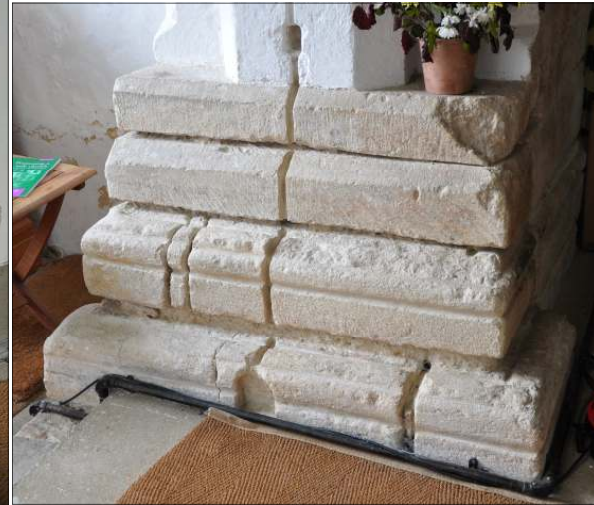
10. The east plinth to the north transept archway. (& see pic 14)

14. Here is another view of the east plinth to the north transept archway (seen previously in pic 10). The jambs of this archway are medieval.

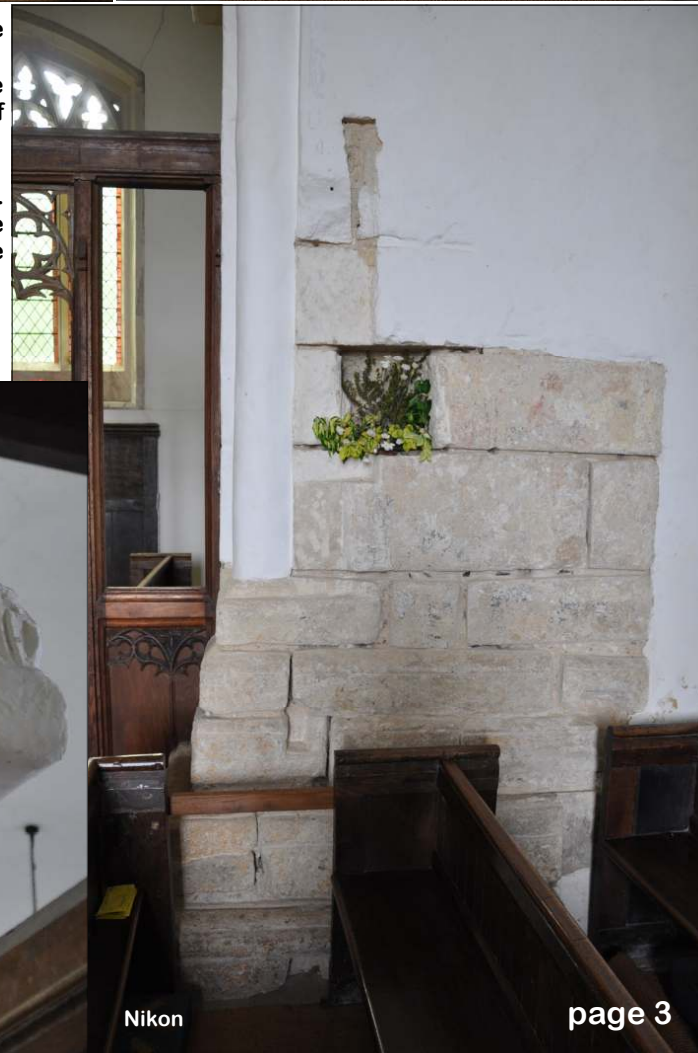
11. The western plinth to the south archway seen from within the nave, note the robust size of the masonry adjoining the plinth.

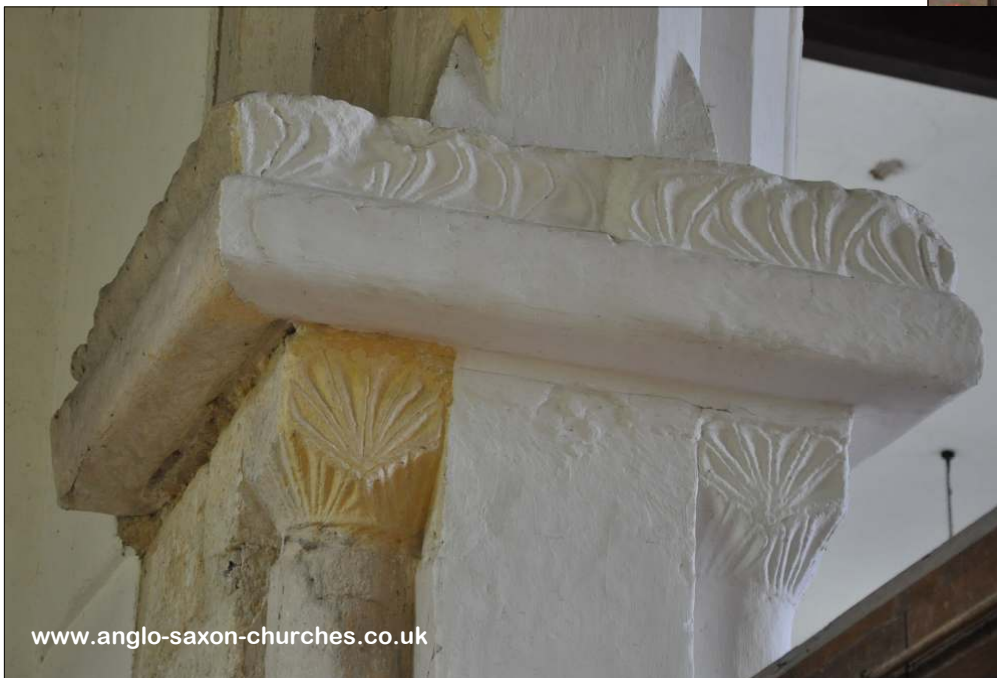
12. This is the impost belonging to the previous picture. Note the 'honeysuckle ornamentation' adorning the capitals and the upper order of the impost (repeating that on the north doorway).

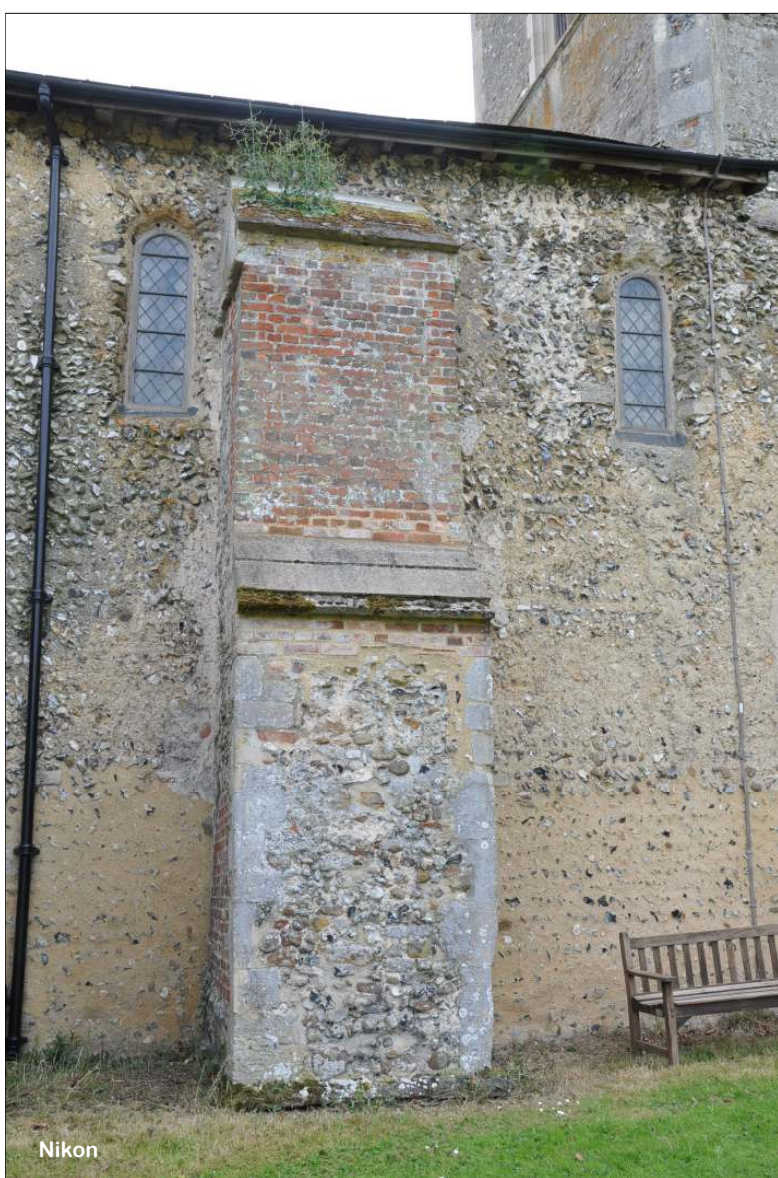
13. Part of the north wall of the nave, with two of the double splayed windows high in the wall, and separated by a later medieval buttress (repaired in brick) and with the west tower just visible to the right.
