Church of St John, Milborne Port, Somerset.

Milborne Port church; chancel.

Milborne Port church; crossing archway bases.

Milborne Port church; late Anglo-Saxon south doorway to nave.

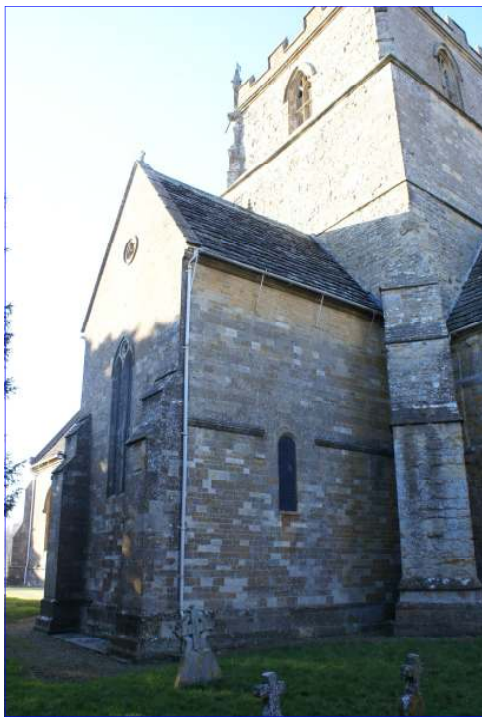
1. Central tower and south 'transept' from the SE. Note the characteristic 'narrower' transept to the tower (as at Wimborne Minster, Breamore, and at Sherborne Abbey). The S transept was heavily restored in 1843.

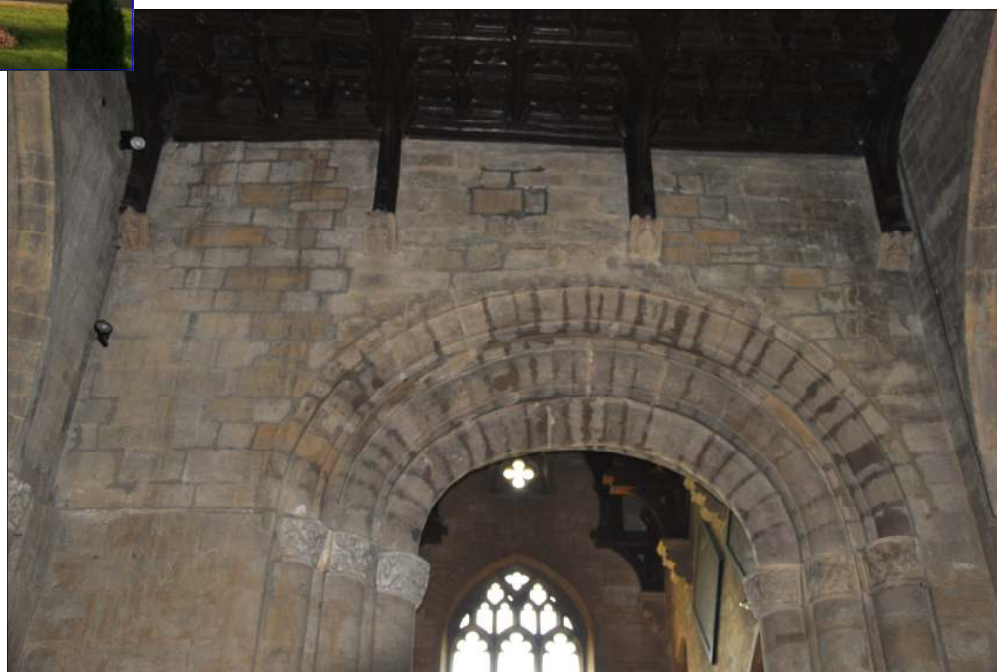
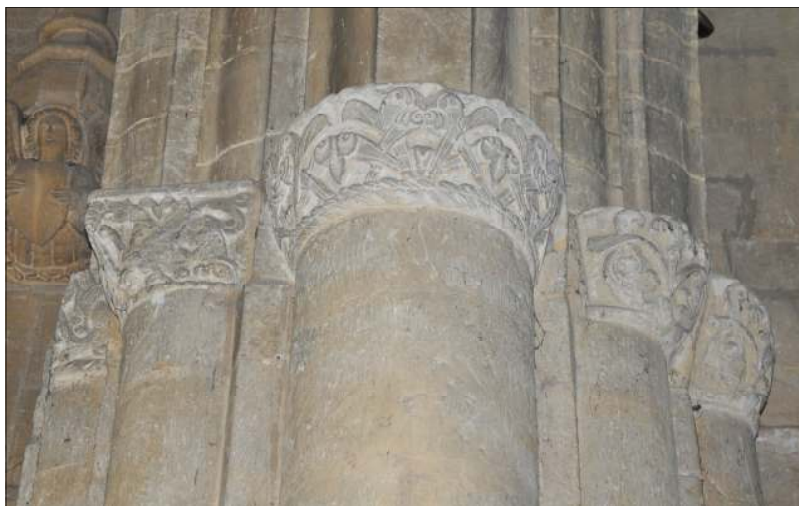
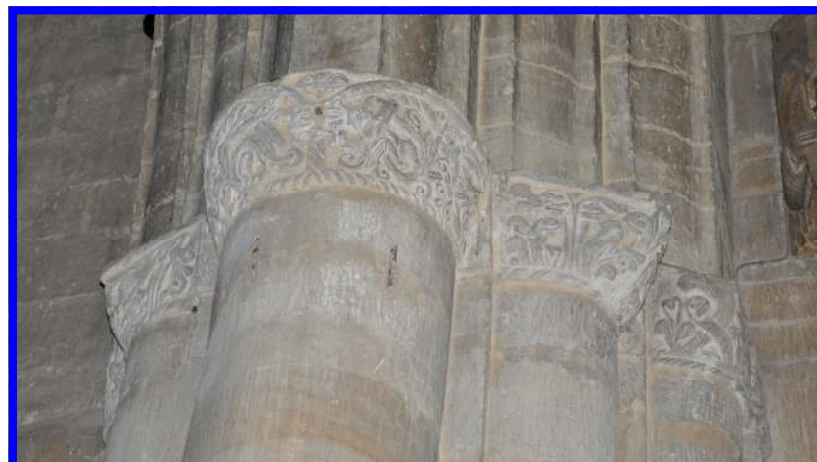
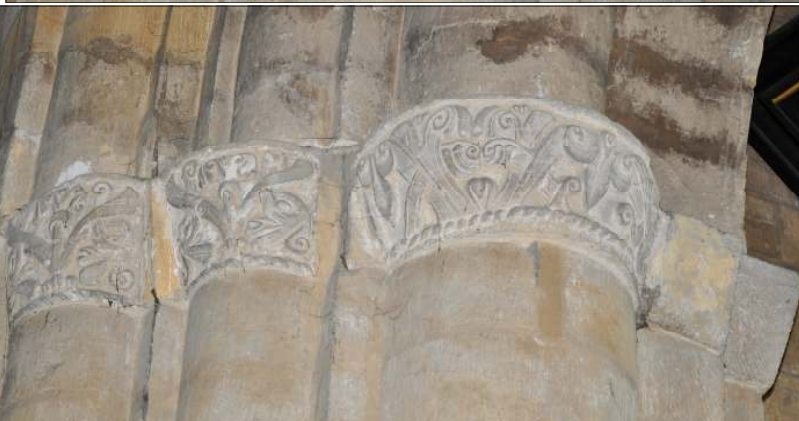
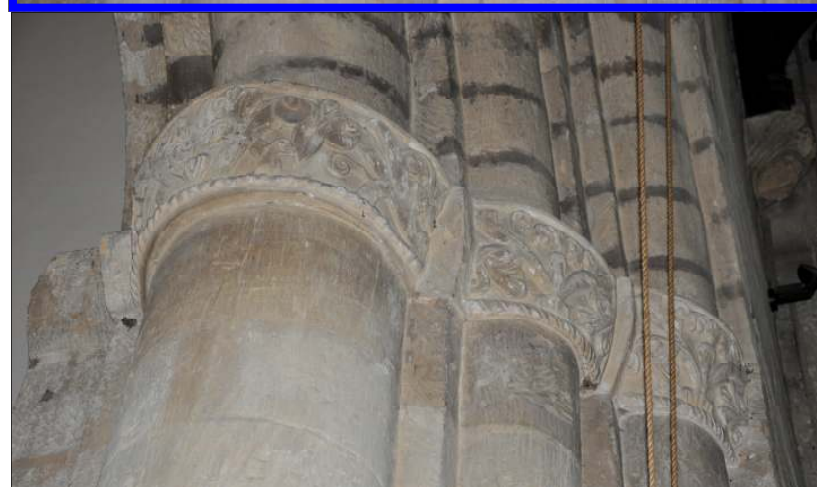
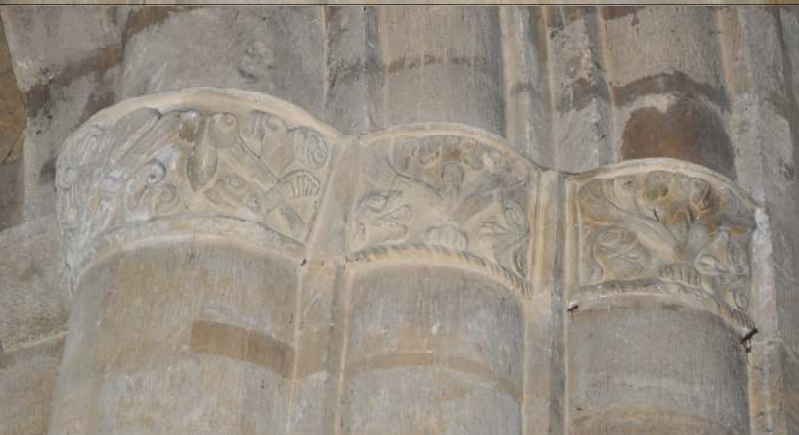
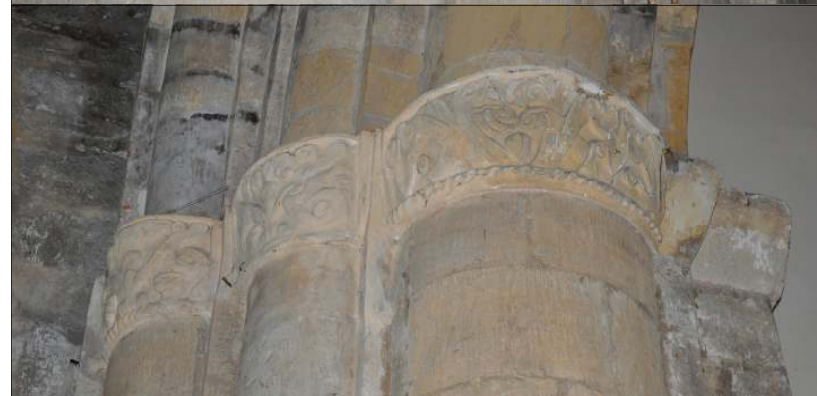
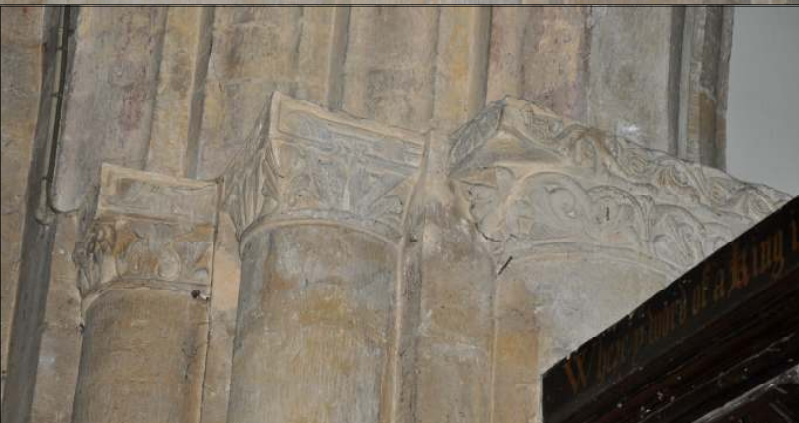
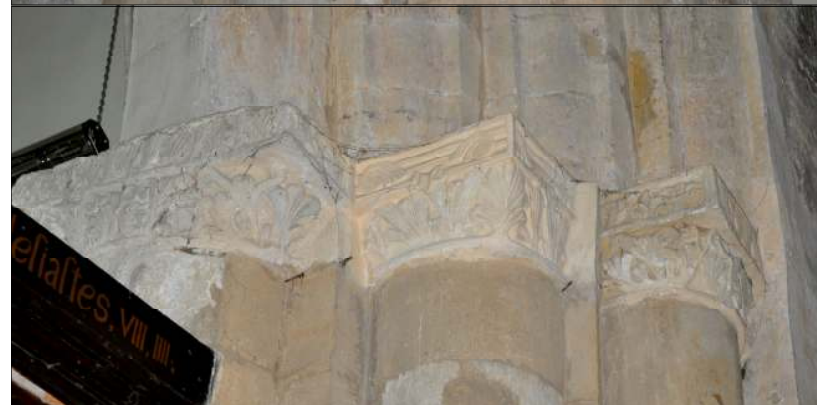
Milborne Port church. Capitals in tower crossing.

Capitals, tower crossing;

First photo (with blue border) is of the SW corner, then moving anti-clockwise around the crossing, thus featuring all eight capitals in strict order (not numbered).

A note about the photos on page 2. The capitals are finely carved in stone (mainly of foliage). But whereas those belonging to the western nave arch of of stone, the others are either executed in stone or in plaster. In the south transept it can be seen how the stone has been finished to receive the plaster since on some faces only traces of plaster remain, the carved plaster area having been removed.

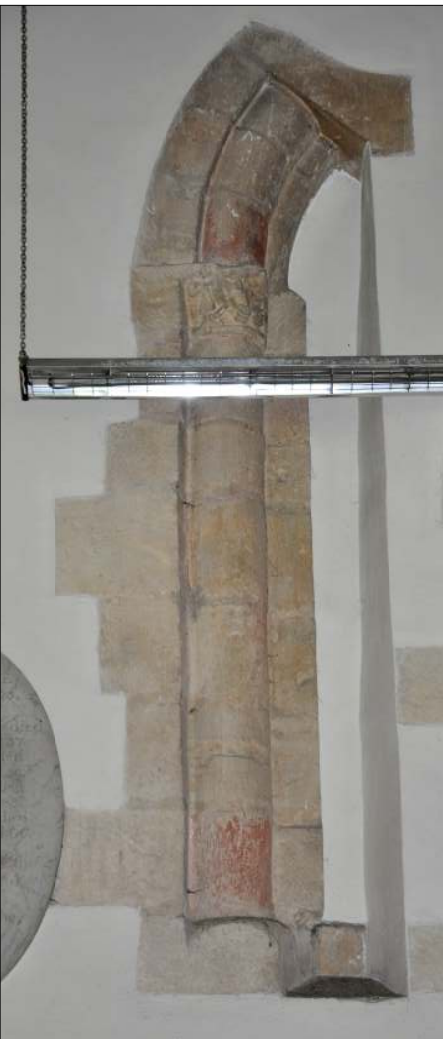
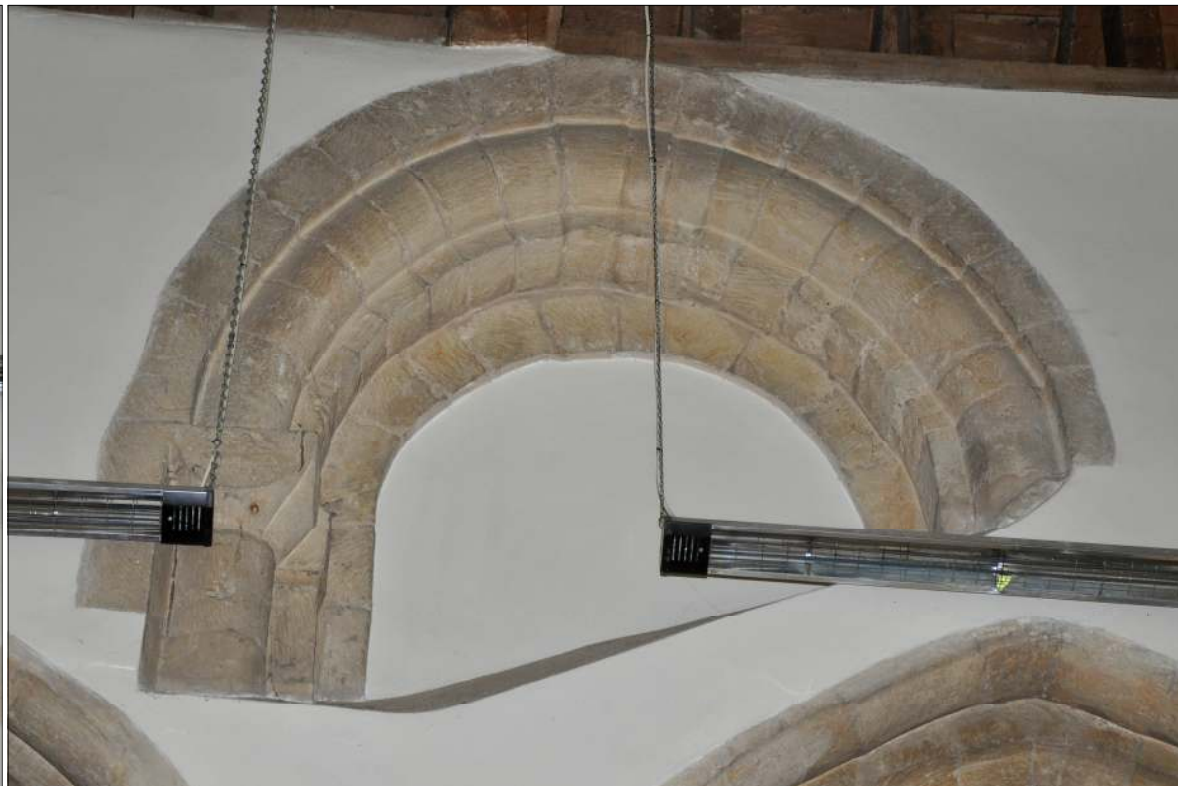
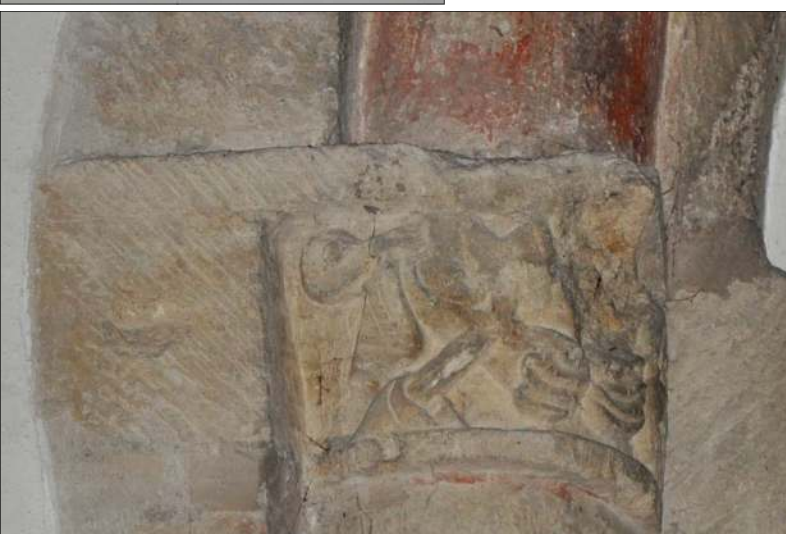
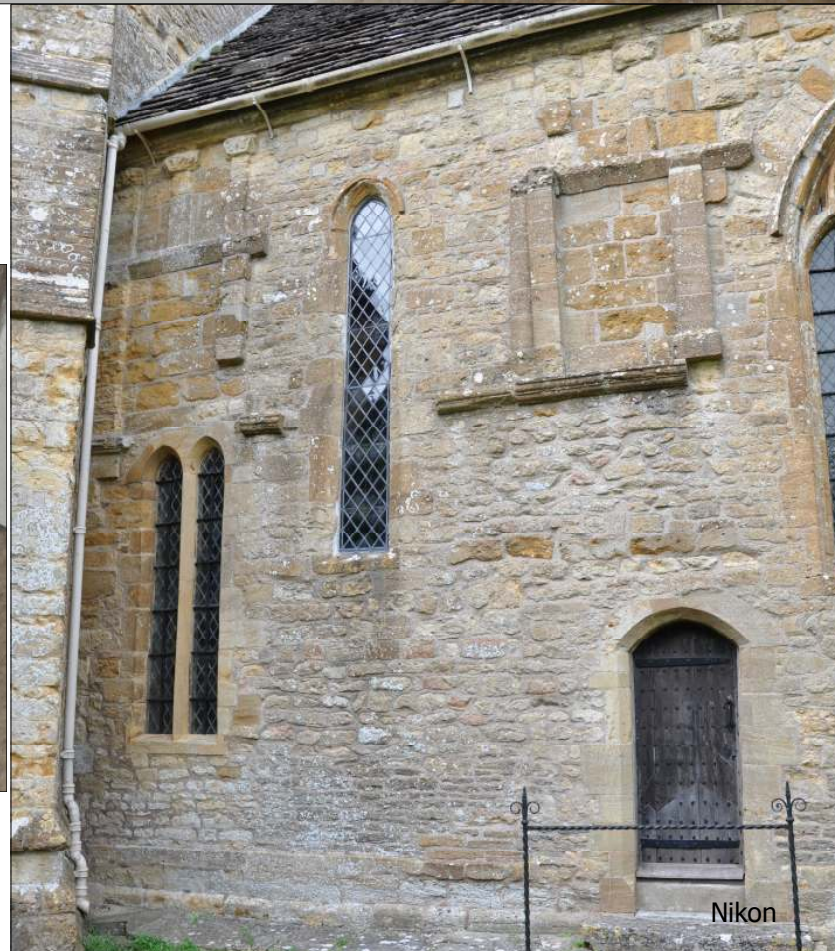
5. South wall, blocked Saxon window with motifs in similar manner to crossing capitals, viewed internally (partly obstructed by heater!).
6. North wall, blocked Saxon window (note non-radial voussoirs), this with 'mature' Continental Romanesque cushion capital (poorly placed heaters intrude again in this picture).
7. A reminder of how the disturbed work appears on the exterior of the south wall (see H.Taylor, 'Anglo-Saxon Architecture' Vol. I, page 427, for explanation).
8. Closer detail of decorated capital seen in picture 1.

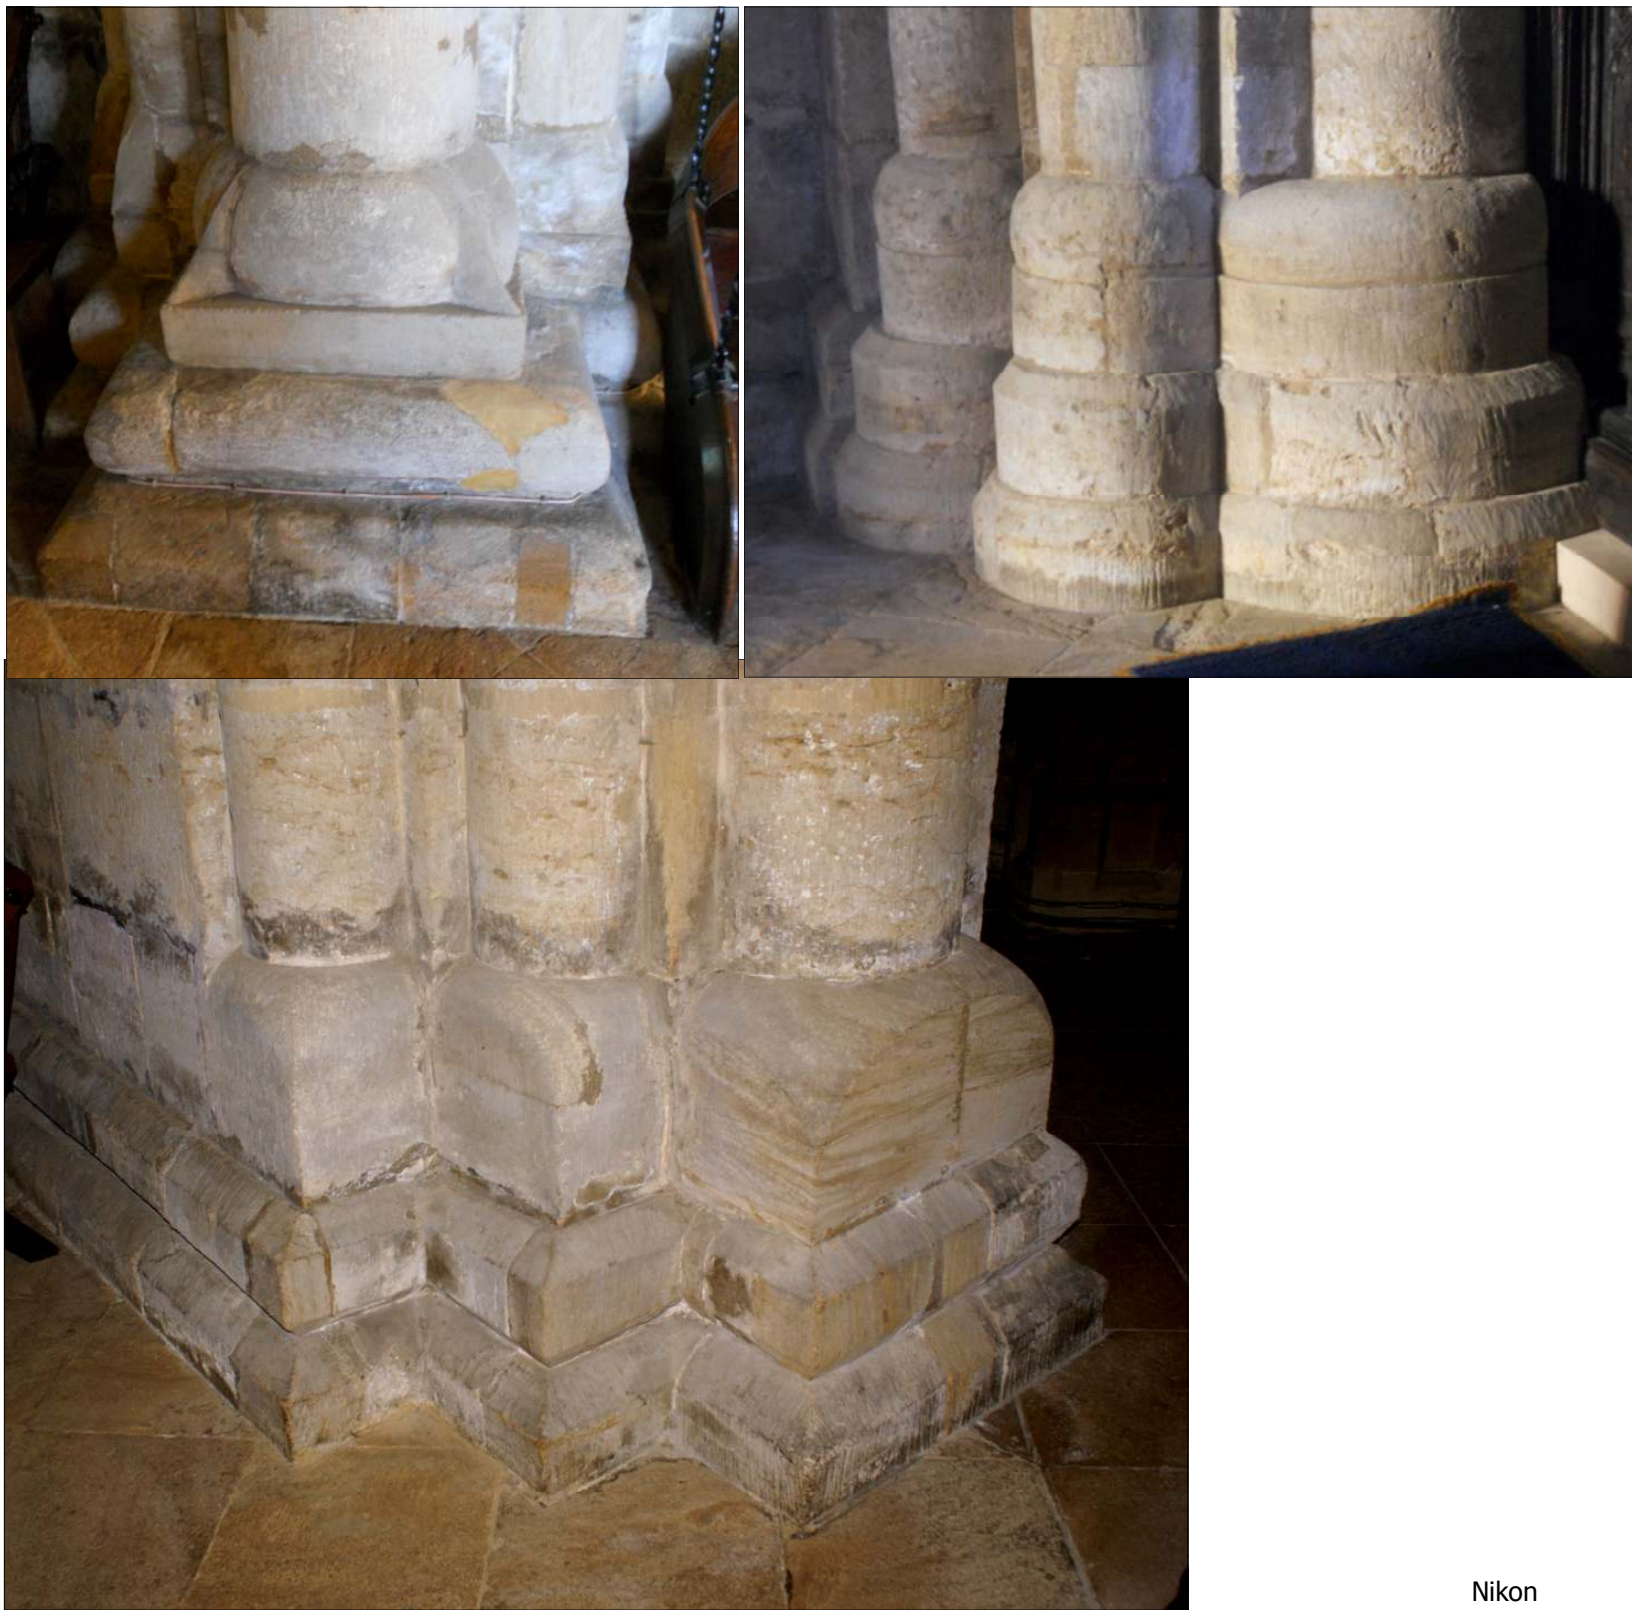
Bases of archways to crossing; although they are perhaps similar there are differences, the nave and chancel arch bases are distinctively different, but both transept archway bases are an identical pair.

- 9. The south base of the nave archway, note the distinctive web, or fillet, to the bulbous top and which is seated upon a square and plain base and which in turn sits atop a two stage stepped, chamfered and undercut base.
- 10. The north east base of the chancel arch, note the distinct difference to that of the nave. There are 3 stages, the lower two are of circular plan and are decreasing and chamfered, the uppermost stage are again decreasing cylindrical but rounded off at the top.
- 11. The north west base which belongs to the north transept archway. Here we have the stepped, chamfered and undercut two tier base as the nave archway, the third and uppermost tier here are the same square plan to match those below but with a generously rounded upper face.

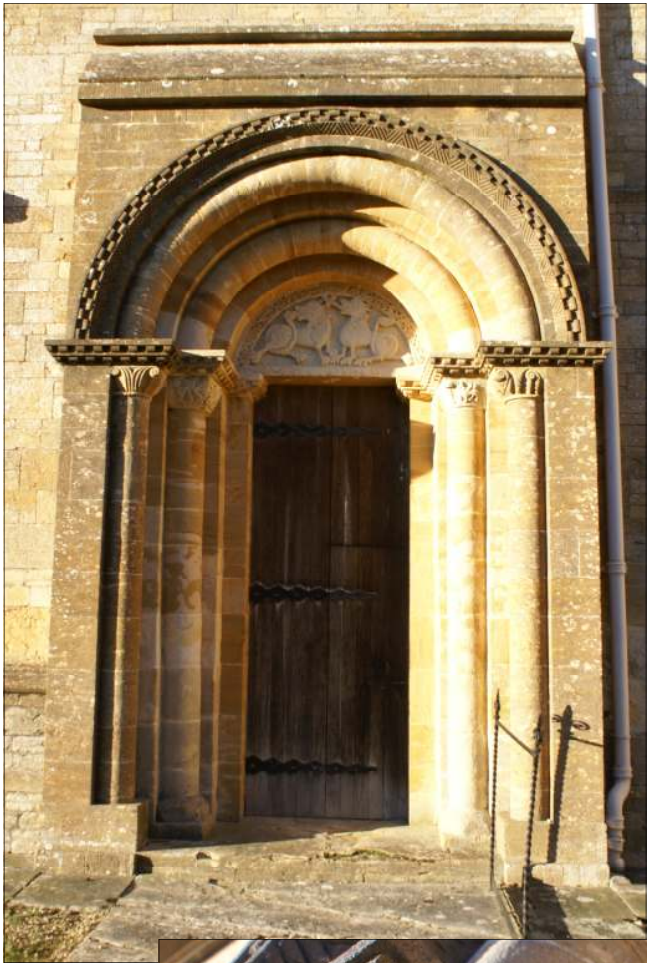
12. A general view of this fine late Anglo-Saxon doorway set in protruding stonework. The outer order in darker stone appears to date to the Victorian restoration of 1867-9 when most of the nave was destroyed.

This doorway shows the dominating influence of Continental Romanesque techniques and style in the two decades before the Conquest. Note however the typically Anglo-Saxon form of the foliate capital in picture 14.

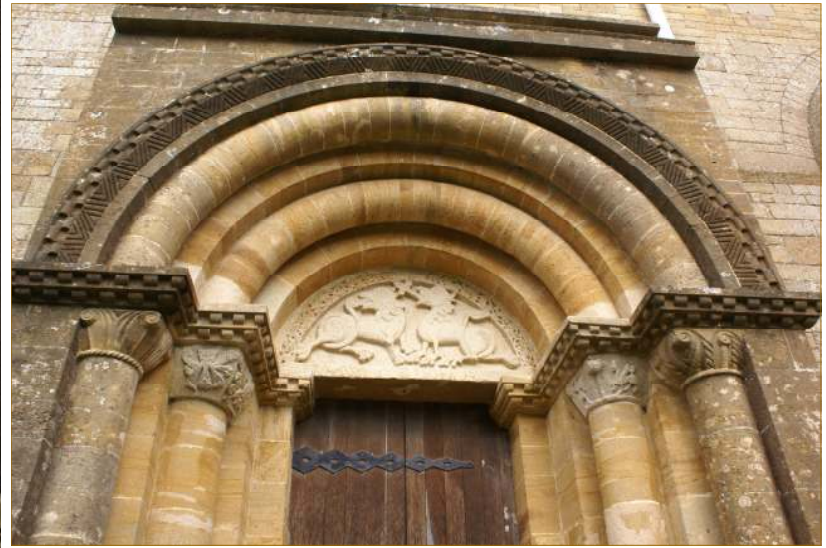
13. The arch of this doorway which shows the receding orders.

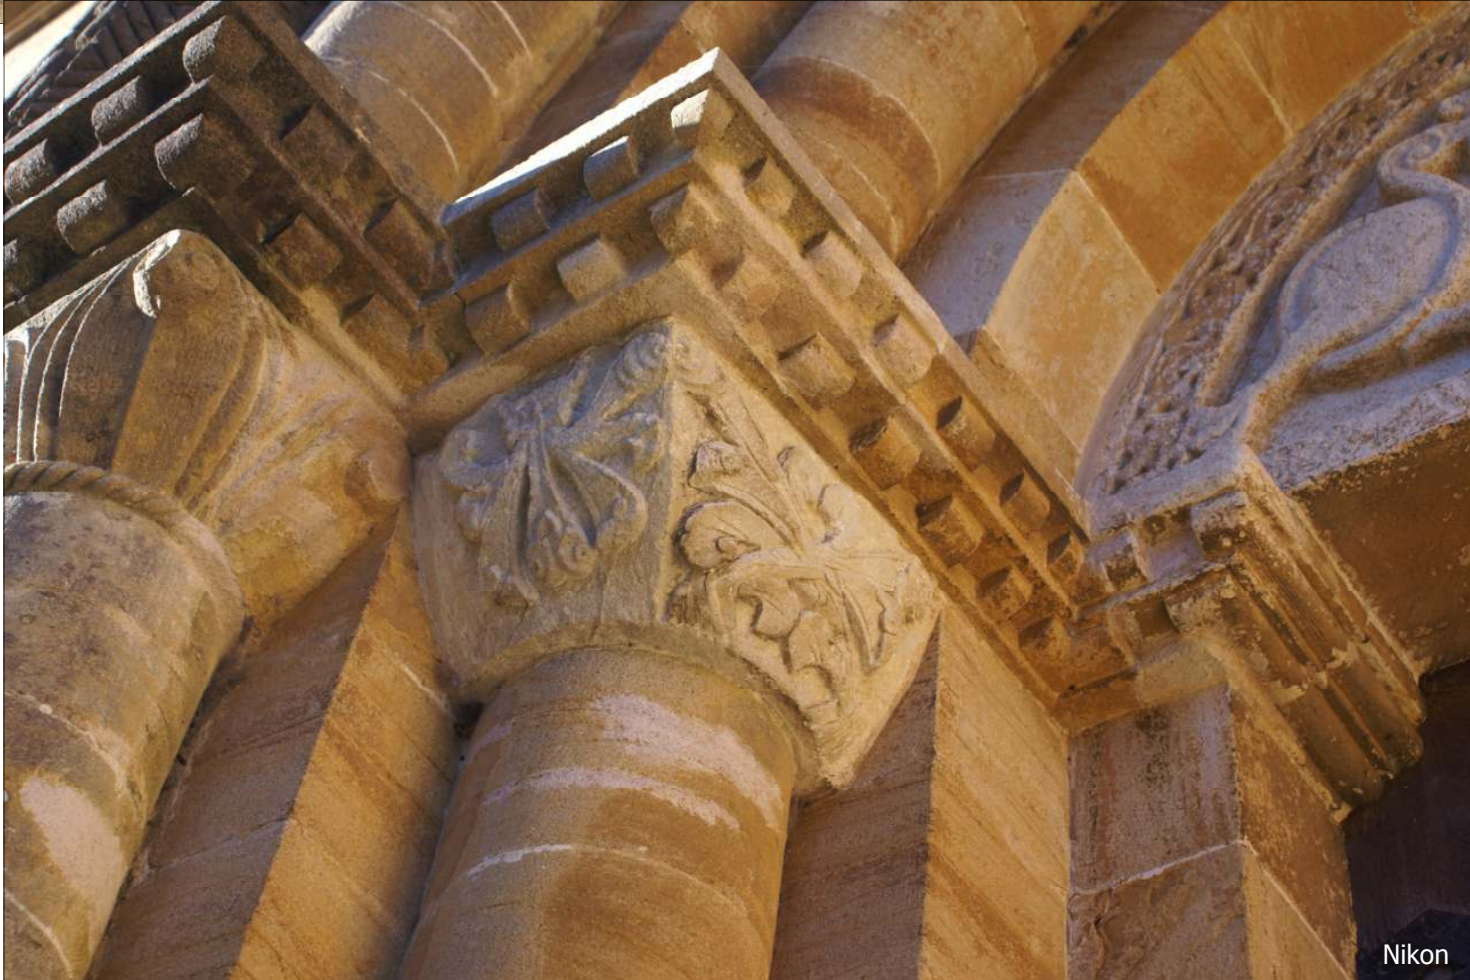
14. A detail of the westernmost capitals and orders.

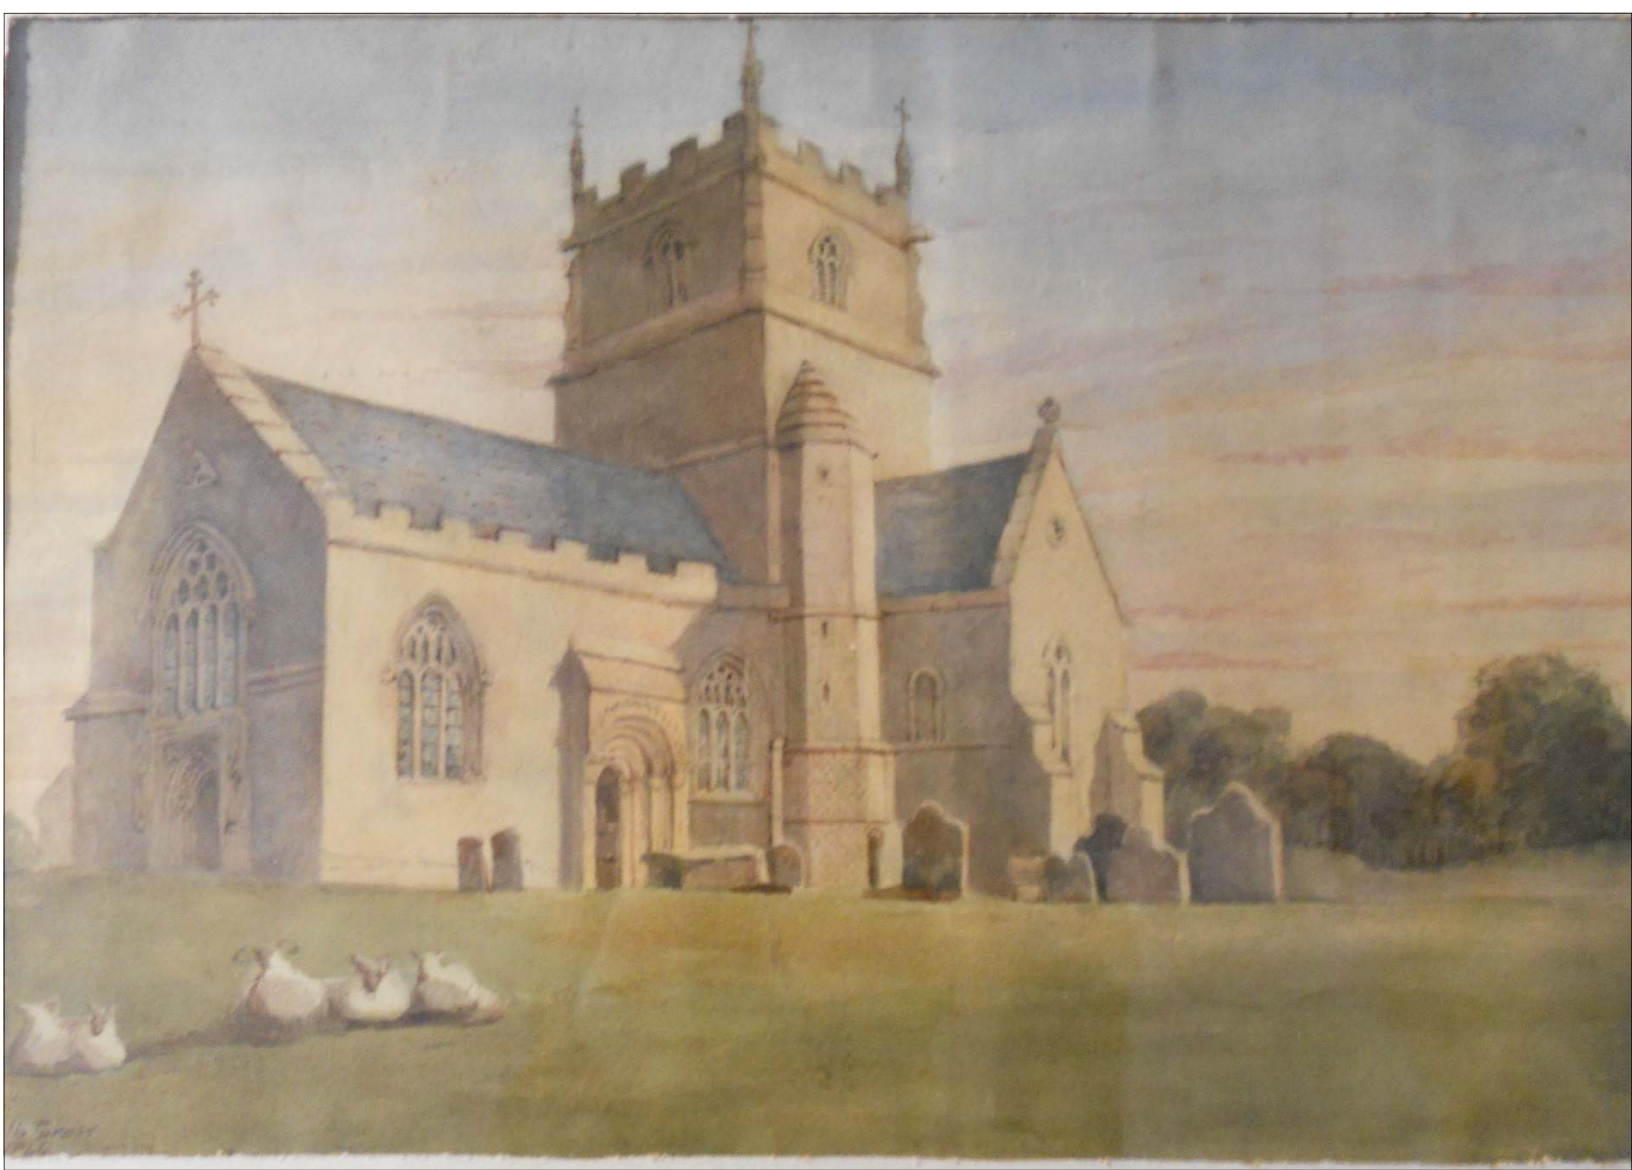
15. A very good watercolour of the church from the SW, by W.H. Turner and dating to 1844. This is some 20 years before the "restoration" when the north transept was rebuilt and the nave in greater part demolished and rebuilt lengthened by some 28 feet (8.5 metres) and with a north aisle. Note the fine Anglo-Saxon south doorway which was retained but partially restored. The spiral staircase to the tower is clearly seen. It seems there is no trace in this painting of the pre-conquest arcading on the old west front, except maybe the strong change in profile mid way up the wall and it is possible this was either a 'capping' over the arcading, or from whence the arcade sprung.
