Examples of Anglo-Saxon quoin types.

Based on H.M. Taylor's volumes "Anglo-Saxon Architecture".

Anglo-Saxon quoin types.

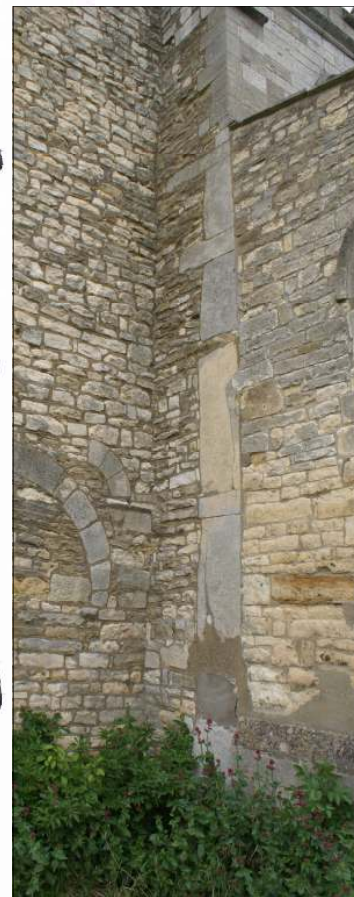
(e) Branston

- e. As 'd' but the stones are set flush with the main face of the wall and the uprights are (thus) square in plan.*
My drawing is slightly different from Taylor's in that I have based it upon the fabric of All Saints church at Branston, Lincs. In this example I have used the SW angle of the nave, and although it is masked on the south side by a medieval aisle I have inferred the general run of the stones on that side. Here the pillar stones are of enormous height, I would say in the most extreme example some 5 feet. The quoins drawn here represent the full extent of the height to where the aisle walls now spring. Taylor describes the quoins as being of 'bold long-and-short work'.

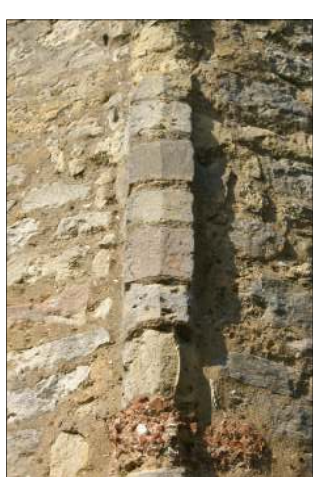
The photo left shows the fine strip-work at the 'corners' of the seven-sided apsidal chancel at Wing church (Buckinghamshire), and which is of the type where carefully selected stones of a regular width are used and which allows the plaster to be taken right up to their edge. Below that photo is shown the south face of that apse, with its associated crypt opening.

Strip-work panelling of wall surfaces. *This panelling, sometimes standing two or three inches forward from the main face of the wall, can be regarded as giving reliable evidence of Anglo-Saxon date. It should be noted that the pilaster-strips are usually of plain square section, less than a foot in width, sometimes even as little as six inches, and that they are often formed of very long stones. Usually the stones have been carefully chosen or worked so as to be of precisely the correct width, but sometimes wider stones are used and the part which is of excessive width is then cut back so as to be flush with the face of the wall. Sometimes the tall upright stones of the strip-work alternate with the shorter stones in a fashion like that of long-and-short quoining. It should be noted that, whereas this strip-work flourished in the south, it is not found north of the Humber.*

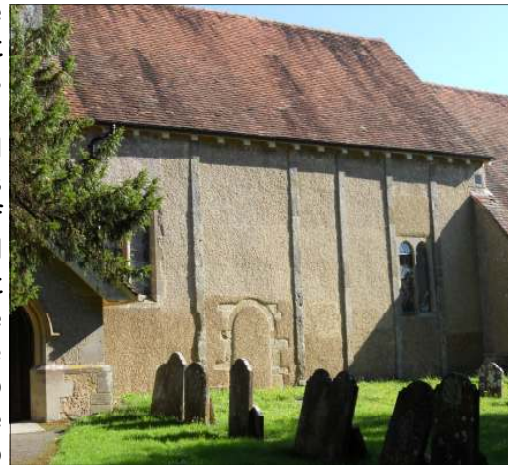
The photo right is of the south wall of the nave at All Saints church, Woolbeding (Sussex) and illustrates strip-work of the 'long pillar' type using stones of between one and two feet in height and between six and eight inches width. The surface of the wall is roughcast and it cannot therefore be determined whether they are of the cut back type (as at Breamore, Hants), or of the type seen at Wing.

Note the absence of a strip where the (blocked) doorway sits, and the probable removal of the strip where the modern window (to the left of the picture) would have cut it. The strips run from ground to eaves without either a plinth or a string course (at the head) to stop them. However, it is perfectly possible that some interference, or alterations, to the top of the walling at some date have resulted in the destruction of a stringcourse. Taylor mentions . . . *a vestige of a string-course to the north of the tower which must have run across the wall at the foot of the western gable, like those at Corhampton and Headbourne Worthy (Hants).* It is at a level where it is quite possible that any continuation of that string-course around the north & south nave walls were destroyed by a re-roofing. Only two vertical strips survive on the north

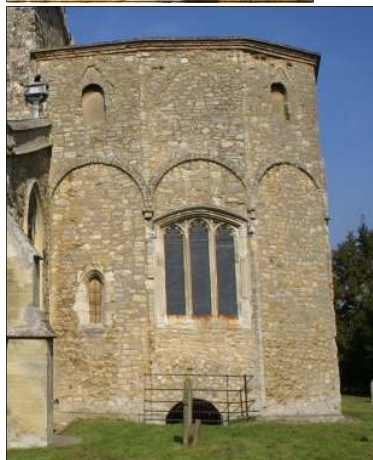
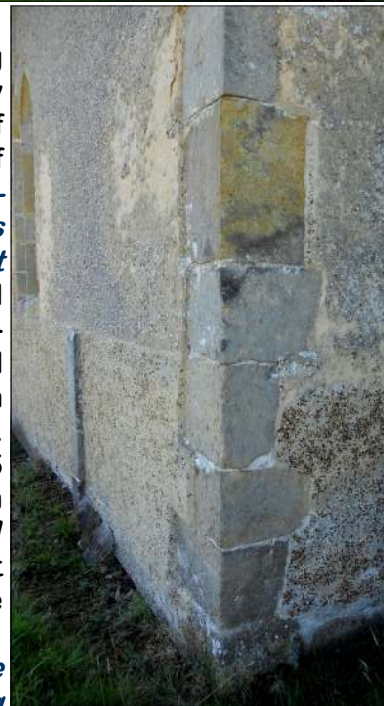
wall, and with the vestige of a base of another extant (which see picture bottom right). I can see how each face of the nave may have been built with six strips, or at least 5 on the north wall. Side-alternate quoins, of large stones, survive (are visible) at both the northern angles of the nave. Next picture down right, the lower part of the NW quoin of the nave. Perhaps interesting, as one might expect to see 'matching' (cut back) long-and-short work at the quoins, but here are large side-alternate stones. The lower five stones in the picture stand to almost six feet (to give an idea of scale).

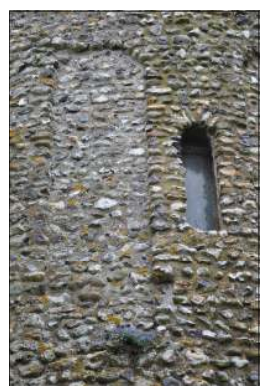
Panelling, or arcading. *In several places in East Anglia the surface of Anglo-Saxon walls is decorated with panelling or arcading constructed of flint or stone rubble, and raised three or four inches from the main surface. See picture left, a part of the circular tower at the church of St Mary, Tasburgh (Norfolk). The arcading is set back from the main face of the walling, there is no strip-work around the opening, but the flints are carefully selected to make a 'justified' edging.*

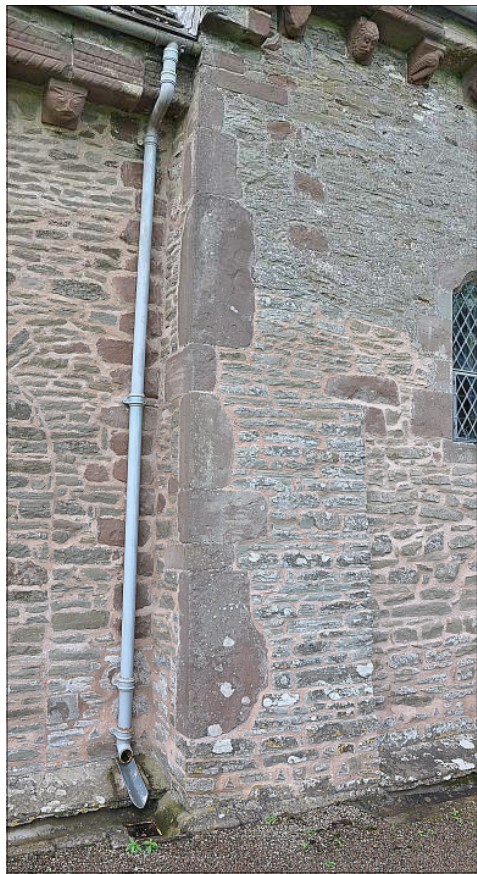
Top photo. At the church of St. David, Kilpeck (Herefordshire) there are, preserved in its north-east corner of its nave a megalithic quoin and a length of about 4 feet of the rough rubble wall of an earlier church. This church is more normally known for its stunningly sculptured ornament of Norman date. The quoin is badly out of the vertical in its lower half and the 'join' is more obvious there. However, this quoin cannot stand alone (as a remnant), that wouldn't make constructional sense and it probably belongs to the remainder of the east wall of the nave. I suspect that the previous nave was first to be rebuilt and then #closely followed by the chancel, and so this quoin 'fragment' is the only visible reminder of the Anglo-Saxon church. Having said that the rough rubble walling of the nave east wall is clearly visible from within. Externally the walling is a little confused by a pinkish pointing applied, on the north side, to the lower half of the building.

One reason I am happy to assign a slightly different date to Norman nave and chancel is that upon examination the stringcourses of these two cells are, although extremely similar, not exactly the same. The base decoration to the nave is worked in a double ribbed, or raised edge, design, whereas on the chancel this strap-like design is marked at the edge by a simpler single incised line. Of course the third cell, the apse, although of Norman date is differently treated as regards both walling and decoration.

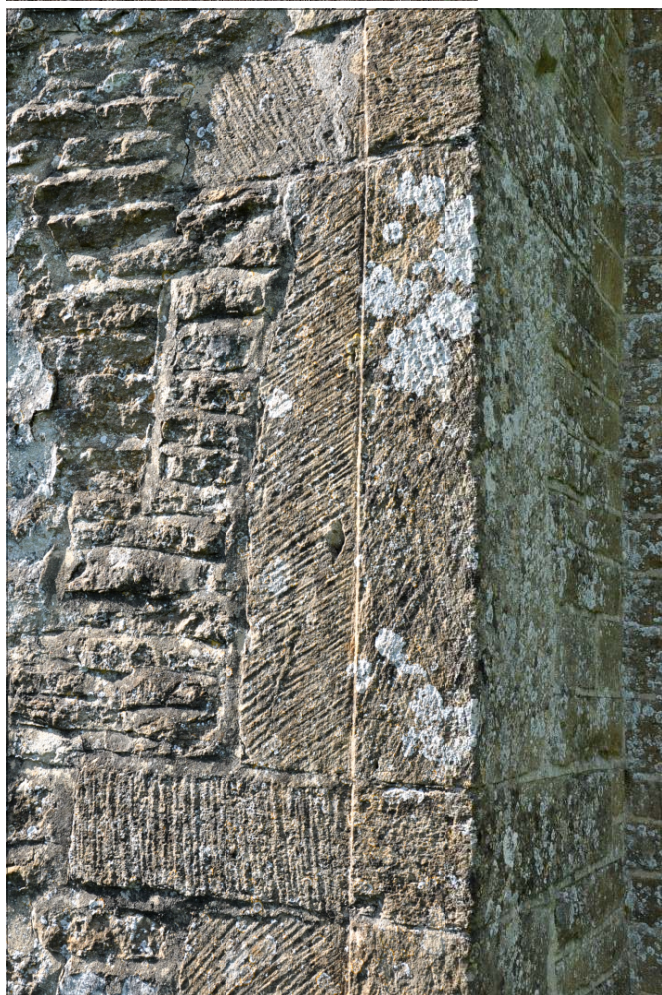
Bottom left photo. At the church of The Holy Cross, Daglingworth, Glos. there are good examples of long-and-short quoins which are cut back (see "d" page 1). This is to make a justified edge for the plaster covering, which no longer exists. As originally intended the stones would have been seen as a tall 'strip' or pilaster at the angles. The 'hatching' or tooling on the cut back part of the quoin is to provide a key for the plaster.

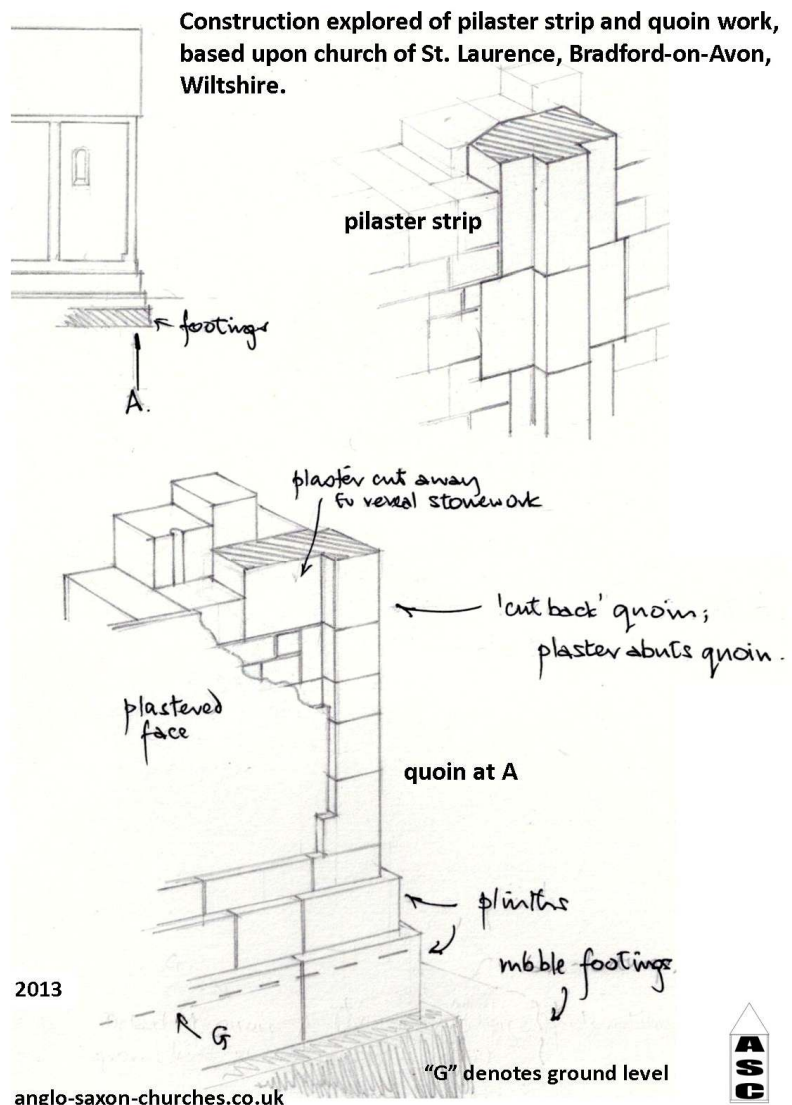
Bottom right. Line drawings illustrating 'cut-back' type of pilaster strip work and matching quoin, based upon fabric at the church of St. Laurence, Bradford-on-Avon.
