# Anglo-Saxon Sculpture and Roods.

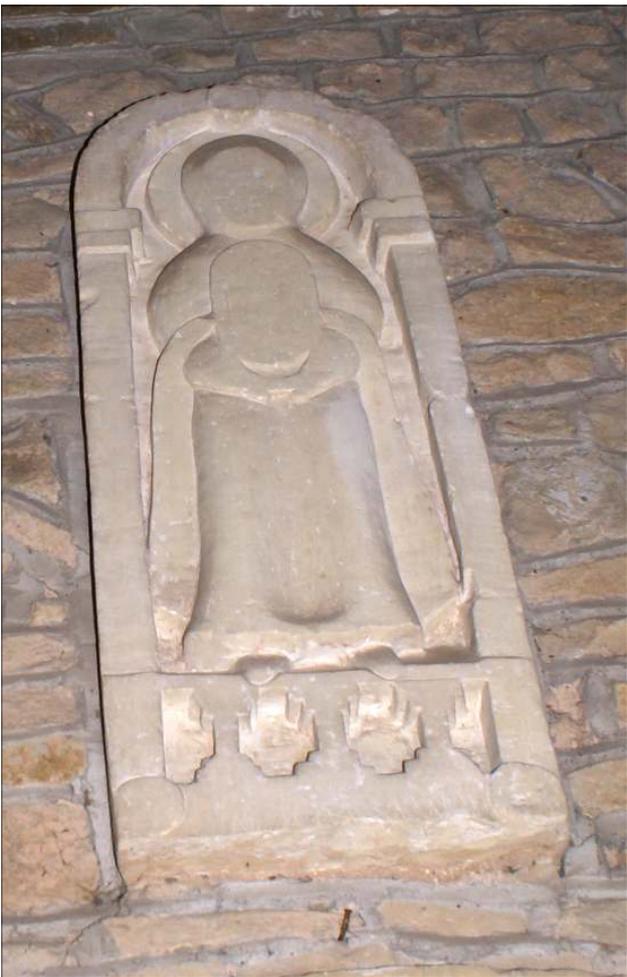
1. Inside the tower (ground floor) at St. Mary, Deerhurst, Glos. Carved stone of the Virgin and child which would originally have the detail painted on. I presume this type of style preceded that which would be more conventional where all detail was carved. Note the feet which show the figure standing on a balustrade with pillars identical to those seen in the elevated tower archway in this church.

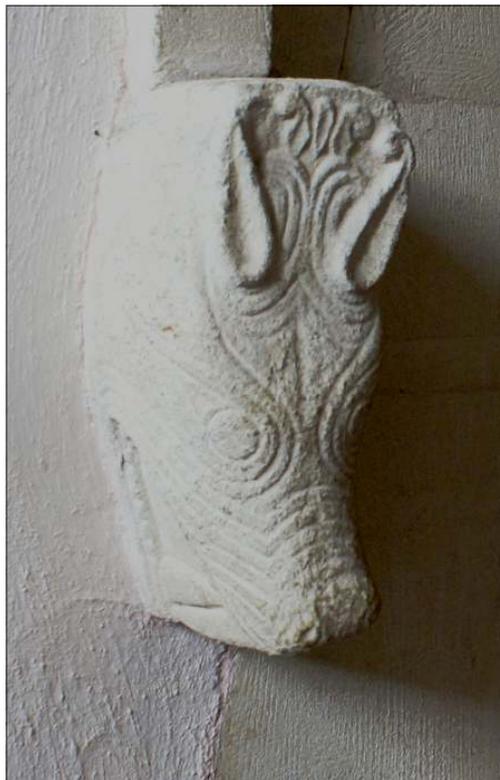
2. A carved animal head as a hood stop, inside Deerhurst church.
3. Carving of an angel at Winterbourne Steepleton church. Compare the very different technique of the Deerhurst Virgin with this example. Taylor notes how it is generally similar in form to the well known pair at Bradford on Avon, but this is carved in higher relief and is seen full face. The carving is dated by Talbot Rice to the first half of the tenth century, 'nearer 910 than 950' or possibly even to the reign of Alfred.

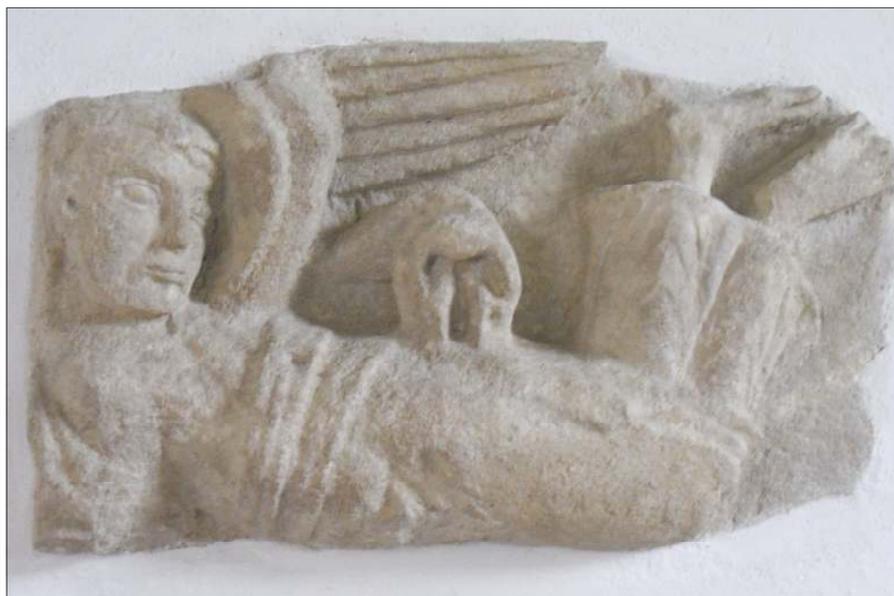
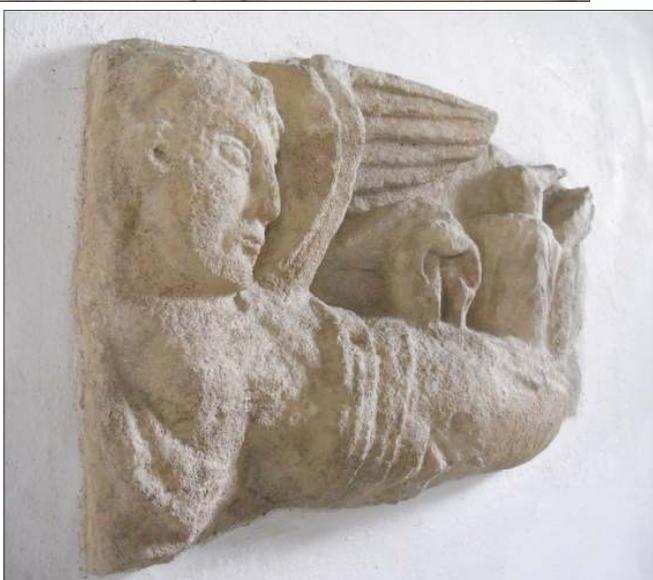
4. Shows a more oblique view to more readily give a better understanding of the relief of the carving.

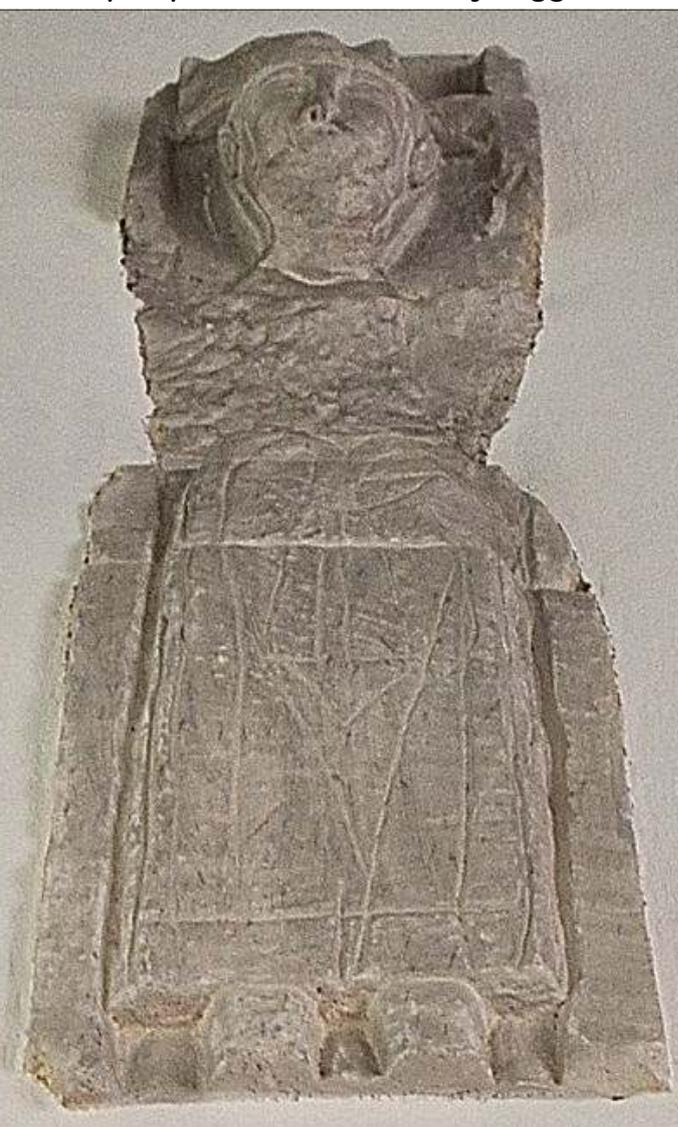
5. At Walkern church, Herts. The carved figure is situated centrally above the (vanished) south doorway, so we may safely assume that it is in its original position. However, at a later date the doorway was partly destroyed (only its eastern impost survives) by an archway of the south arcade so that this carving is now seen from the south aisle. This enhanced photo shows the figure which is partly defaced, a section about a foot in height across the upper part of the body has been cut back to the surface of the wall. The head is in high relief with well defined features including a moustache. The removal of the area where the arms would be makes it difficult to say with certainty how the figure was portrayed but Taylor states that the draped part of the lower body suggests the same general treatment as that of the large rood at Langford.

The high relief of the head contrasts with the flat form of the lower body with lightly incised lines indicating folds of the drapery and knotted belt. The feet are shown below the skirt a few inches apart as was usual in Anglo-Saxon times, and in contrast to the crossed feet usually shown in later medieval representations of the Crucifixion.

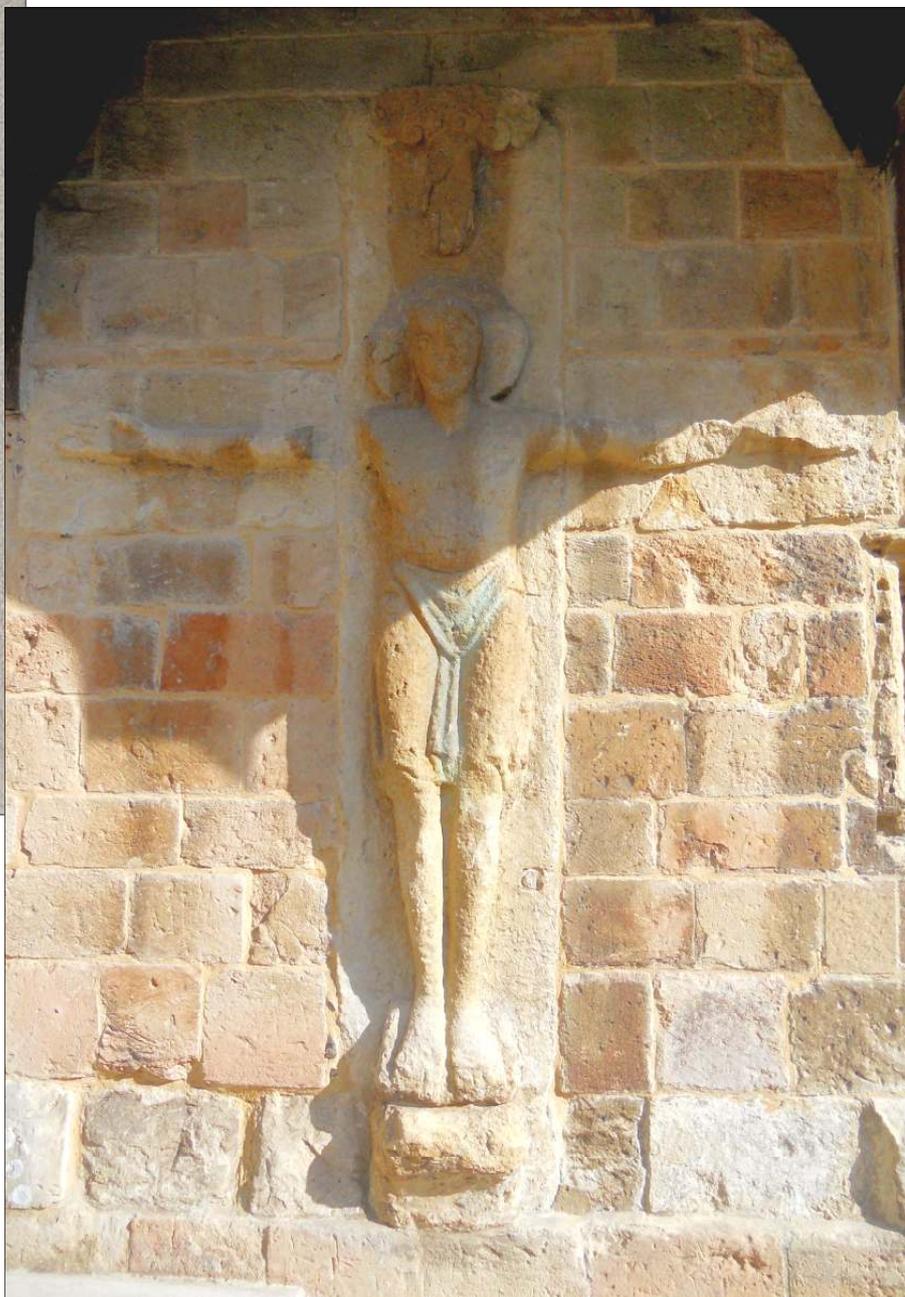
6. At Romsey Abbey there are two roods, the larger has been moved to a position outside on the west facing wall of the Norman south transept. The figure of Christ is carved on

a massive stone of which at the head is the hand of God descending from a cloud, as at Breamore and Headbourne Worthy. The importance of this feature in settling a pre-Conquest date was first pointed out by Casson and was subsequently emphasised by Clapham. Talbot Rice dates the Rood circa 1010. Due to its lengthy exposure to the elements it has suffered from weathering, especially the face which has lost much of its detail.

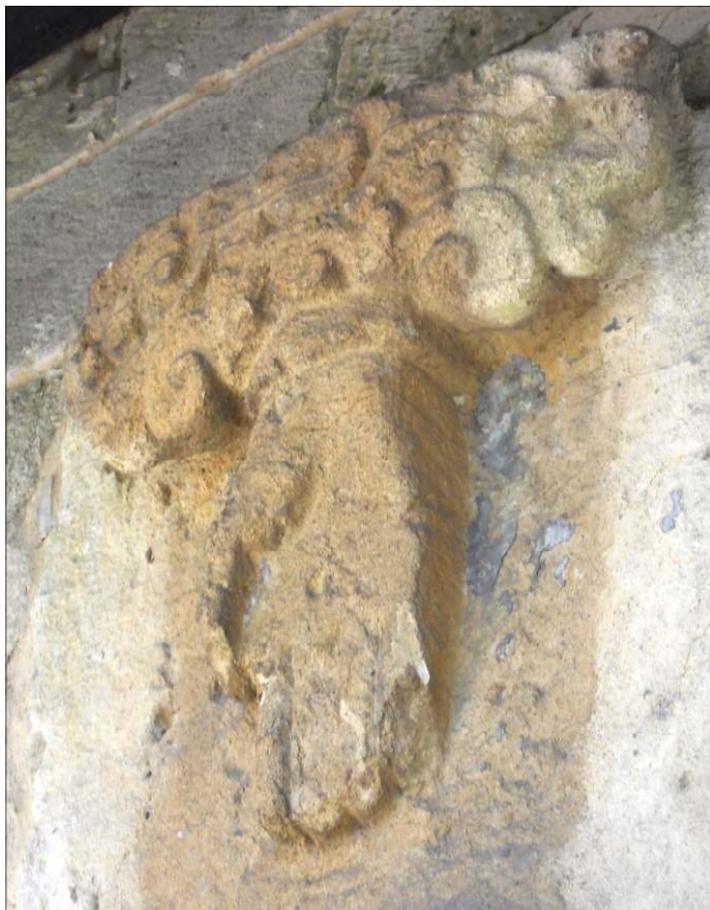
7. At Romsey Abbey, the hand of God descending from the clouds, seen in the previous picture.
8. Inside Romsey Abbey, the smaller Crucifixion, measuring about 2ft 6in in height, dating from about the year 960. The Anglo-Saxon Abbey dates from the mid nine hundreds, although a possible earlier foundation as was claimed by a spurious charter attributed to Edgar. St. Elflaeda was abbess here in the 10th century. The foundations of the Anglo-Saxon Abbey remain under the later Norman building. Thus the two sculptures were removed from the earlier church at some time when the Norman Abbey was in building.

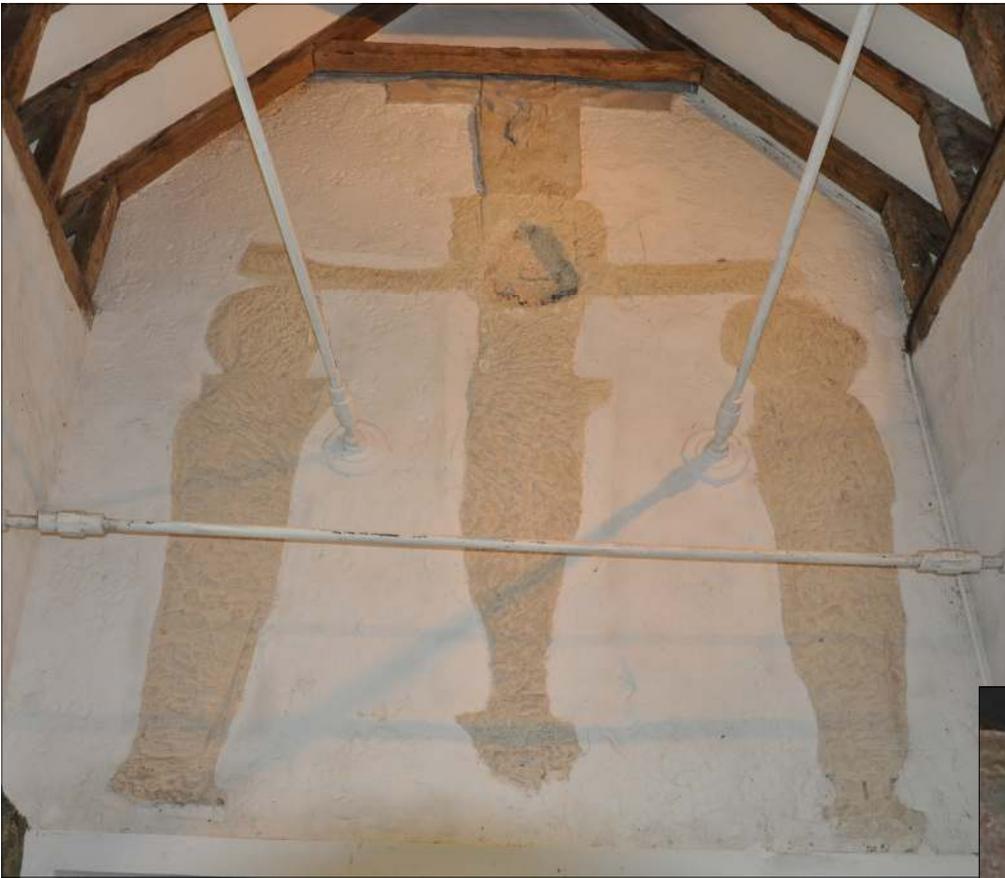
9. First picture is of the Rood at the church of St. Swithun, Headbourne Worthy, Hants. It sits directly above an Anglo-Saxon doorway and upon the west face of the west wall of the nave. It has been severely cut back to the wall face. Doubtless mutilated in the time of Bishop Horne (1560-80) who is recorded as ordering the destruction of all Crucifixes in the Diocese of Winchester. This Rood, like that at Breamore now sits inside a later 'porch' - except here it is accessed only from within only. However, the hand of God descending from the clouds has in great part escaped mutilation.

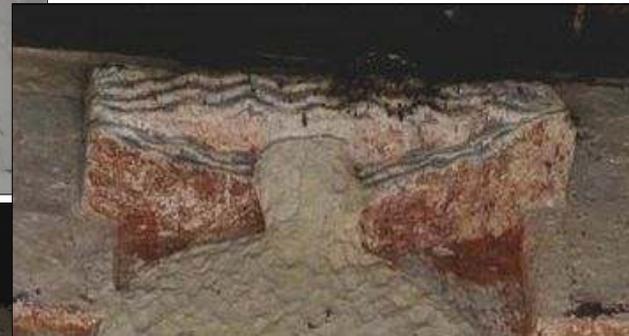
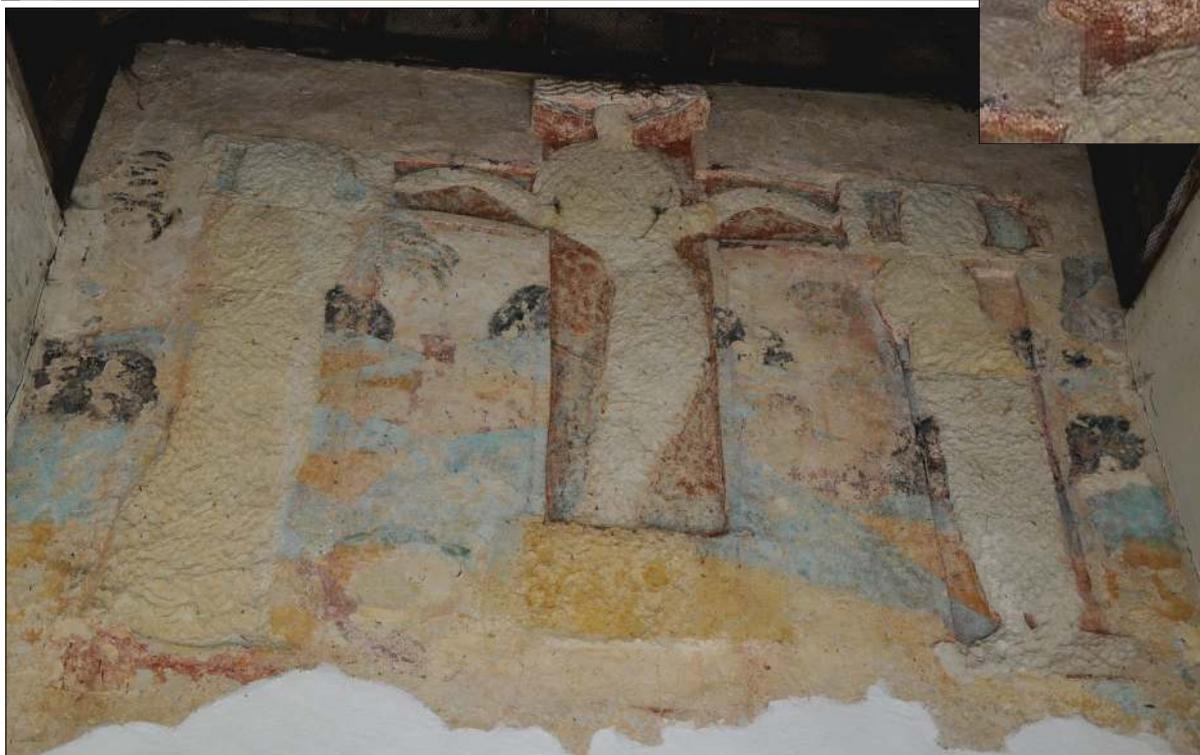
10. The Rood at St. Marys church, Breamore, Hants and which sits above a doorway of late Anglo-Saxon date and protected by the Norman south porch. The small inset picture shows the hand of God descending from the clouds. Here the hand has not escaped mutilation but the magnificently represented clouds are intact.

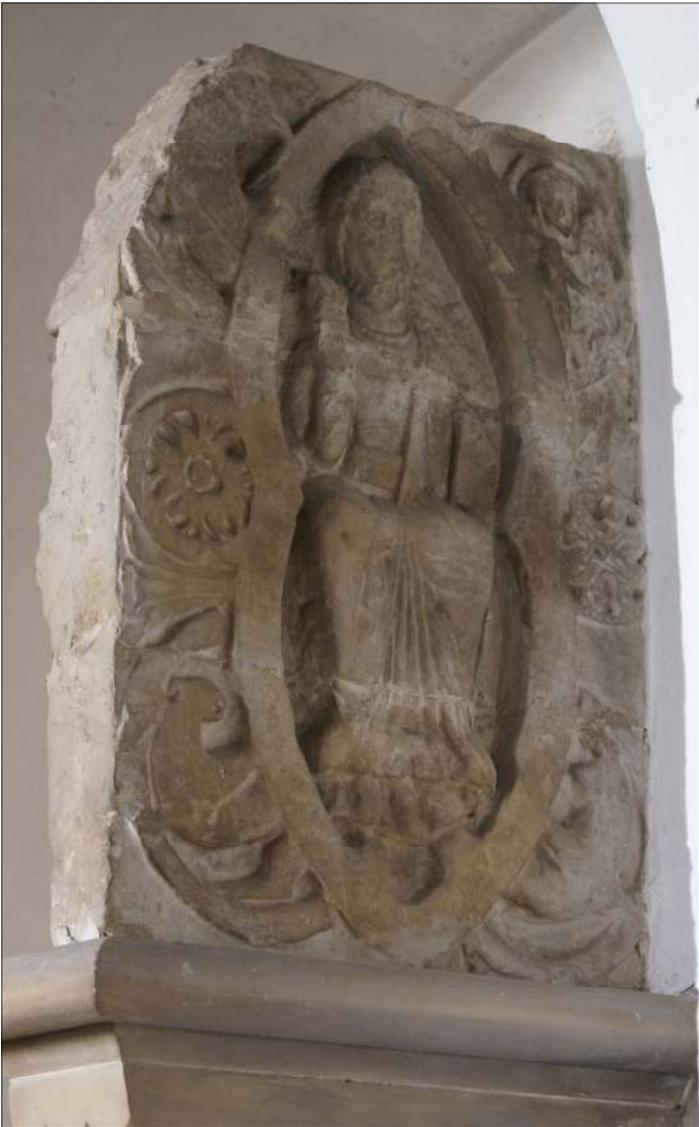
11. Here we see two pictures of carved stones at the church of St Mary, Sompting, Sussex. H. Taylor mentions them in Vol II of his Anglo-Saxon Architecture, page 562. He mentions Talbot Rice and Clapham as dating them to the early part of the eleventh century. This picture is of a nimbed abbot. The way in which the figure is carved shows a great maturity of technique and must rate high on the list of known Anglo-Saxon carvings.

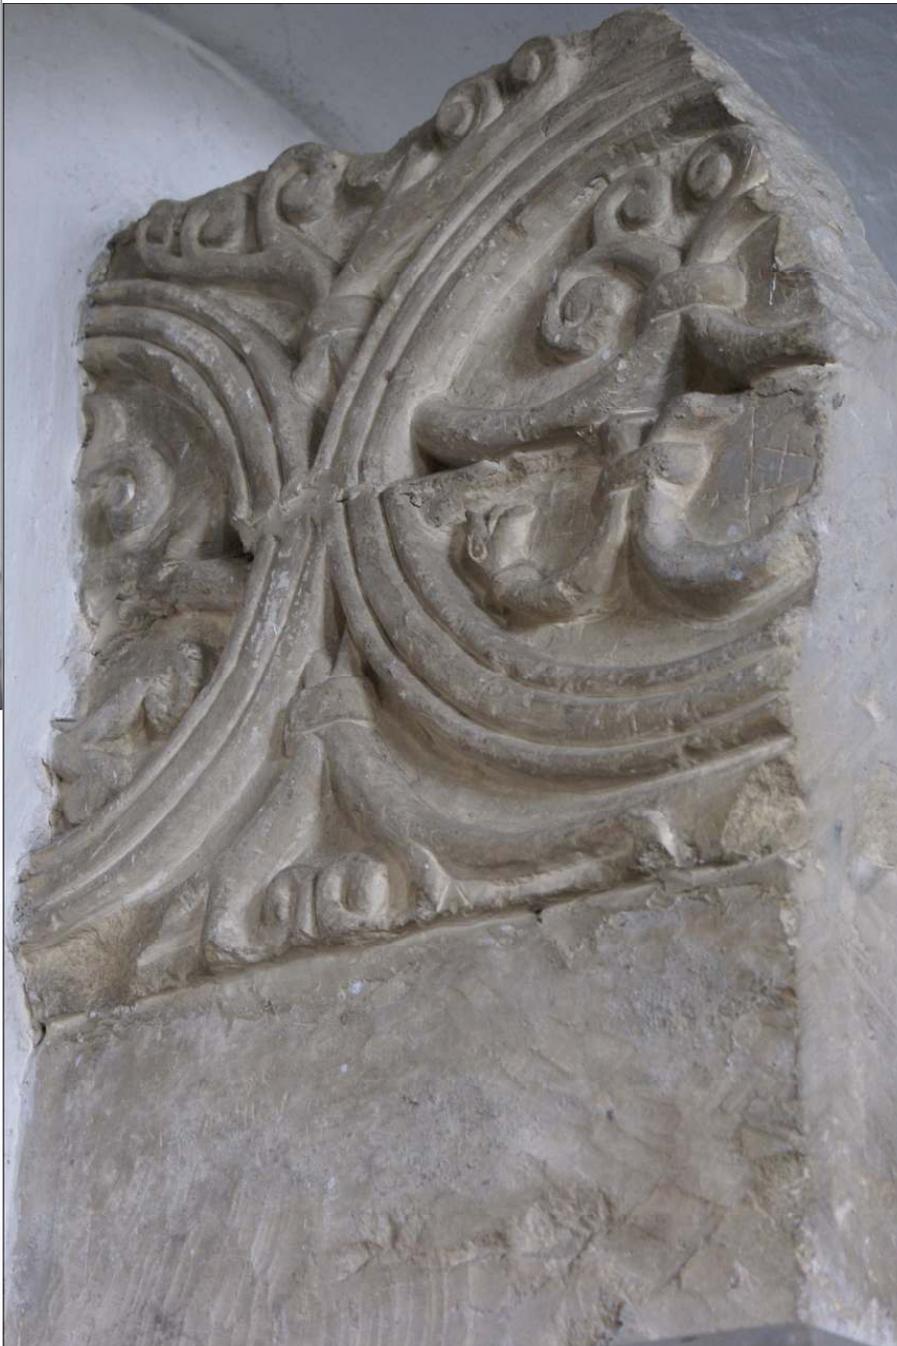
12. This stone is a fragment of scrolled ornament and is beautifully carved. Taylor mentions four carved stones in total however. Clapham gave reasons why he assigned them to the same early eleventh-century date as the main fabric of the tower.

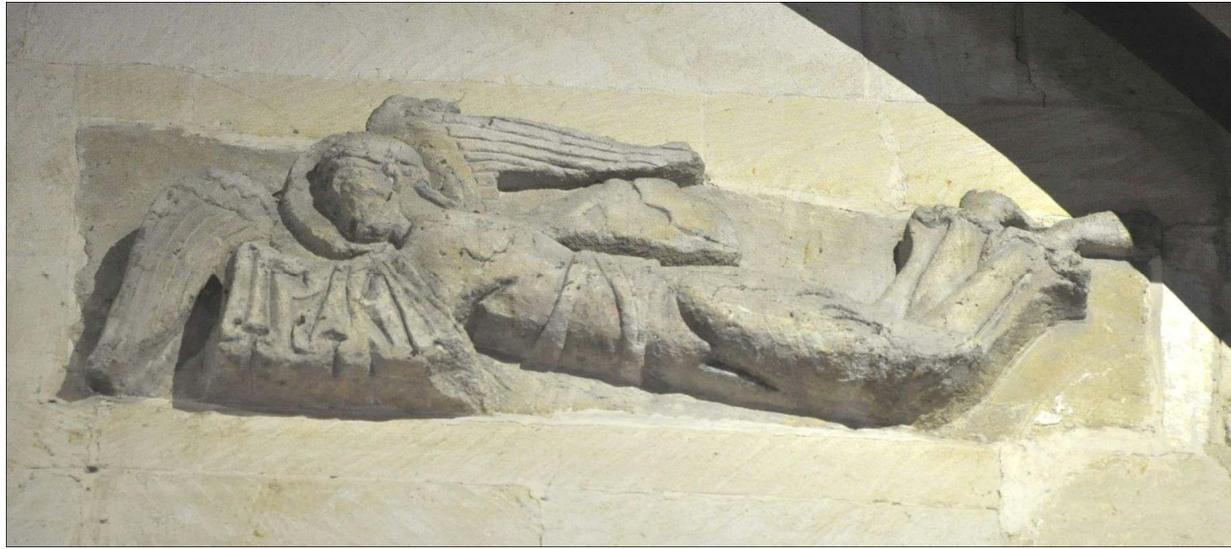
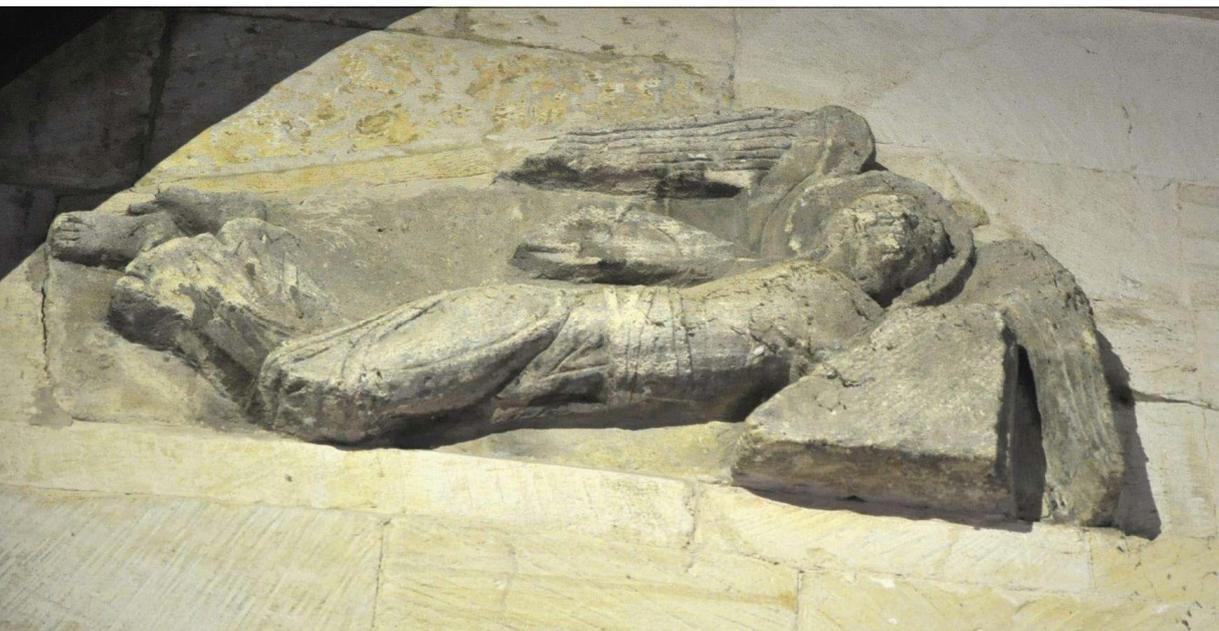
13 & 14. At Bradford on Avon, Wilts, on rising ground above the River Avon stands a high status pre-conquest chapel, the original building being dedicated by St. Aldhelm to St. Laurence in the early 8th century. High up on the east wall of the nave are two sculptures which may well have been a part of a crucifixion. These sculptures, of angels, are not now in their original position. To appreciate their size go to the photo file on the church (and see picture 13 on page 4).

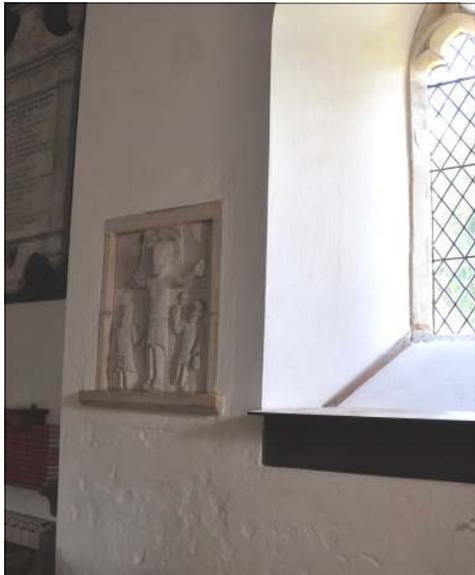
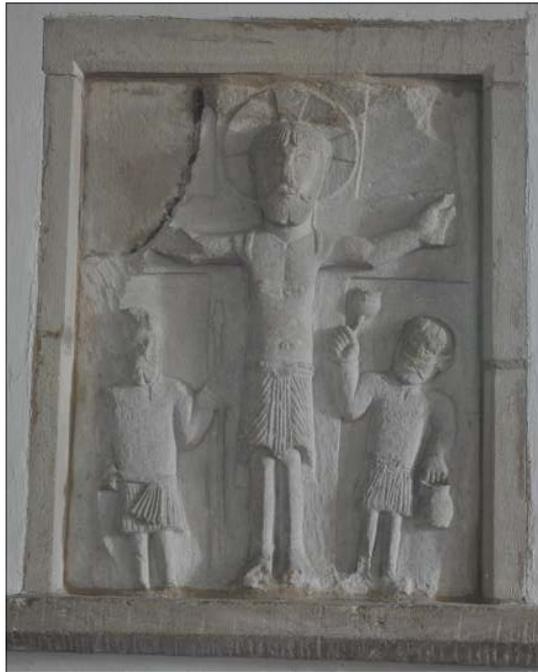
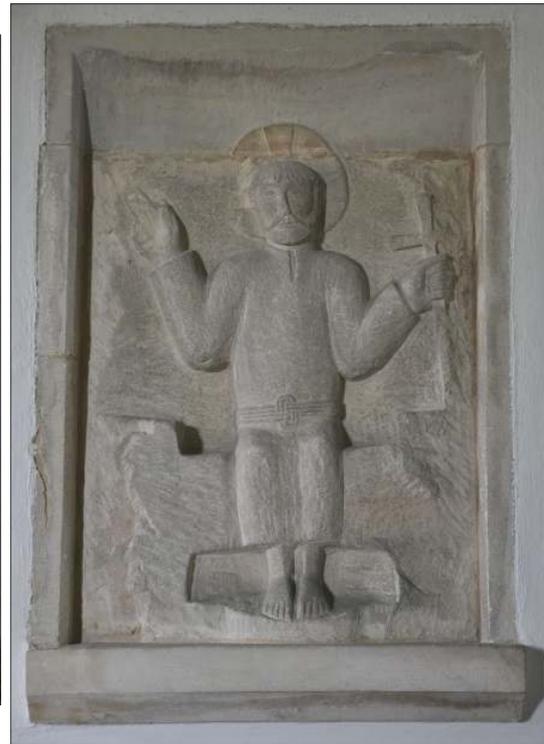
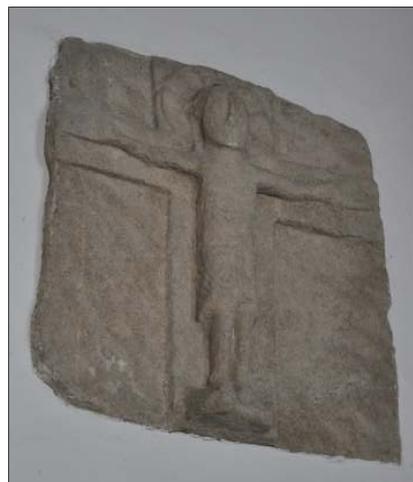
15-20. At the church dedicated to The Holy Cross in the village of Daglingworth some 3 miles distant from Cirencester, and not far from a Roman road, stands a church exhibiting cut back quoins and an interesting Anglo-Saxon chancel arch. Inside there are various Anglo-Saxon sculptures now set into the nave walls.

H. Taylor describes these sculptures in some detail, and gives a date at the beginning of the 11th century. It will be noticed that photo 19 is of a sundial, in a similar style to that at Corhampton, Warnford, and Winchester, but being sheltered inside a later porch it is in a very good state of preservation. Taylor states: "The circular dial is outlined by a raised roll-moulding. The horizontal diameter is marked by an incised line, and the lower half-circle contains four incised radii of which three divide it into four equal 45 degree spaces while the fourth radius divides the first into two."

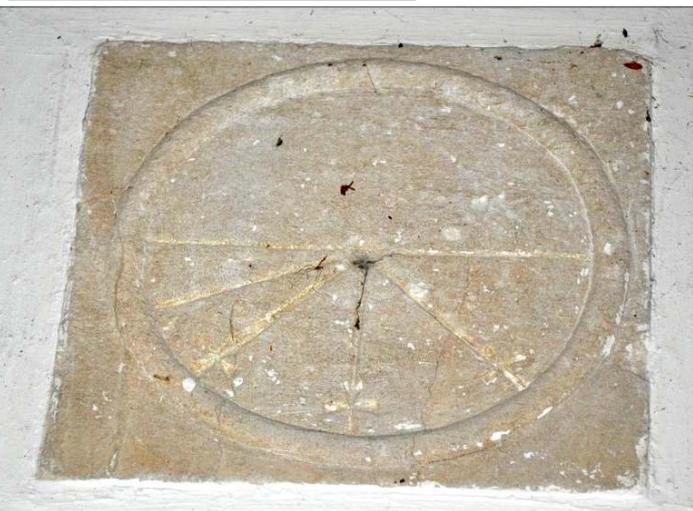
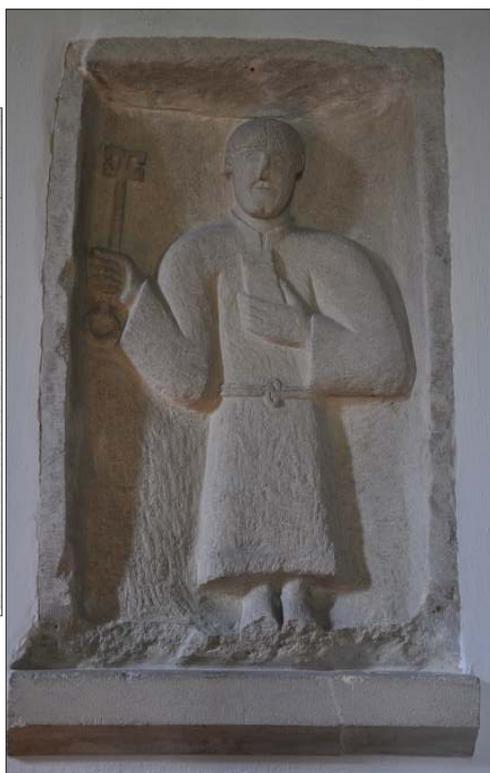
It appears that in those times the day was divided into periods for prayer, and church devotions were marked, long before hours had any meaning. If you increase the size of this file you will see that three of these incised lines (and at their bottom end) there are elaborate little crosses, or more like tied raffia crosses with the uprights both being split in two at their ends.
