Church of St. Mary, Sompting, W.Sussex.

Sompting Church

Further notes on the fabric of the church.

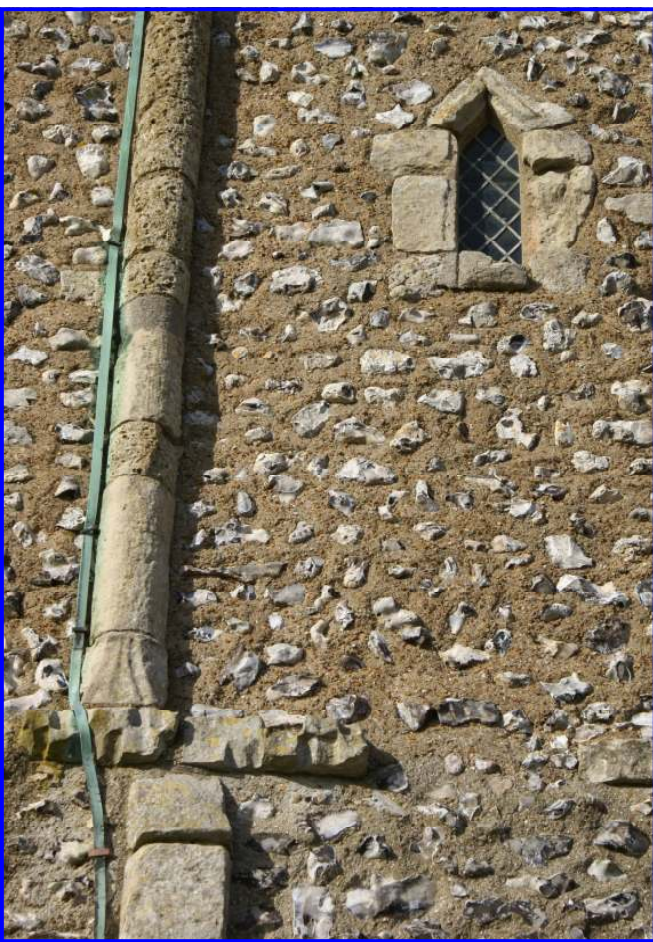
6. Detail (at stringcourse level) of junction of stages at centre of south face of tower. Note the base of the central pilaster which springs from a foot with fluted, or leaf decoration. A triangular headed window is seen above right.

There is evidence on the long-and-short pilasters of the south wall of the tower being 'cut-back' to receive plaster, definitely a pre-conquest technique. There are also partial remains of at least three pilaster strips on the lower stage of the north side of the tower which have been destroyed by the later medieval chapel. Taylor mentions that a post-conquest date had been assigned to the tower, hinging on the Norman "billet" decoration to be found on its string-course separating the two stages. He describes it in detail and explains how it differs from billet and is actually pairs of vertical half-round channels gouged out of the square string-course, and those above the lower pairs are one-half of an increment offset so as to be above the gap between them. Thus upon careful examination not billet by any stretch of the imagination.

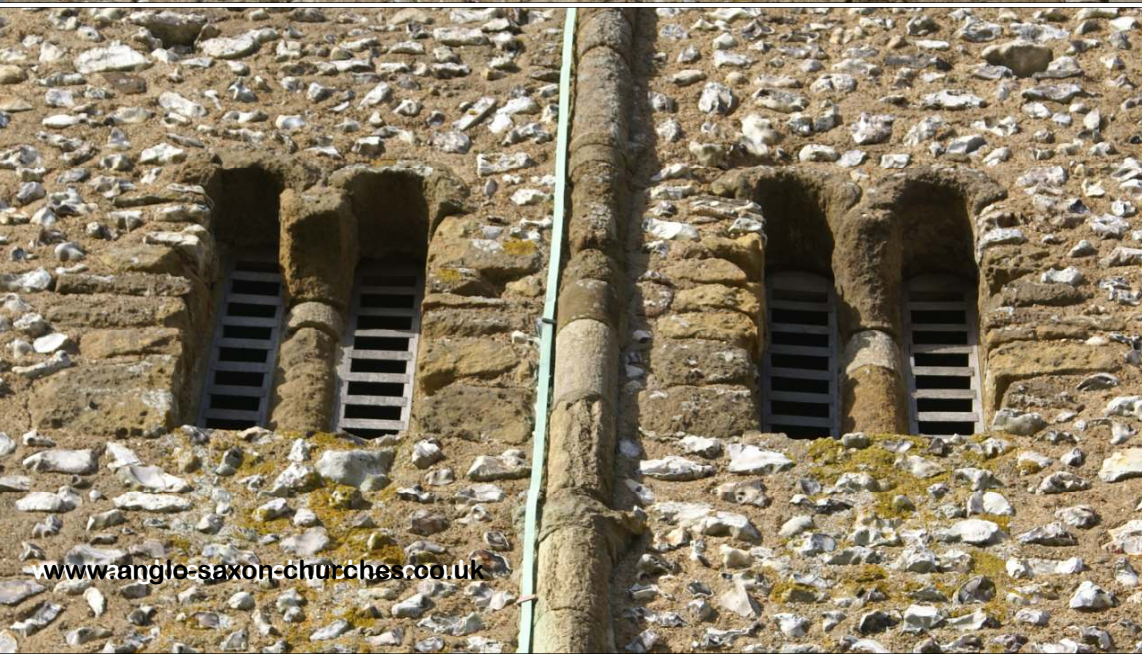
9. Two arched openings upper stage, S face tower. Note the mid-wall shafts supporting through-stones.

Referring to my photos of the tower and at the top stage in particular there are, high up in that stage, two pairs of double belfry windows in both north and south faces. These openings all have a central shaft which is a "mid-wall" type supporting a through-stone. This very nicely fixes them in the pre-conquest era (no self-respecting Norman mason could possibly conceive of using such a technique which would be foreign to his schooling); it is a matter of debate exactly where it places them, but one might reasonably indicate a date of no earlier than (i)950 and 1050 at the very latest bearing in mind the decoration to be found and the general makeup of the openings. I think it is rather a red herring to be trying to date the structure using the quoins, that is often the last resort if no openings such as windows or doorways remain, but here we have perfectly good, un-restored, belfry openings that fix that part of the tower at a pre-conquest date.

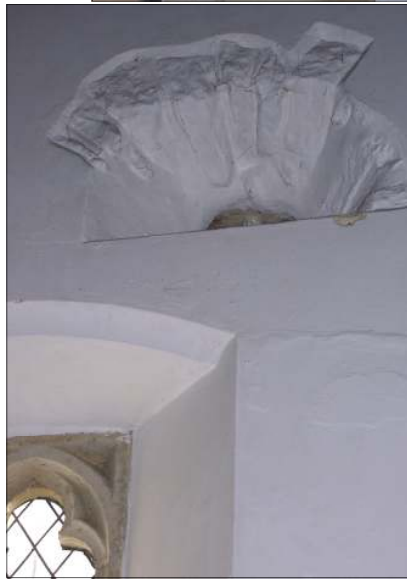
15. Blocked Saxon window S wall nave (cut by insertion of later window).

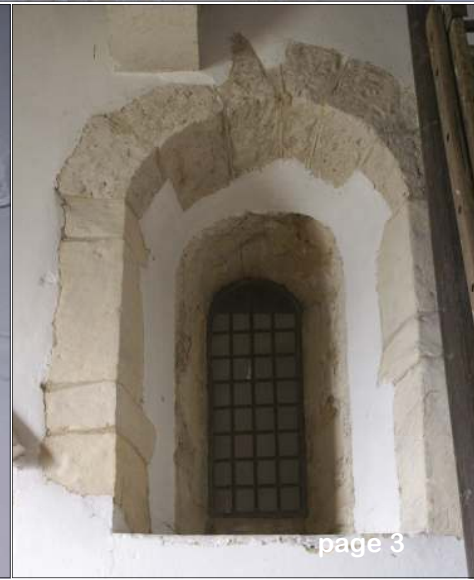
16. Detail of picture 13, showing contrasting stone, possible use of Roman worked stone (right).

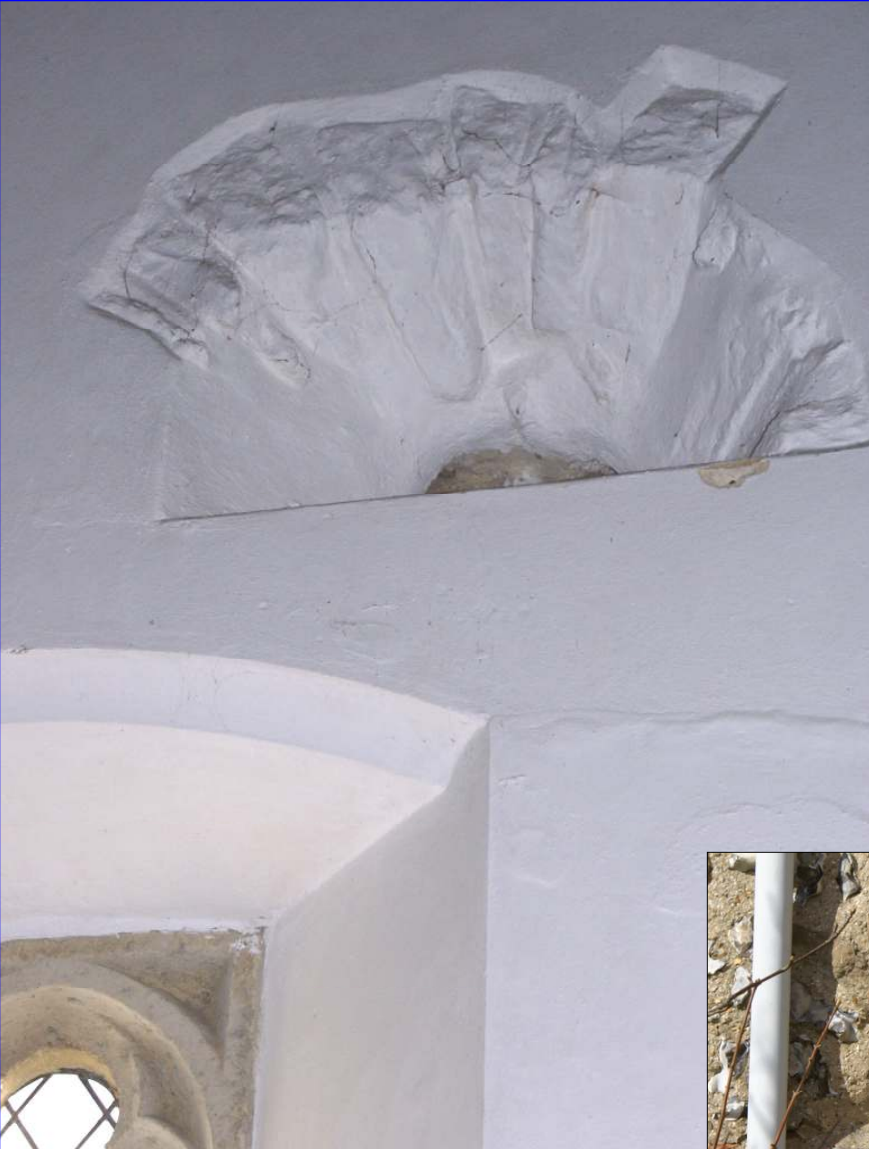
17. Remains of arch of blocked pre-conquest window in south wall of nave and no more than a few yards from where the tower abuts the nave. This would seem to have come to light within the last decade.
