This picture file covers archways, doorways, windows and stairways.

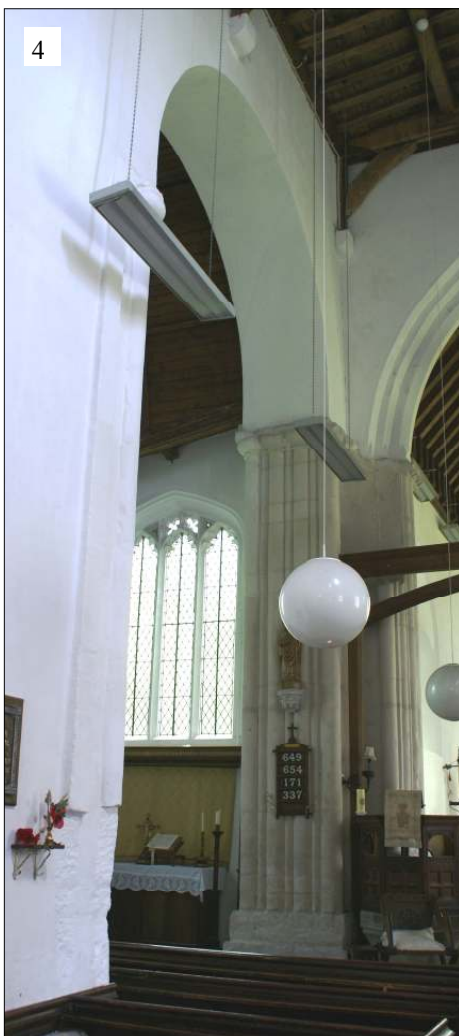
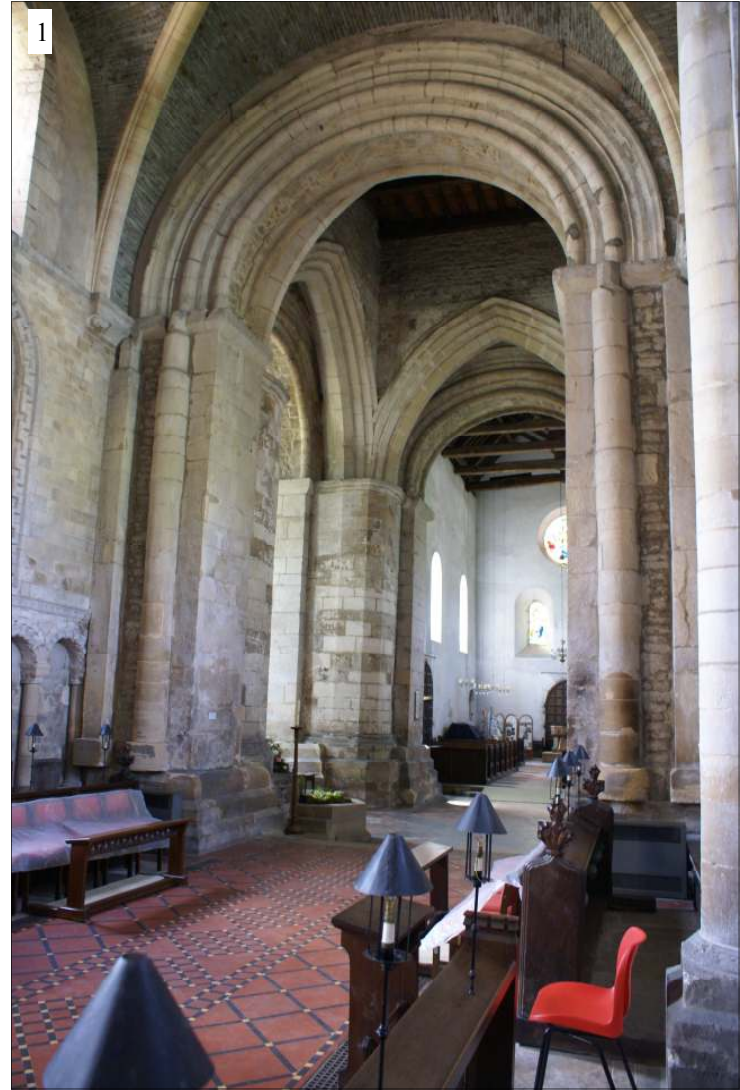
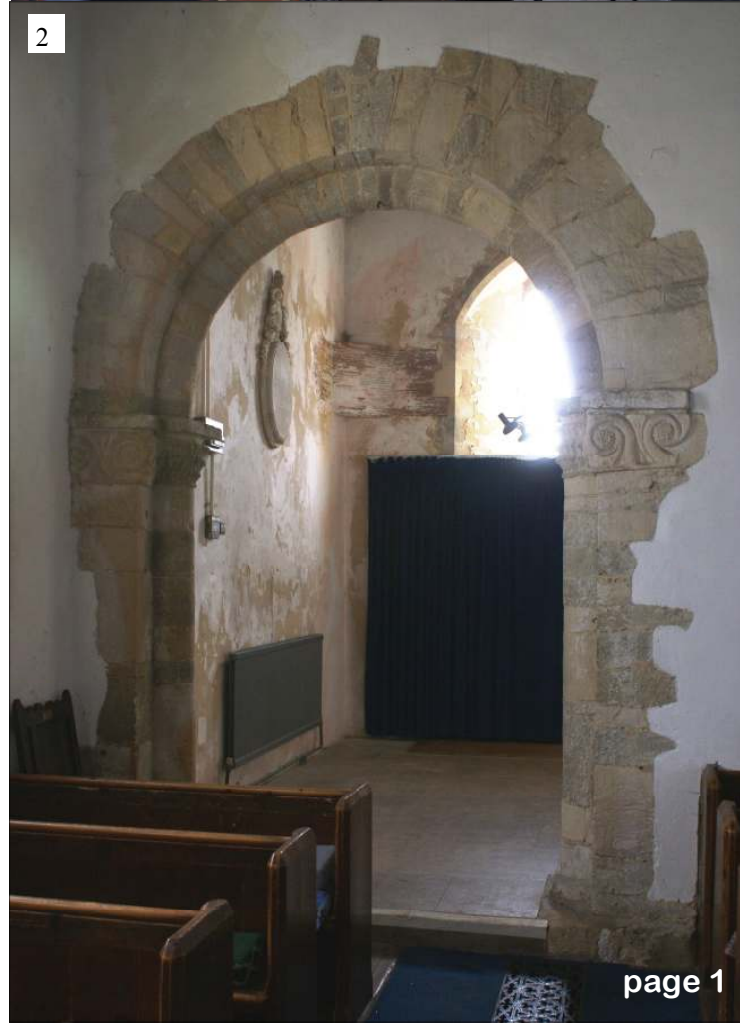
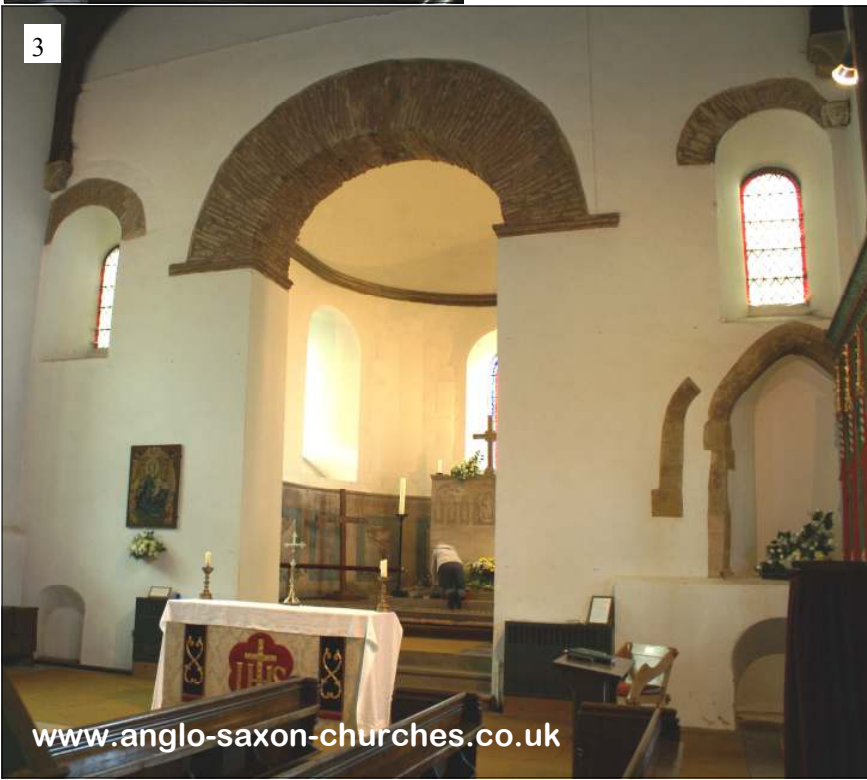
1. **St. Mary Minster, Stow, Lincs**; the chancel arch from east (see the dedicated file on Stow for fuller information).
2. **St. Mary, Sompting, W. Sussex**; the tower arch from the nave.
3. **Church of All Saints, Brixworth, Northants**; the chancel arch and associated windows viewed from the west.
4. **Holy Trinity church, Great Paxton, Hunts**; remains of crossing;

on the left is the north transept arch, to the right remains (jambs) of the chancel archway and out of the picture is the archway to the south transept where only the jambs remain but not to their full height (the nave archway and associated walling has been totally removed). Of the Saxon tower there is now no trace above eave level. The north archway seen here (once leading to the north transept) is approx. 30 ft. to the crown and is very comparable in size to the crossing arches at Stow Minster (in fact within a few inches).

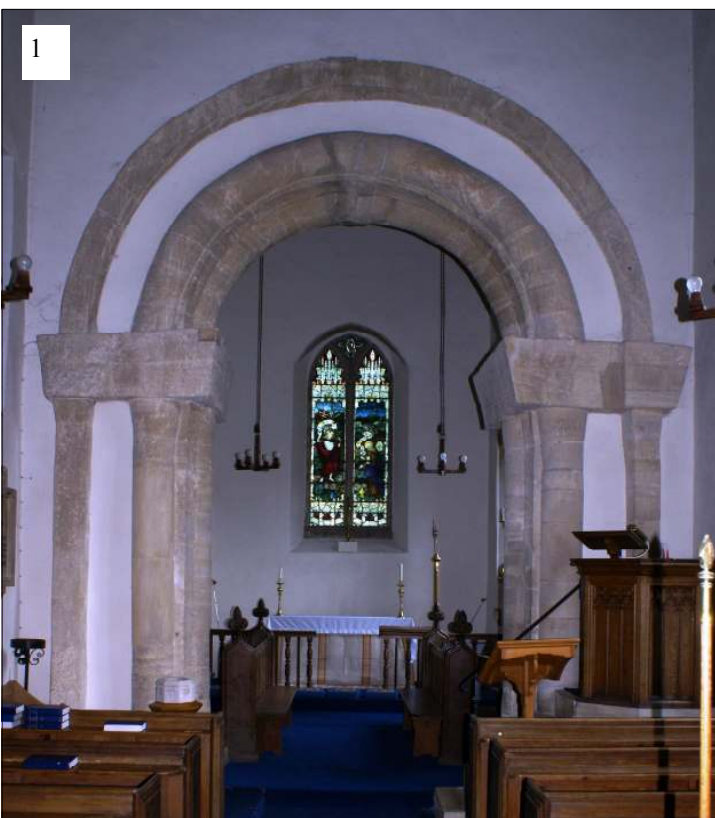
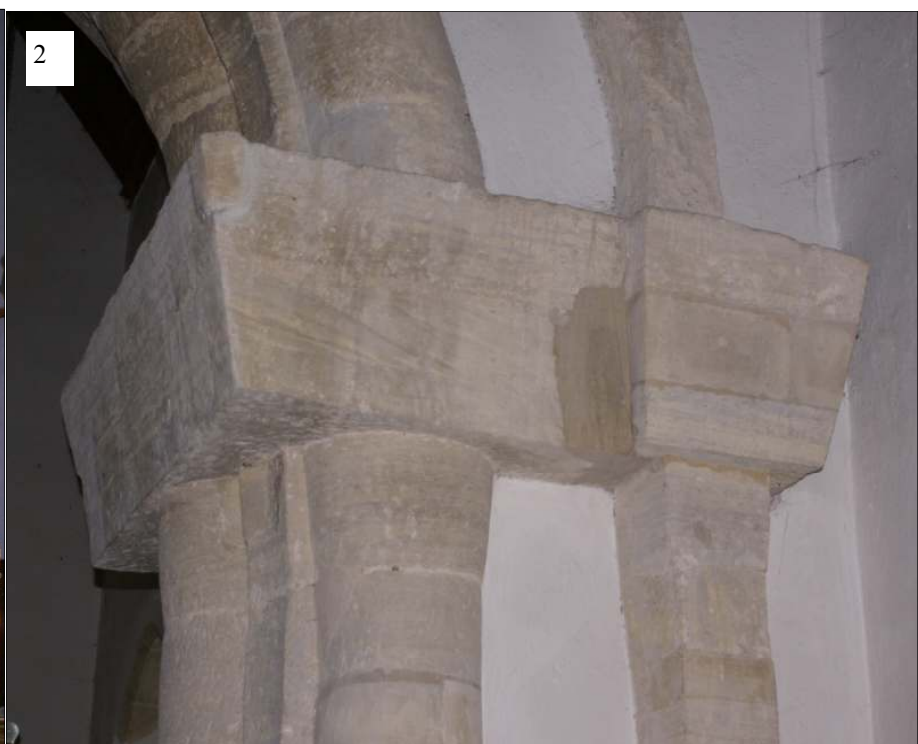
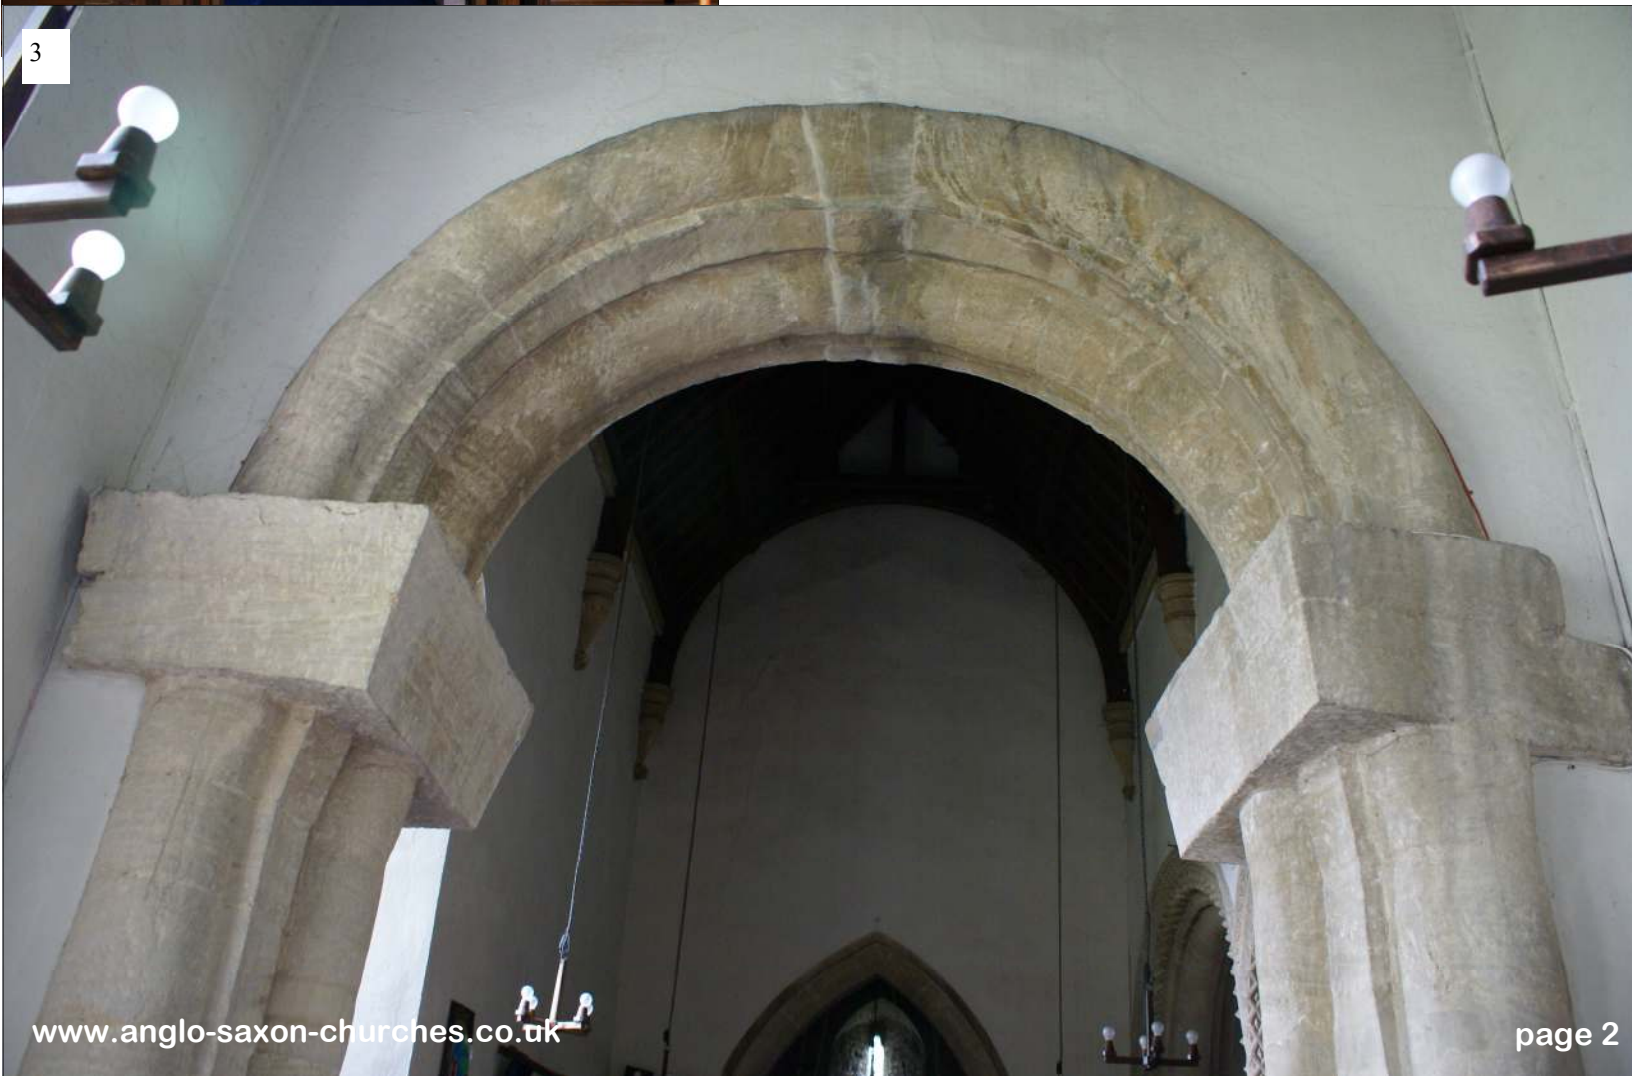
All Saints church, Wittering, Northants.

1. Chancel arch from west.
2. South impost and springing of arch, and showing 'outer pilaster in square section.
3. Chancel arch viewed from the chancel.

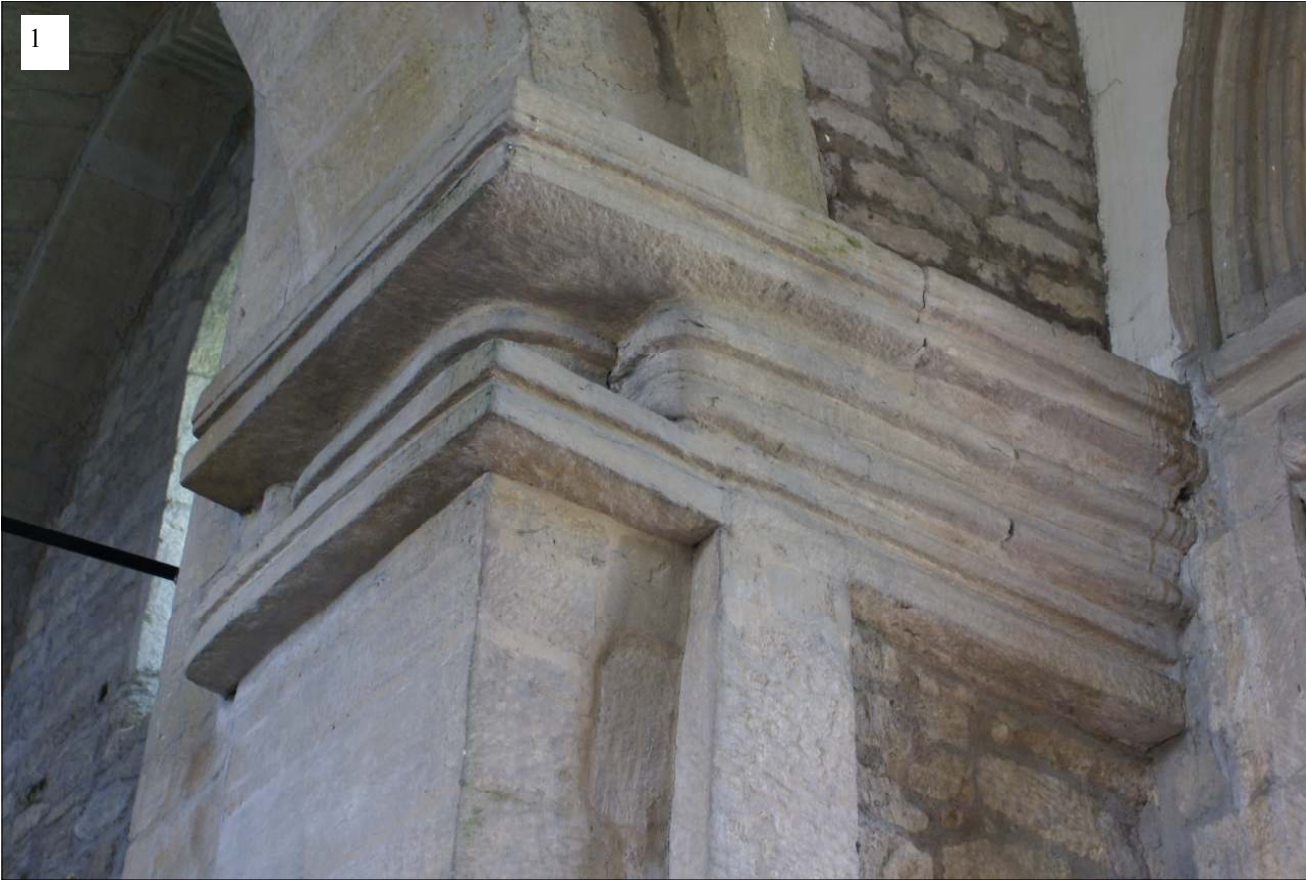
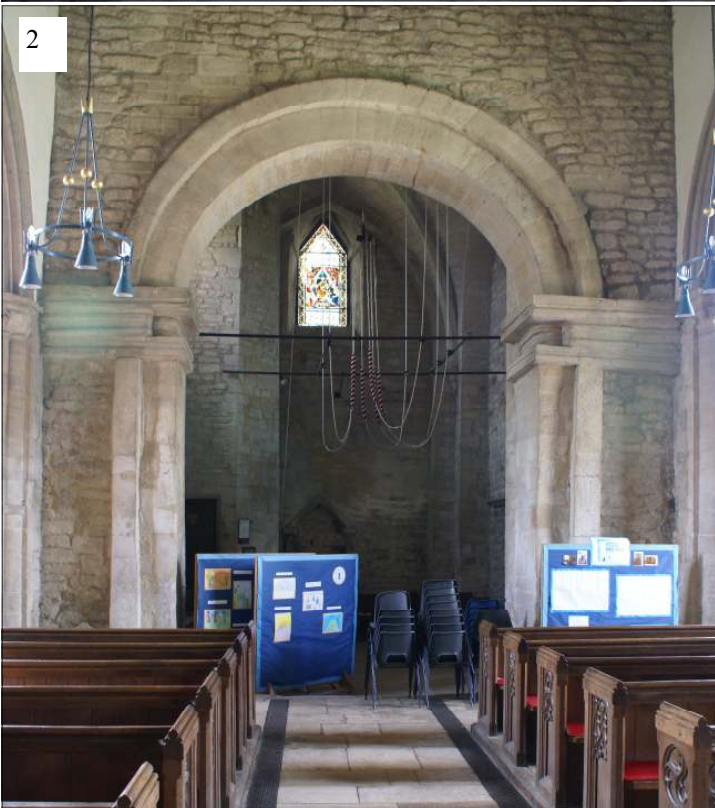
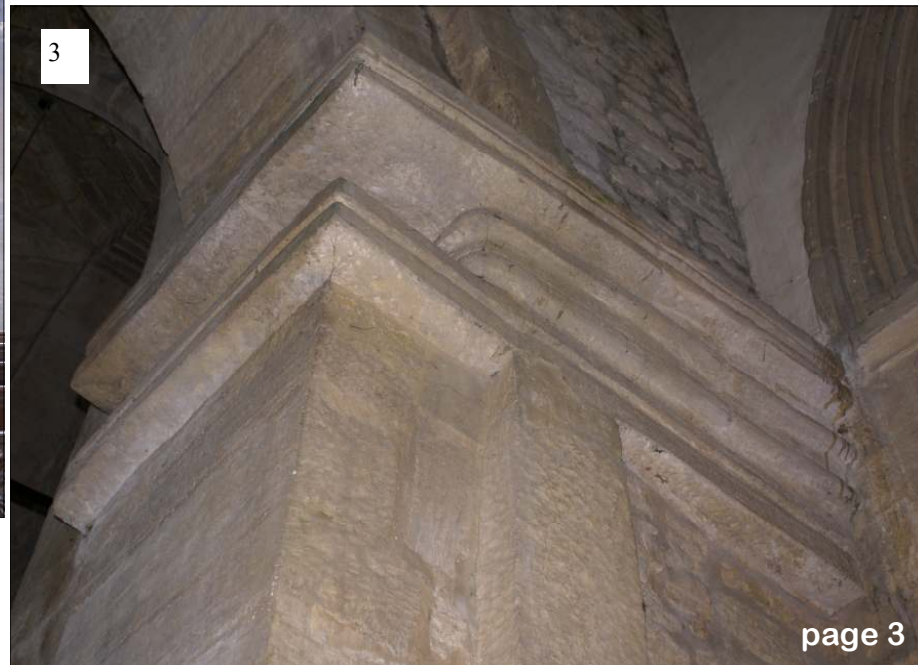
Church of St. John, Barnack, Cambridgeshire.

1. Tower archway showing curious 'sandwich' type construction of (north) impost.
2. The archway viewed from the nave.
3. As picture 1, but viewed from a different (lower) angle.

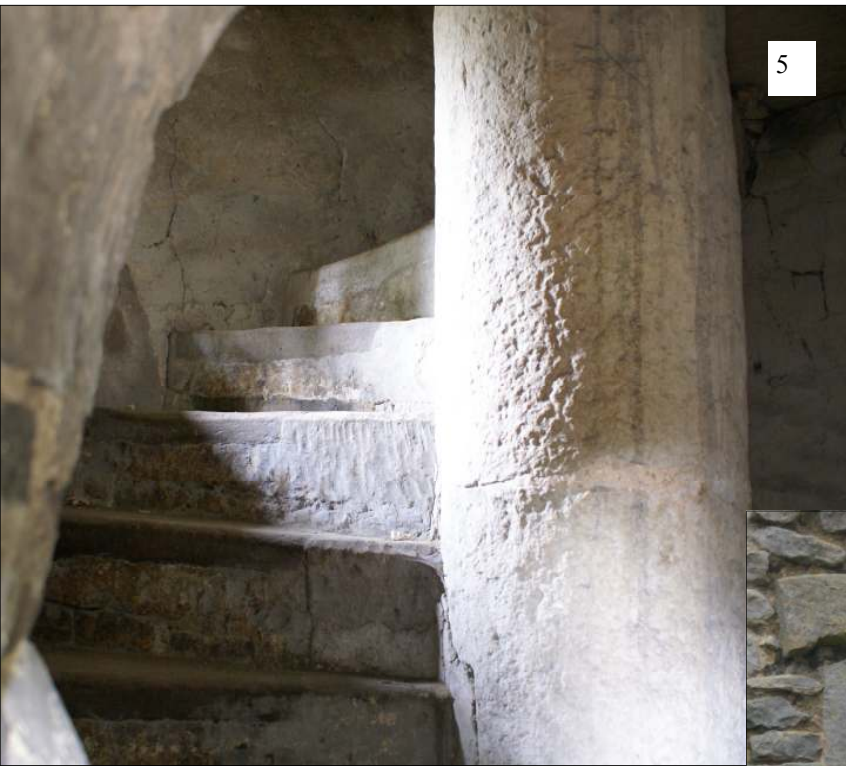
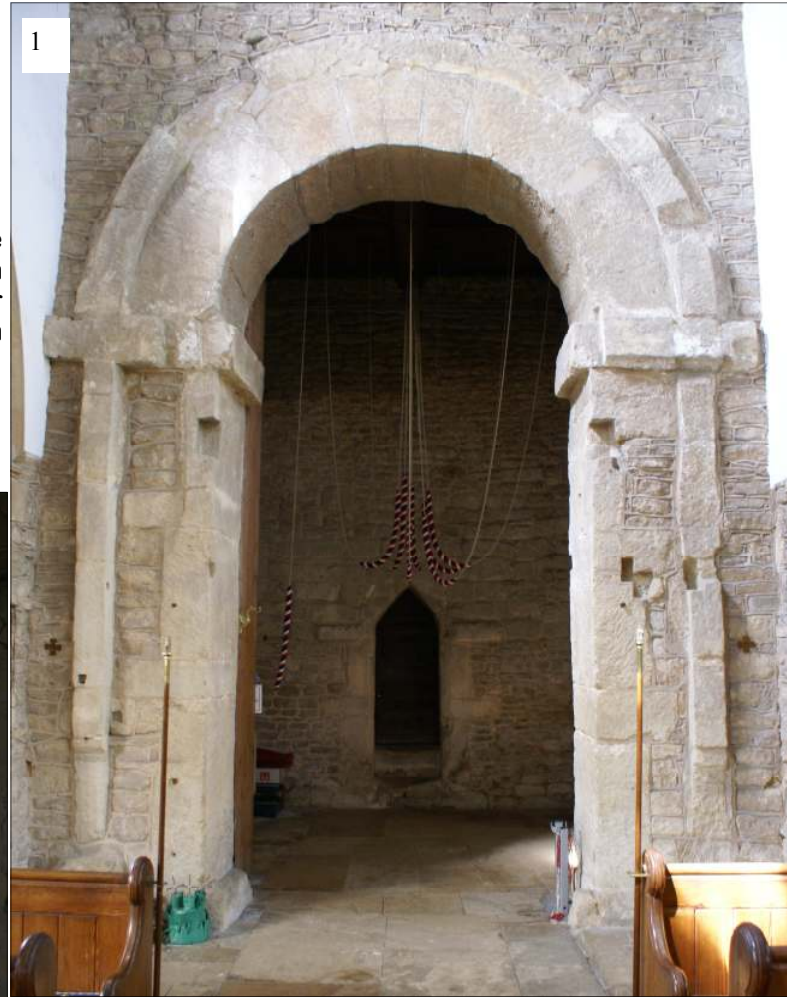
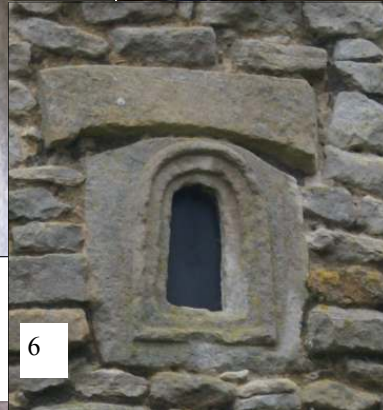
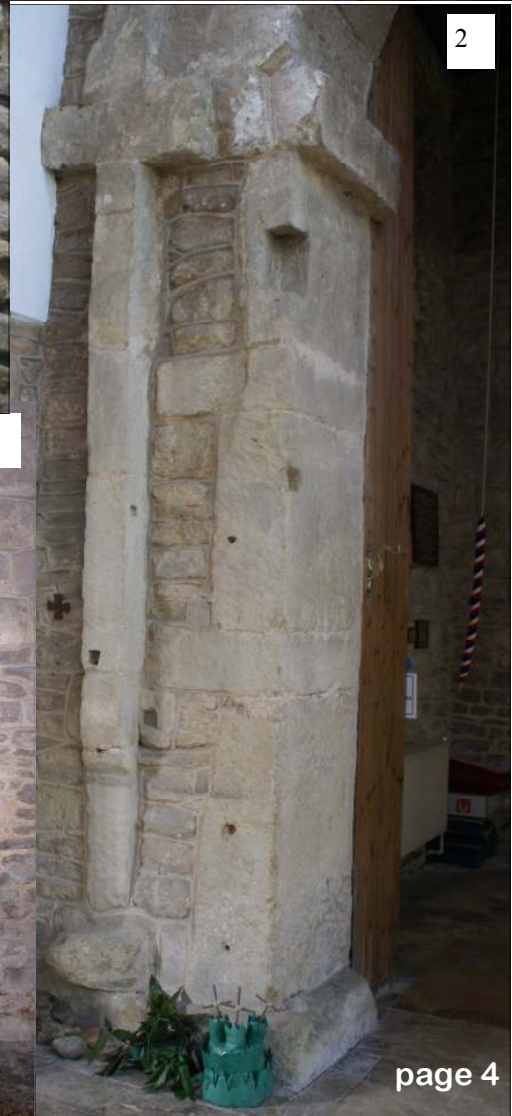
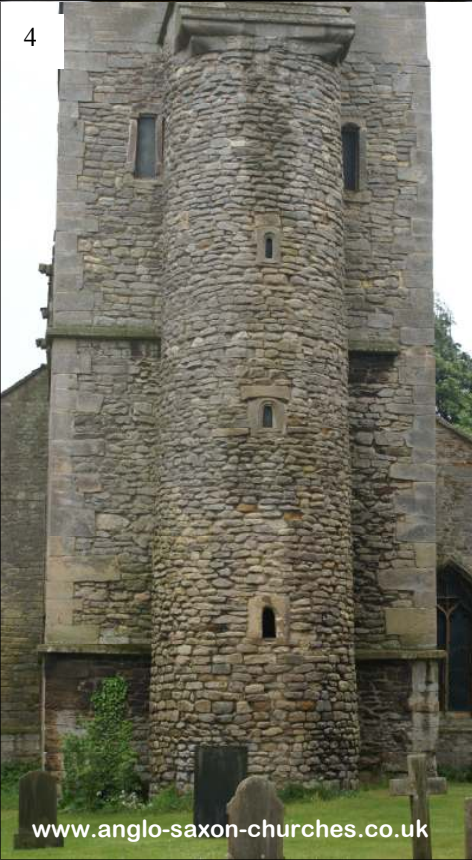
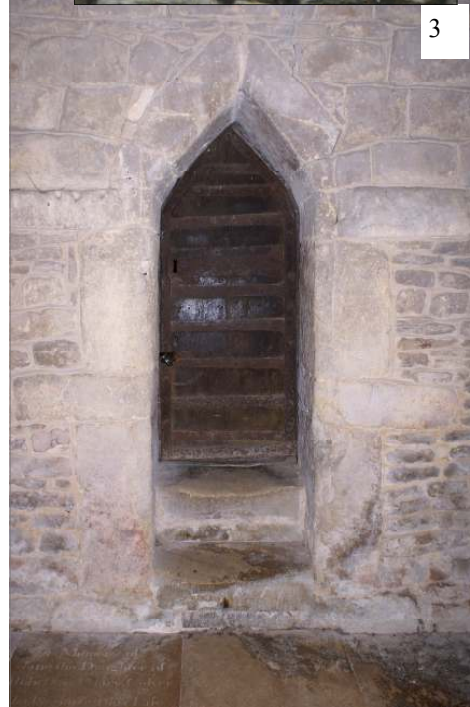
Church of St. Andrew, Brigstock, Northants.

1. Tower archway viewed from nave.
2. The detail of the pilaster on south side of that arch.
3. Doorway, triangular headed, leading from tower to stairway.

4. Saxon tower and W stairway turret.
5. View inside the turret, note the treads are formed quite separately from the newel (column), a distinctive Saxon method of stairway construction and NOT employed after the conquest. The nave of the church, incidentally, is of an earlier date than the tower.
6. Detail of monolithic window in stairway, the 2nd 'up' in photo 4.

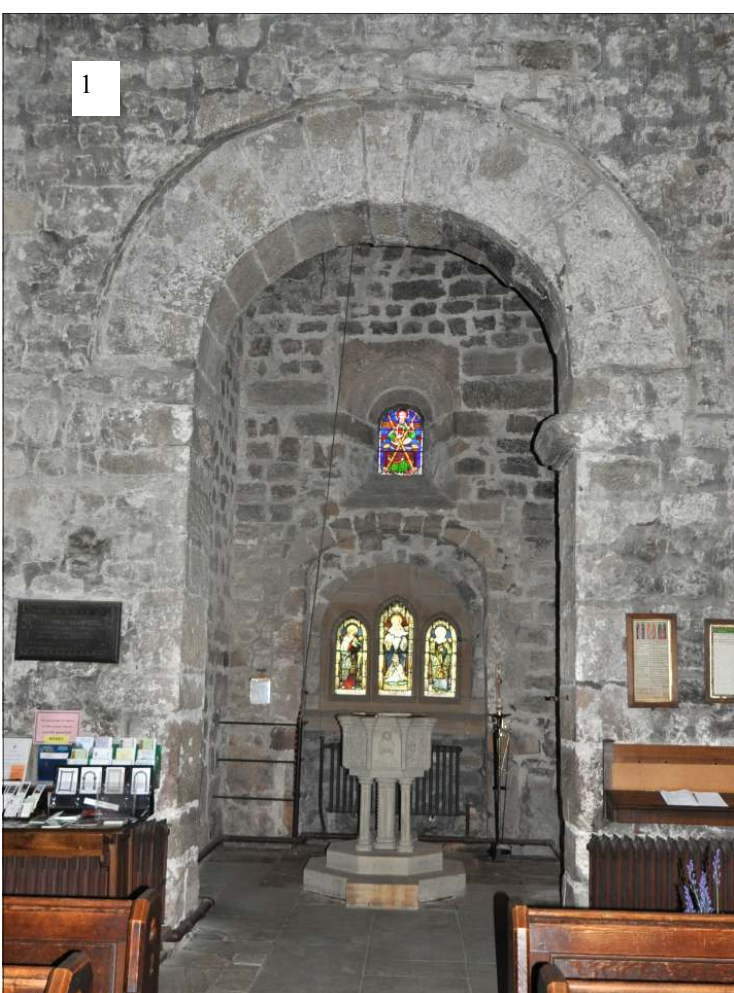
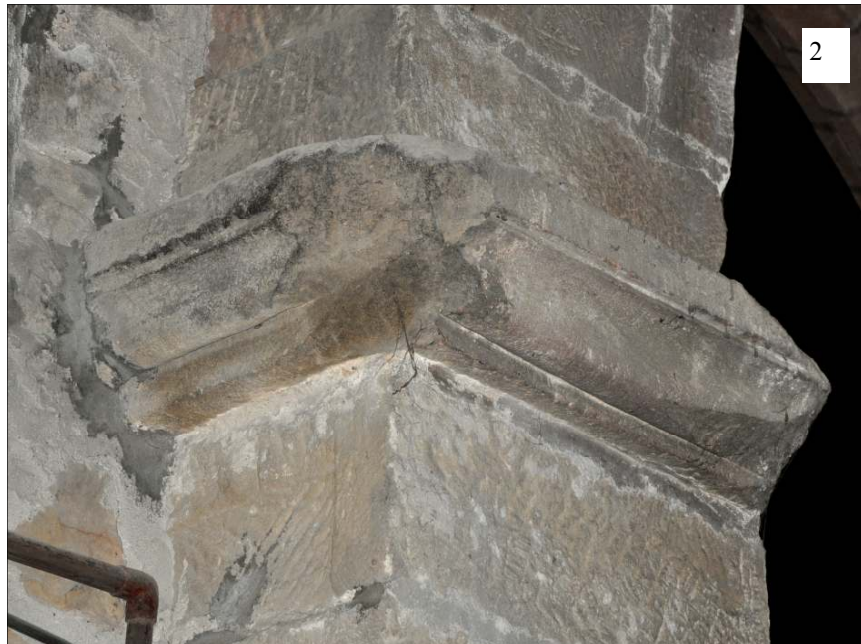
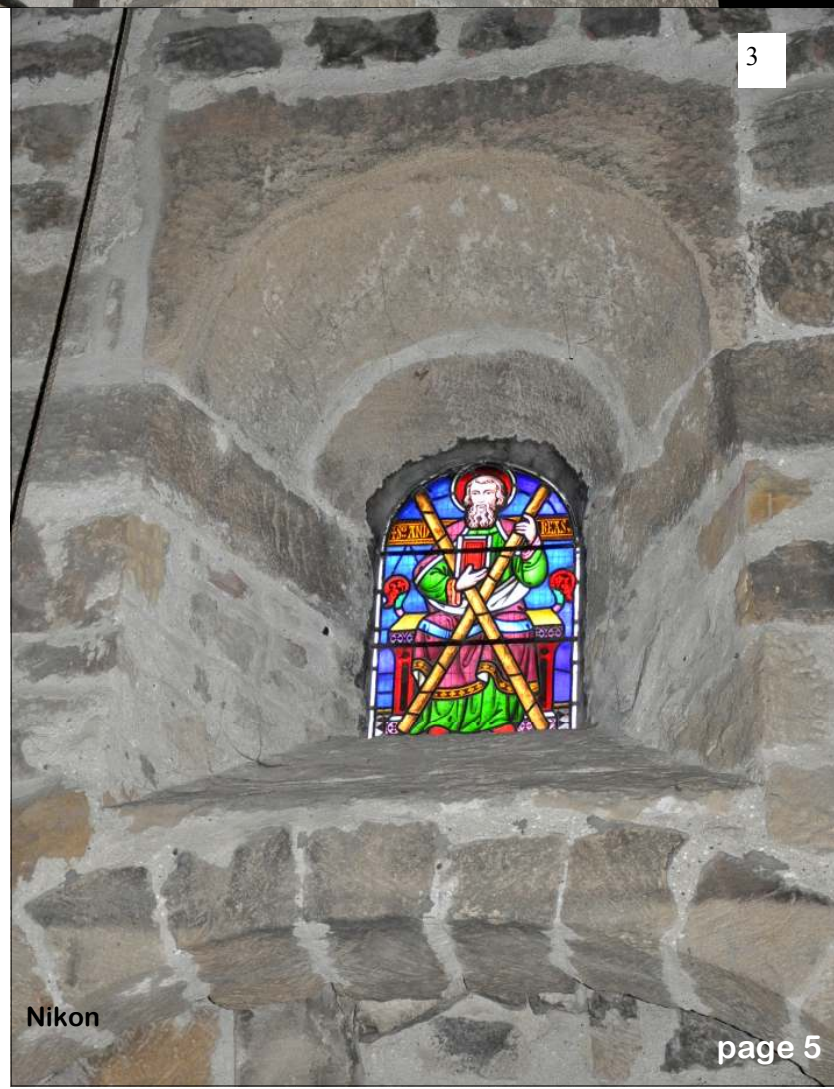
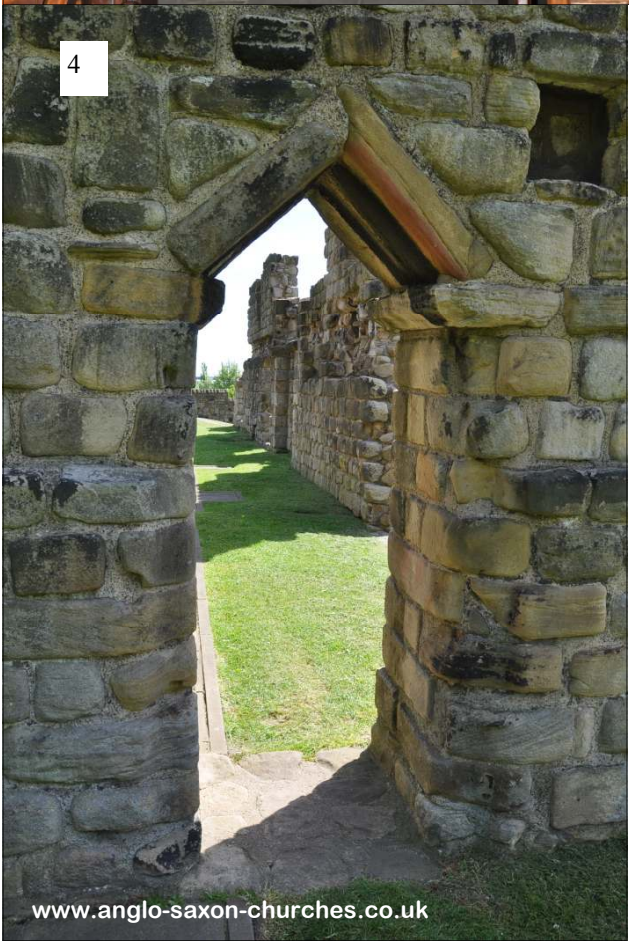
Various features.

1. Reused Roman; tower archway at St. Andrews church, Corbridge, Northumberland (no doubt from nearby Corstopitum). Note the first set of stones (left and right) above the imposts are wrongly placed since they are not tapered, they belong below the imposts (obviously the numbering of the kit of Roman parts went wrong!). This gives the arch a curious stilted appearance. Dimensions 8ft 2in. wide and 16ft 3in. high. Note that the 'left hand' impost has been severely defaced.
2. North impost of arch, seen from inside the tower. The damage may have occurred during removal, or earlier; this arch is, after all, almost one thousand nine hundred years old!
3. West window in ground stage of tower, viewed internally.
4. St. Paul, Jarrow, Co. Durham. Triangular headed doorway in monastery buildings, in west wall (which runs north/south) and seen from W.

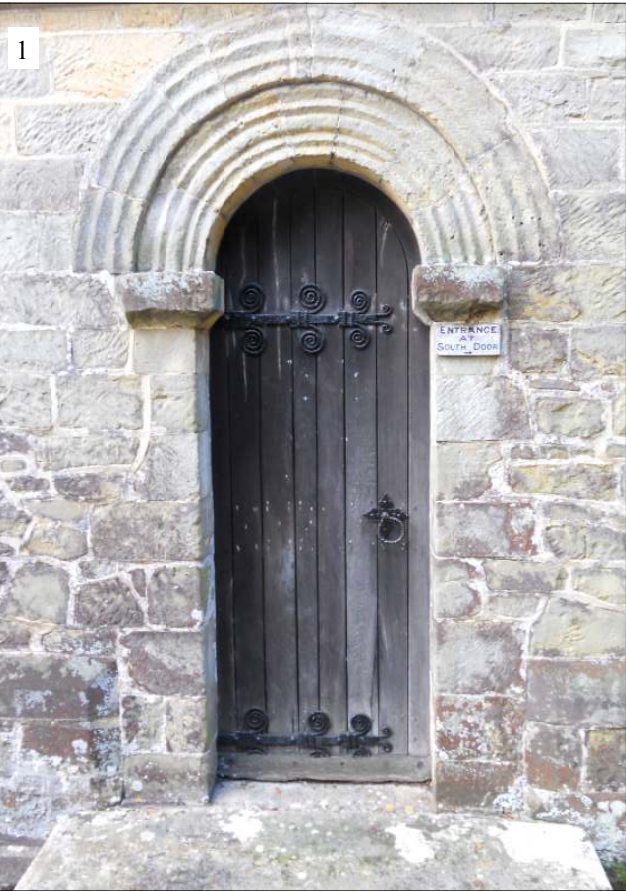
- 1. St.John the Baptist, Wivelsfield, E.Sussex (about 2 miles SSE of Haywards Heath). This Anglo-Saxon doorway now stands in the north wall of the north aisle of the nave which was built during a restoration and enlargement in 1869. H.Taylor says- *"This doorway has quite plain jambs, which are rebated for the hanging of the door. The imposts are chamfered, and the round head is of two orders, of which the inner is only slightly recessed, and both are carved with simple concentric mouldings on their vertical archivolt faces. On the inner order, the ornament consists of a half-round moulding between two of V-shape. The outer order has three concentric V-shaped mouldings."*

- 2. A closer view of the head of the doorway seen in 1. The red arrows pick out a "thicker" section of the mouldings of the inner order, and so you will appreciate that the mouldings do not repeat across the face as there is a distinct change of shape of this particular one moulding.

- 3. At St. Mary Magdalene, Bolney (W.Sussex, and some 5 miles west of Wivelsfield) there is a sister to the Wivelsfield doorway and which is set in the south wall of the nave and protected by a porch of possibly early Georgian date. Taylor thinks the archway may have been reset in this wall at some point. Certainly it has suffered from unsympathetic re-pointing but that seems to have been done at some time in the past forty years. The imposts are 'defaced' - shaved away to match the 45 degree chamfer that is carried down the jambs, and is likely to be a medieval reshaping possibly in the early 15th century.

done at some time in the past forty years. The imposts are 'defaced' - shaved away to match the 45 degree chamfer that is carried down the jambs, and is likely to be a medieval reshaping possibly in the early 15th century.

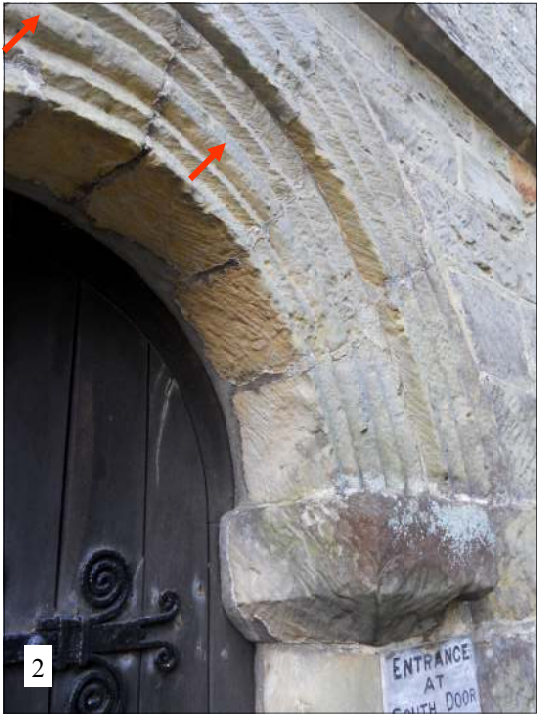
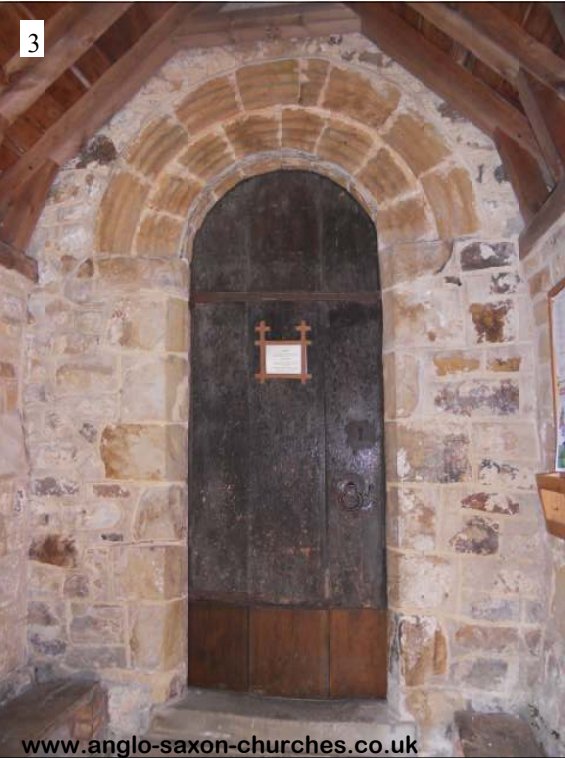
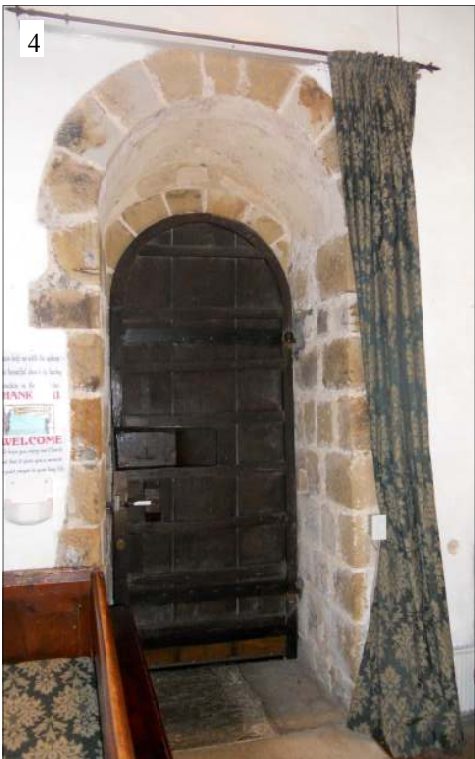
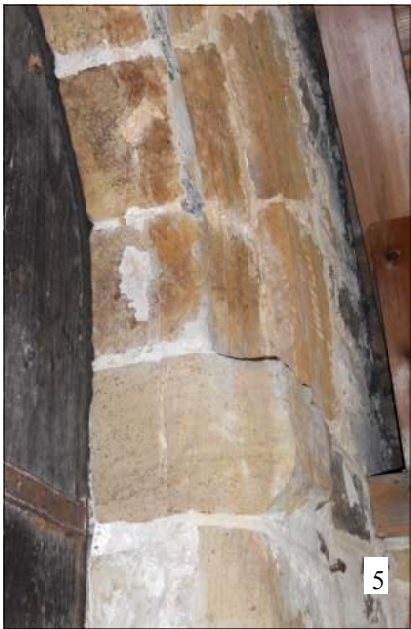
- 4. The doorway seen from inside the nave.
- 5. A detail of the east impost showing the chamfer and the shallowness of the relationship of the two orders, a typical feature of Anglo-Saxon practice in arch construction. Taylor states - *"The inner order is recessed only 2 inches behind the outer, and the archivolt face of the arch is ornamented with seven shallow mouldings which are carried round the head in the form of circles concentric with the arch itself."*

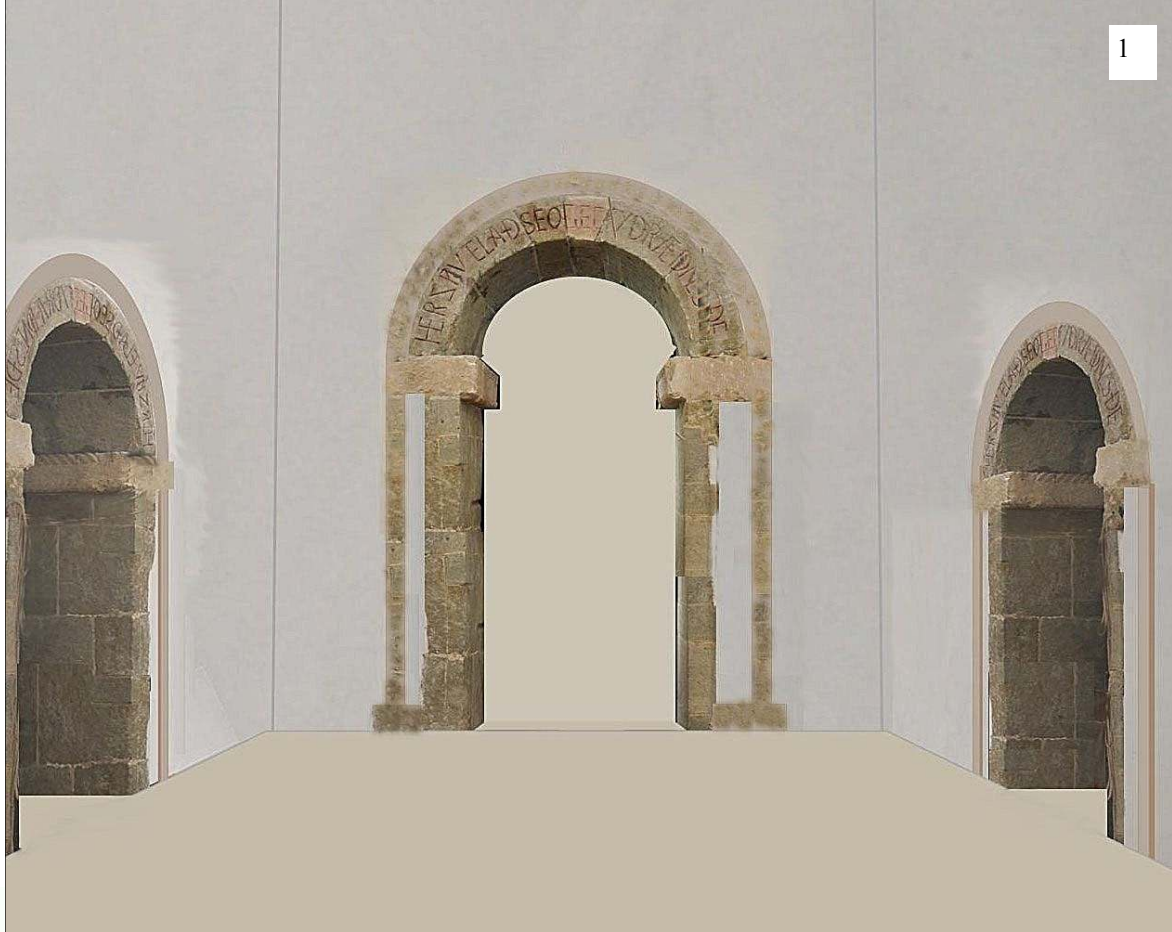
1. At Breamore St. Mary's (Hampshire) the arches under the tower, shown 'restored' and as the crossing may have looked in pre-conquest days. Looking east the chancel arch is centre, the left archway gave access to the north porticus and on the right is the one remaining arch (from the original five). From the form of the incised letters a date in the latter part of the reign of Ethelred II (978-1016) has been suggested. It may be that the lettering is an addition to the arches but at least this fixes the very latest date for their construction to the second decade of the 11th century. See the photo file on Breamore for further information.

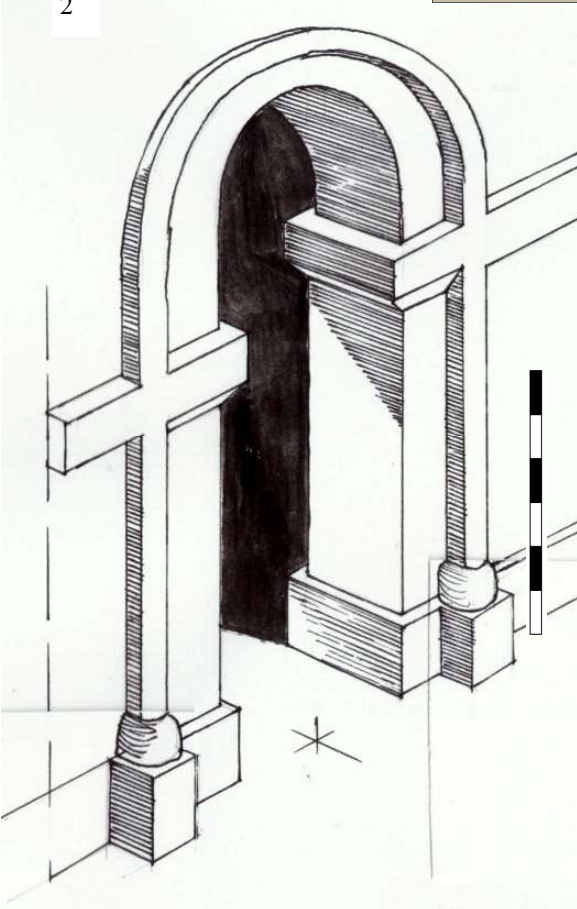
2. The Anglo-Saxon archway at Sherborne Abbey which originally led to the westwerken. This drawing has been made, noting the remains of pilaster strips and hood mouldings on its west face, and shows how both faces probably would have appeared in 'as built' condition, with rectangular section hood-moulds and matching pilaster strips. The 're-styling' (perhaps in the 12th century) resulted in the hacking back of the pilaster strips and their stops and the hood-mould, together with shaving back the imposts. A tympanum was added. This defacing has totally destroyed the character of this archway, radically weakened its aesthetic strength and negated its classical impact. For scale the ranging rod is six feet.

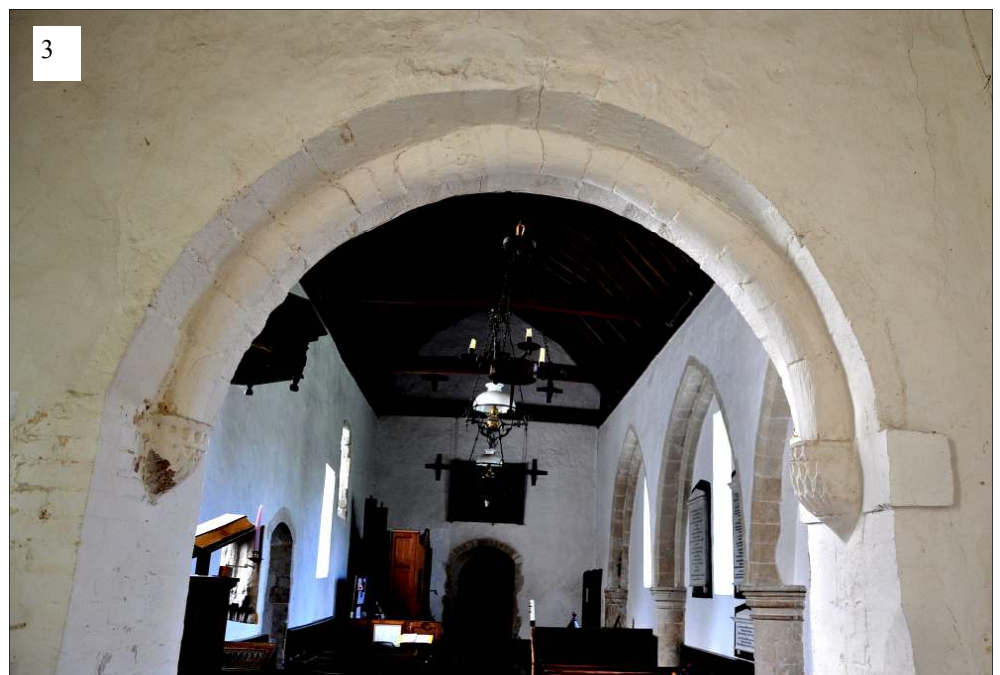
Picture 3, text see next page.

Previous page (7), picture 3, and this page. St. Botolphs church, Botolphs, near Old Shoreham, West Sussex. Situated near the west bank of the Shoreham River and where a bridge probably crossed the river in Roman times stands a church with nave, chancel and west tower, the nave and chancel probably dating to the first quarter of the 11th century. There are some side-alternate quoin stones remaining on the south side of the nave. The chancel arch has some similarities with the tower archway at nearby Sompting. The archway shown in picture 3 and below is simple in that it has a round-headed opening with plain square jambs, the arch being of through-stones having a soffit-roll worked on the inner faces of the voussoirs, this roll being carried down and springing from each corbel which is of conical shape and ornamented. These corbels are not dissimilar to those of the tower archway at Sompting, one might say a poor copy, and have, as one can only describe them, elongated 'scoops', as if made by pressing a date stone (set on the finer edge) into putty. They are arranged in geometric order and each sit between the two scoops above to give a kind of 'net' pattern to the whole.

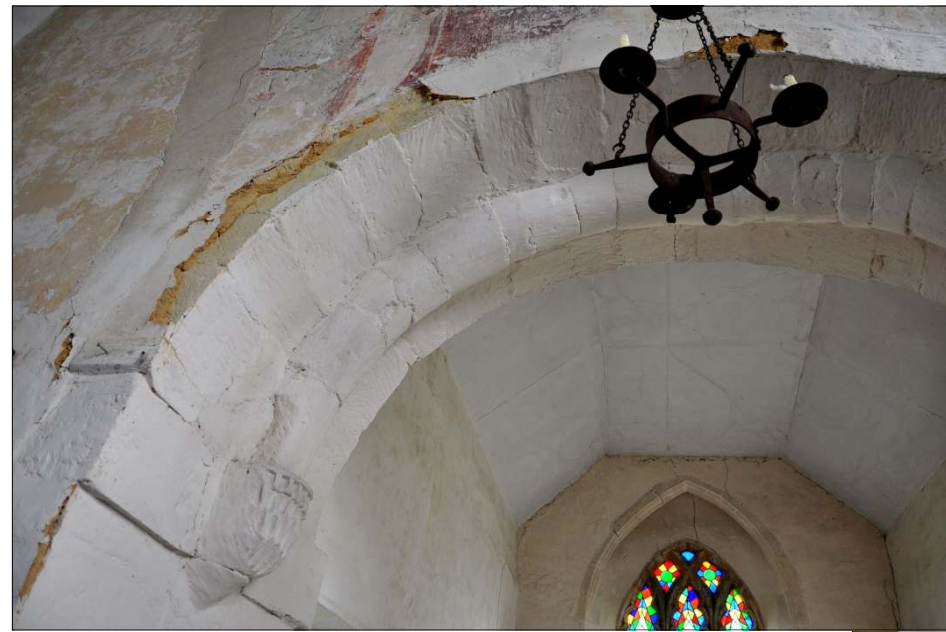
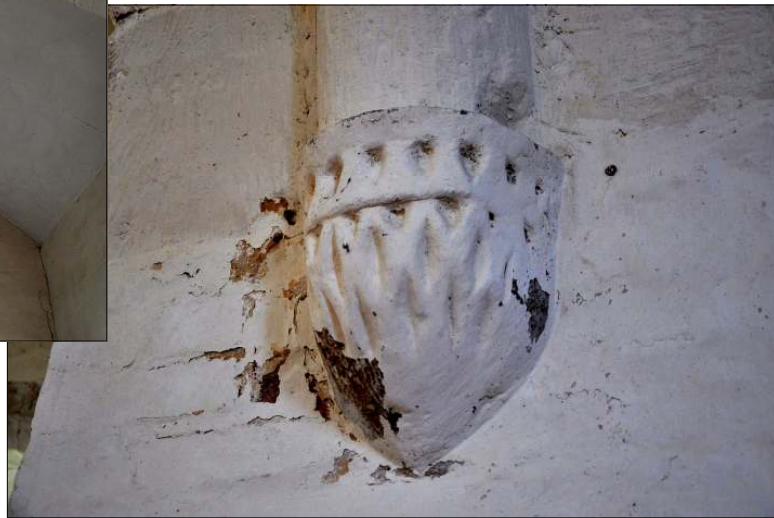
Unfortunately the whole is whitewashed but flaking reveals a sandstone beneath. The two (unnumbered) pictures here show both the sweep of the arch and the other one of the corbels in closer detail. The interior of the church is suffering from ingress of water and is in a much poorer condition than I remember it some fifty years ago.
