# Anglo-Saxon windows, belfry openings, etc.

## The types and techniques explored.

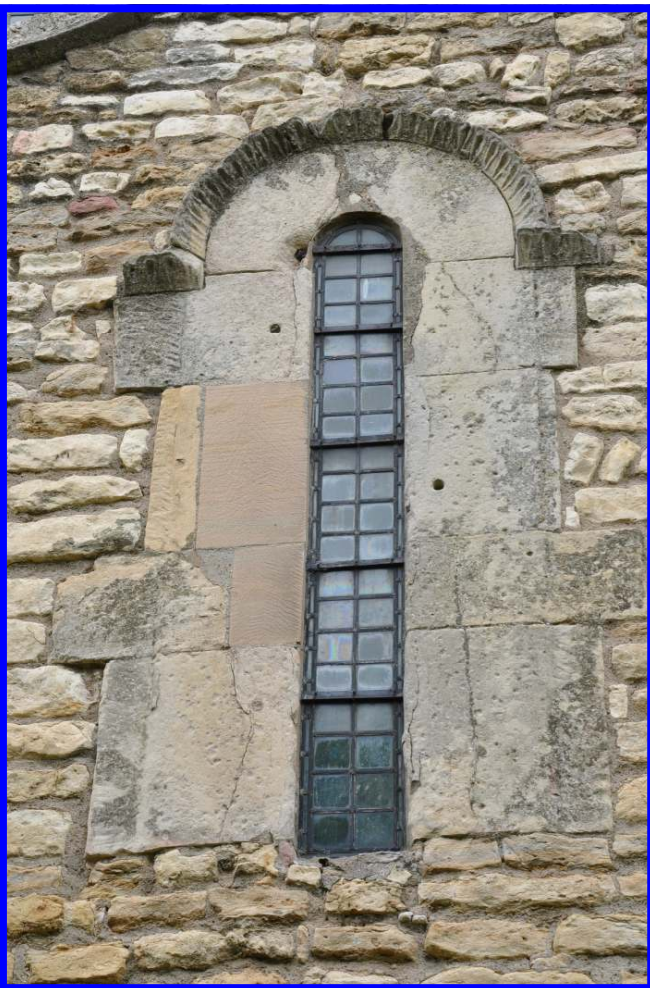
1. Stow in Lindsey minster church, Lincs. High status work, window in south wall of Sth transept. Note the hood worked with palmette decoration (this matches the work on the nave crossing archway.) The dimensions of the aperture of this window are approximately 6ft 6in tall x 10in. wide. Its sill is approx. 13ft 6in. above the lowest order of the plinth. Thickness of the wall is 2ft 6in. This window, dating to the 'upper work' (after the fire), can reasonably be assigned to the work of Eadnoth I in the first half of the 11th century. (source: H.Taylor)

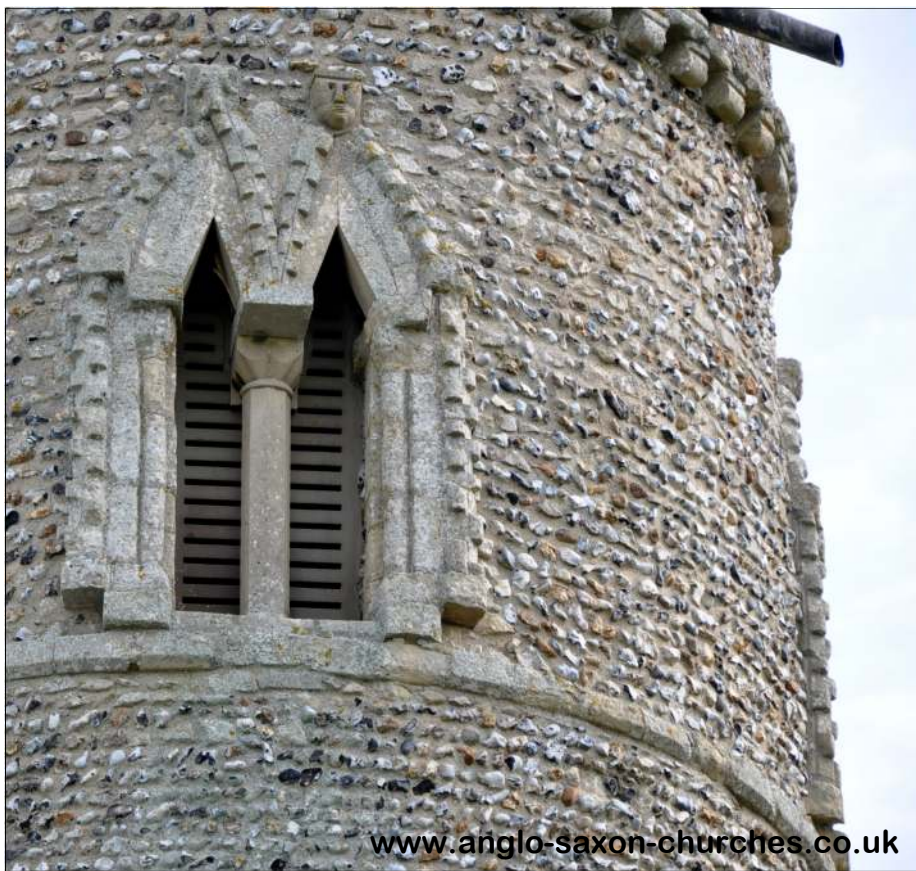
2. Haddiscoe church, Norfolk. Belfry window Nth, (one of four). Note triangular heads and with surrounding strip-work enriched with billet ornament. The Anglo-Saxon characteristic where the through stone is supported on a central shaft, but here with attendant billet decoration, gives an indication of the influence of Continental-Romanesque practise. Perhaps dating to before 1050.

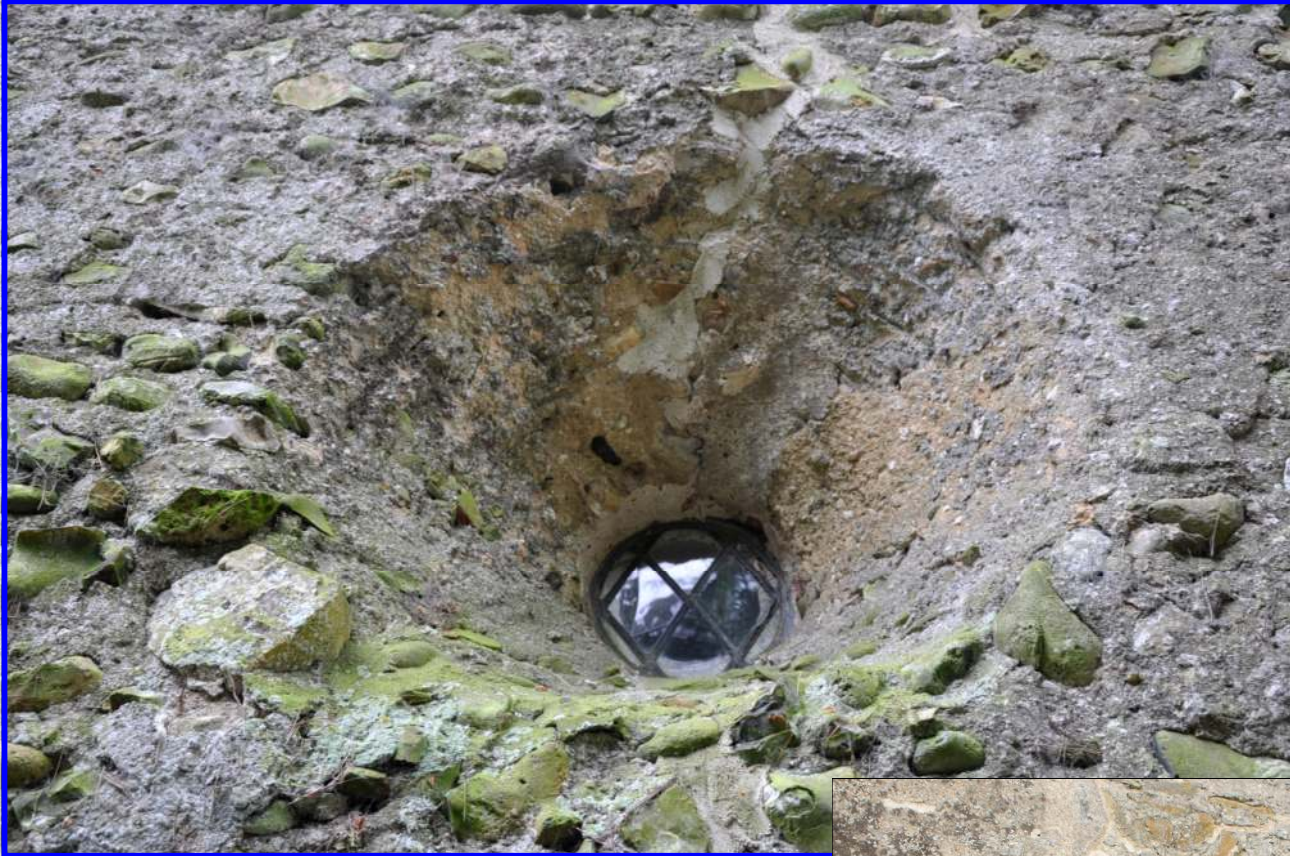
3. Framingham Earl, Norfolk. Circular window in south wall of chancel. Clear signs of 'basket-work' technique can be seen on the surrounding cement and flint, and this photograph is reproduced to such a size that this feature can perhaps be seen. Look carefully for the concentric 'rings' of the basket still imprinted in the surrounding mortar, here more discernable to the upper right. Thankfully the Victorian restoration did not get this far! For those not familiar with the technique, a woven basket was positioned in place, and in the case of double splayed windows (which seen here) the two baskets were placed base to base, and the walling was then risen around them. Once the walling had set firm the baskets could then be broken away and discarded and in this simple way an aperture, or simple window opening, was formed. In some cases the original oak frame can survive (and see Odda's chapel picture 4).

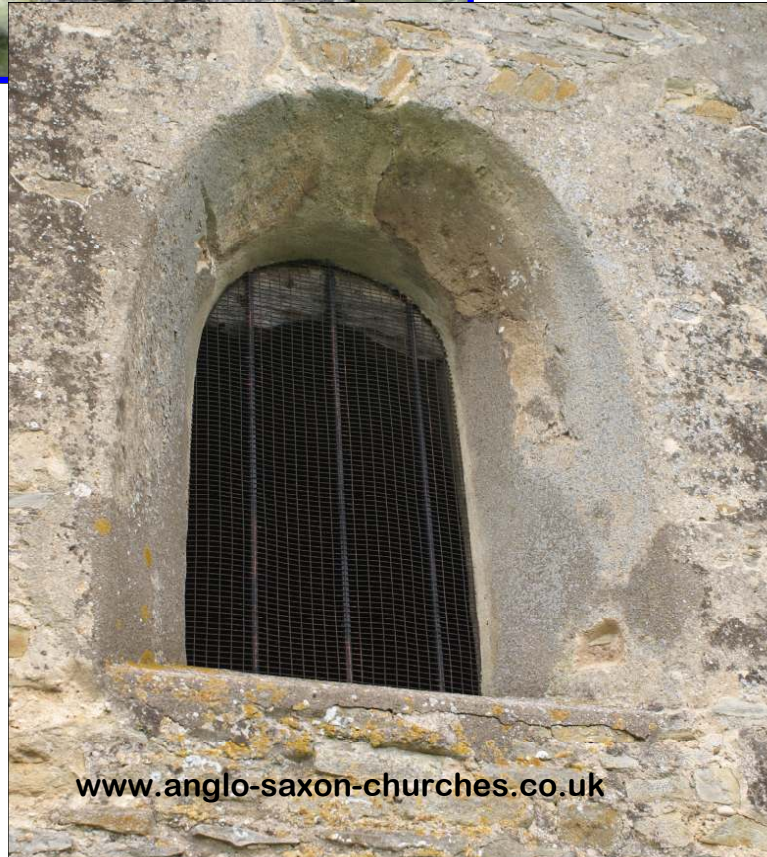
4. Odda's chapel, Deerhurst, Glos. North window, double-splayed, viewed externally. Note the remains of the oak frame, seen at the head of the window and inside the present metal grill. The fabric, interestingly, is precisely dated by the dedication stone, 12th April 1056.

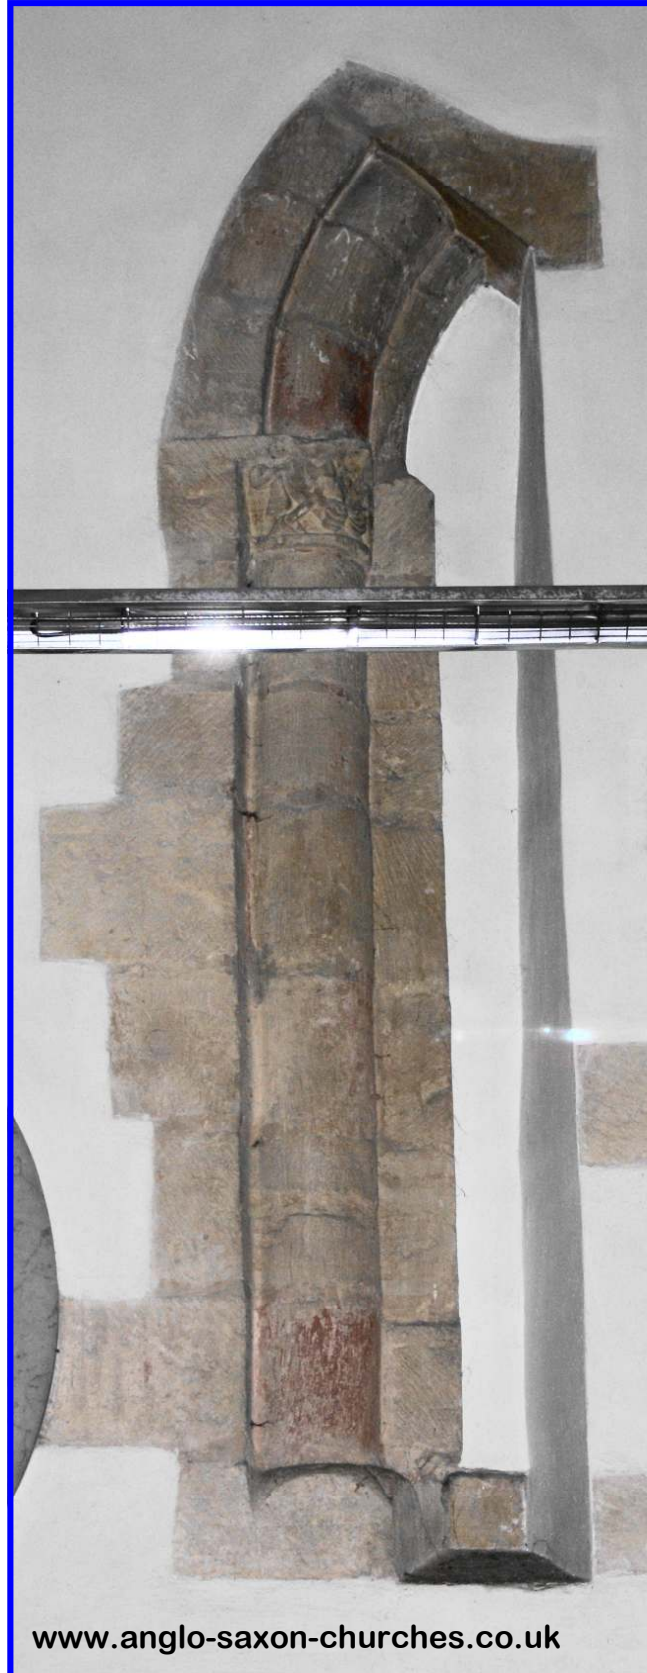
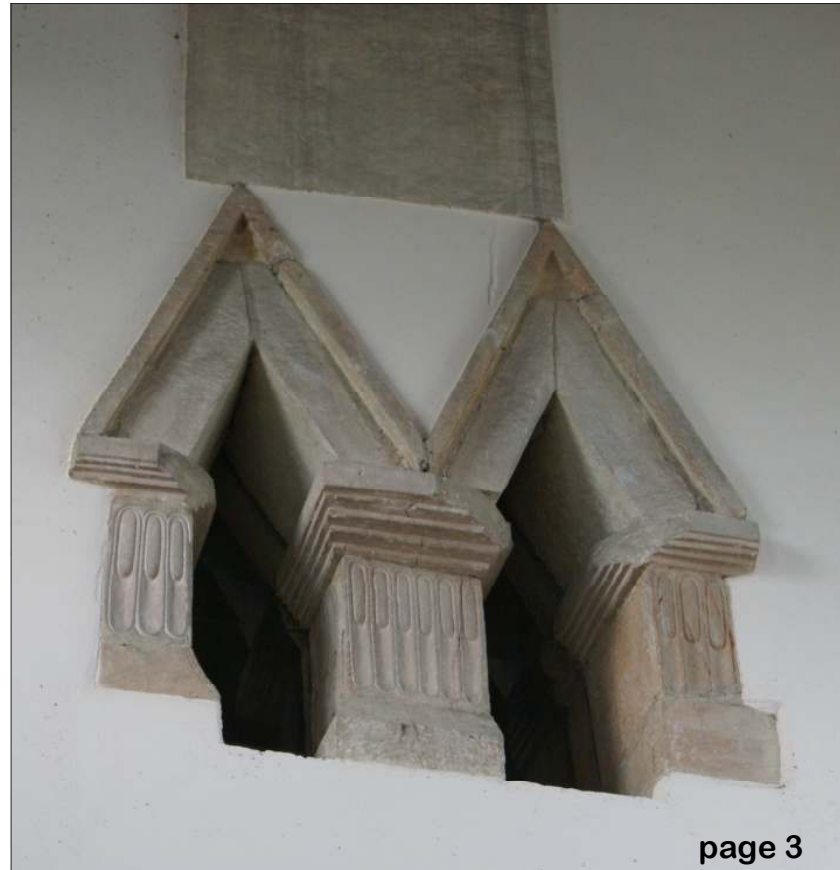
6. No description of Anglo-Saxon work could possibly be complete without mention of the remarkable opening in the west face high up in the nave at St.Mary, Deerhurst, Glos. This much altered and rebuilt monastic church (which evolved during the Anglo-Saxon period) dates from prior to 804, and features a west tower that had its beginnings as a single story porch, and Nth & Sth porticus. Shown here the double triangular-headed opening faces into the nave from the tower, evidently 'mutilated' by the conversion from a window to a doorway (leading to a now vanished upper chamber in the nave). The southern window rises from chamfered bases but the north window is cut back to convert it into a door. All three pilasters are fluted on their eastern faces and the upper half of each flute is further ornamented by the insertion of reeding. Immediately above this double window a rectangular flat stone rests on the heads of the hood moulds, as though to carry an inscription or a painting, but there is no trace of any such decoration on it. The church stands in the kingdom of Hwicce.

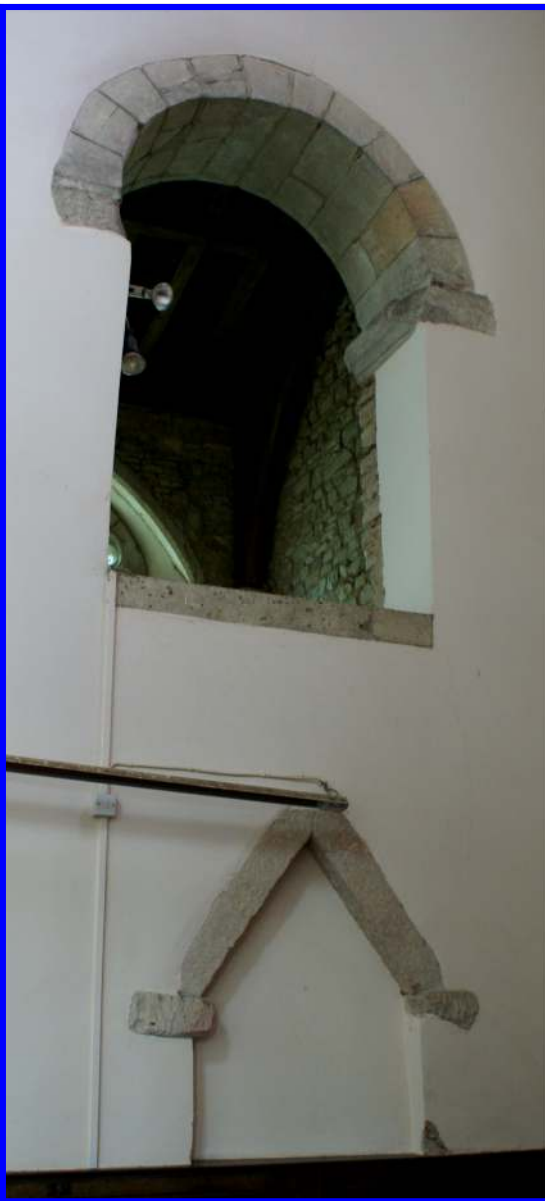
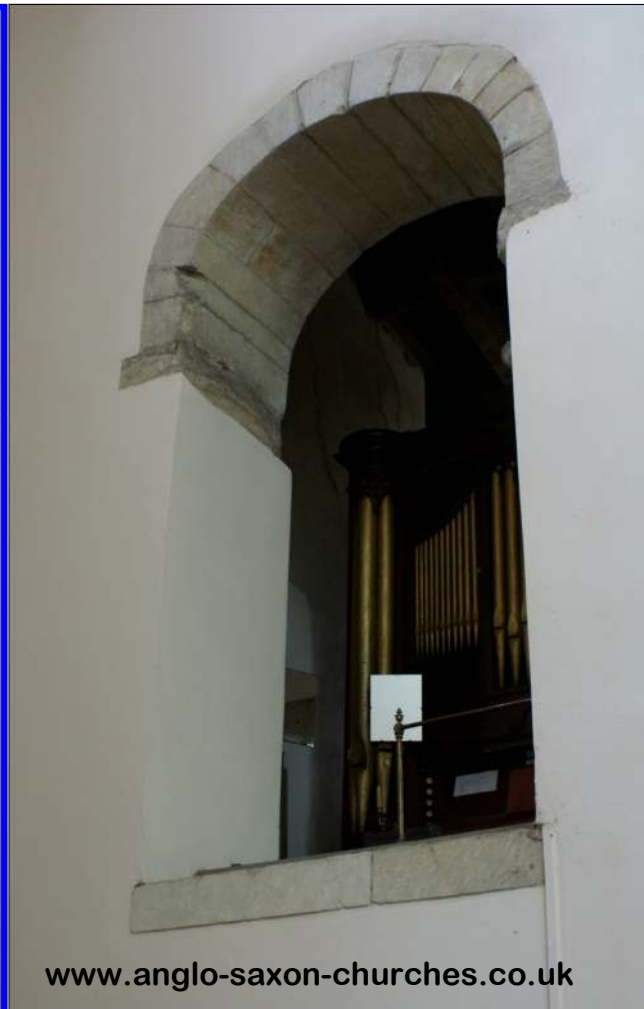
7 & 8. Deerhurst. The elevated doorways leading to first floor levels in the N & S porticus (respectively), viewed from the nave. Situated at the eastern end of the N & S walls of nave. Harold Taylor did much research at Deerhurst in the 1970's.

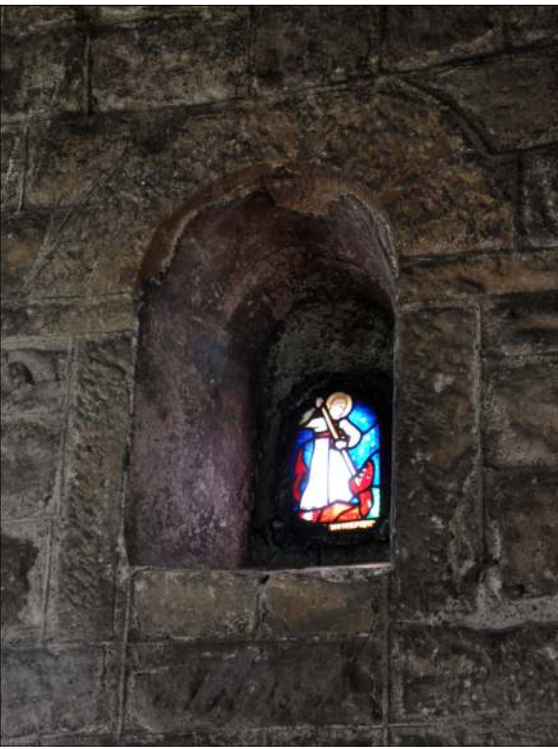
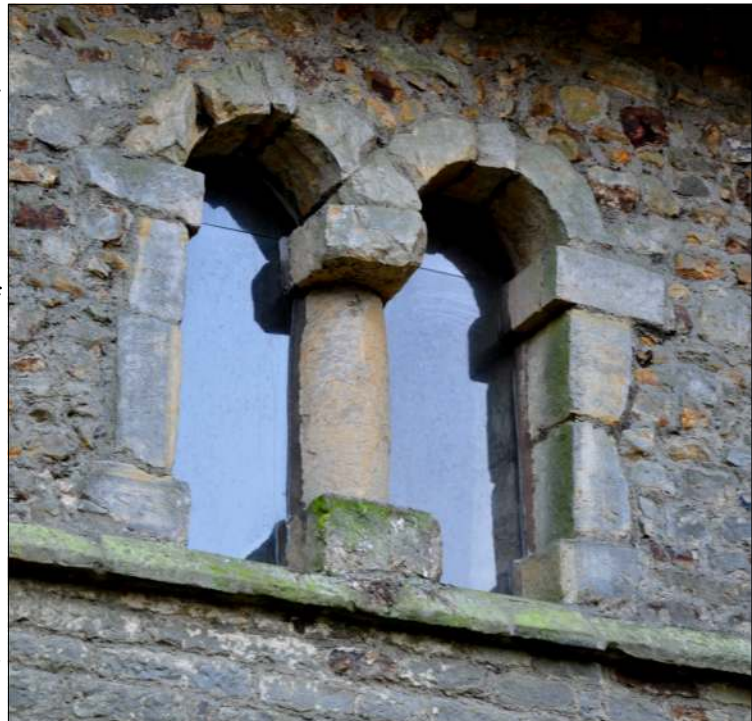
9. The church at Worth, Sussex is set in the depths of what was once the ancient forest of Andredswald. One of the three remaining two light window openings in the nave, the modern glazing here has been sympathetically executed. Dating to the first half of the 11th century or possibly earlier.

10. One of the three small windows set in the south wall of the chancel of the monastery of St. Paul, Jarrow, Co. Durham. The Venerable Bede lived there for all but the first few years of his life. The original nave was sadly demolished in 1782. A dedication stone now high up inside the nave/tower records the date of 23rd April 684/5.

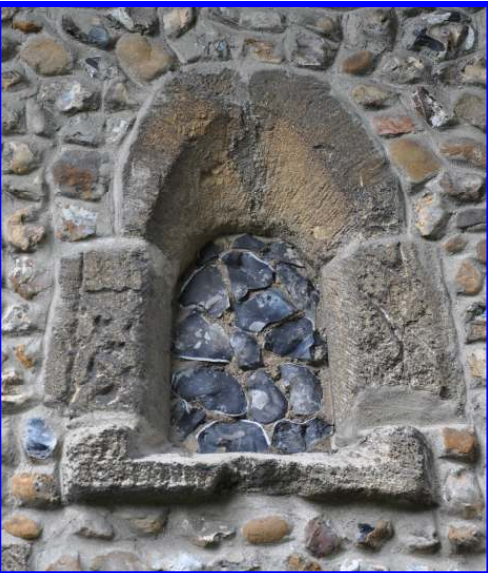
11. Window (blocked) in S wall of chancel, church of All Saints, Little Shelford, Cambridge. Note the carved uprights, that on the left-hand side exhibiting interlaced knotwork.

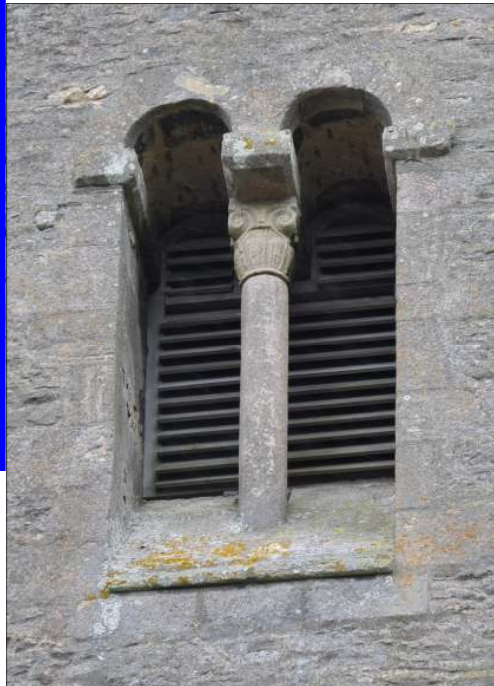
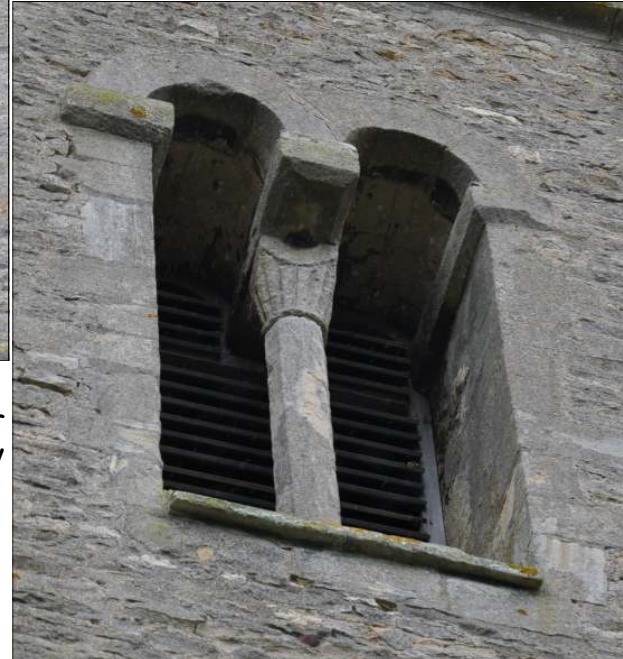
12, 13 & 14. Three windows illustrated here, in the tower of St. John at Great Hale, Lincs. Picture 14 is of the smaller (south) window in the ground floor.

12 & 13 show two of the belfry windows. The tower is of late Saxon date rising unbuttressed and sheer for about 60 feet without string-course or offset. The round heads of the double belfry windows are formed of single stones cut to semi-circular form above and below; in the centre of each window these heads rest on a through-stone slab and mid-wall shaft; the square ashlar jambs

have chamfered imposts, and the mid-wall shafts have ornate capitals of unusual but nevertheless tentative form. (H. Taylor).

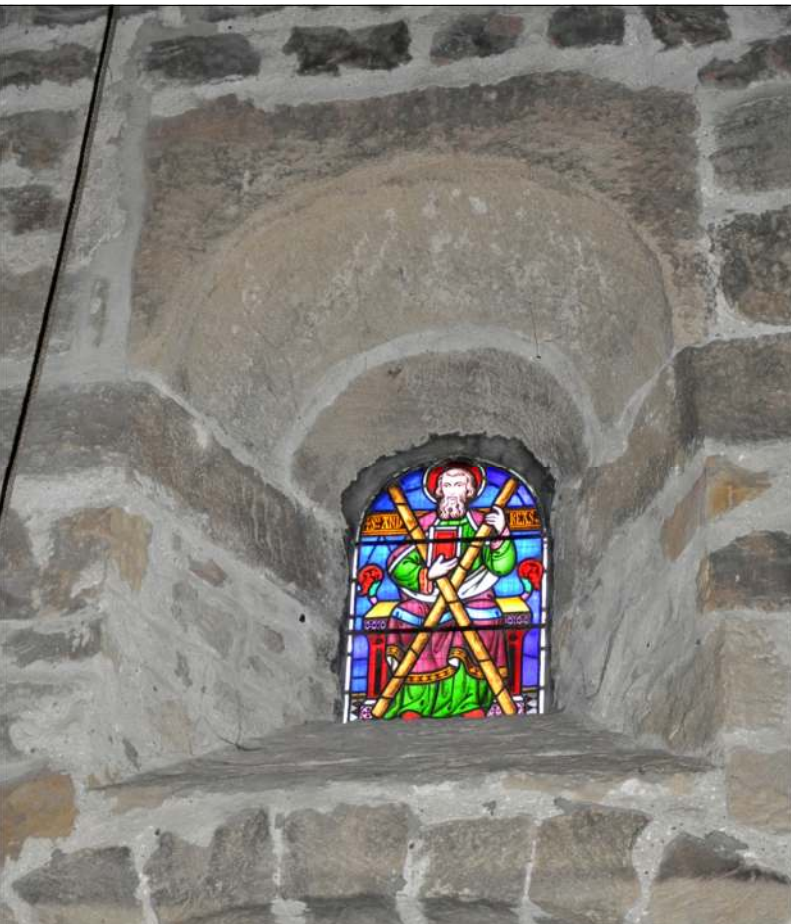
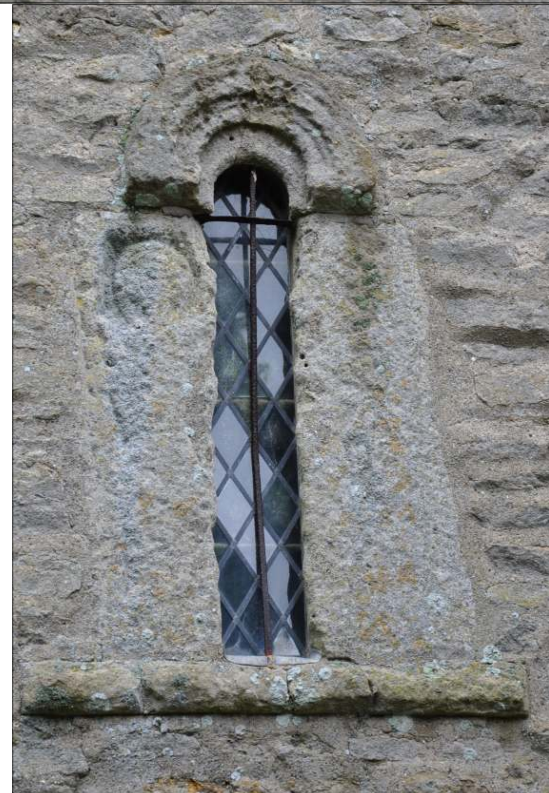
15. Interior view of the lower W window in the tower of the church of St. Andrew, Corbridge, Northumberland. The tower comprises re-used Roman stone from the site of nearby Coriosopitum.

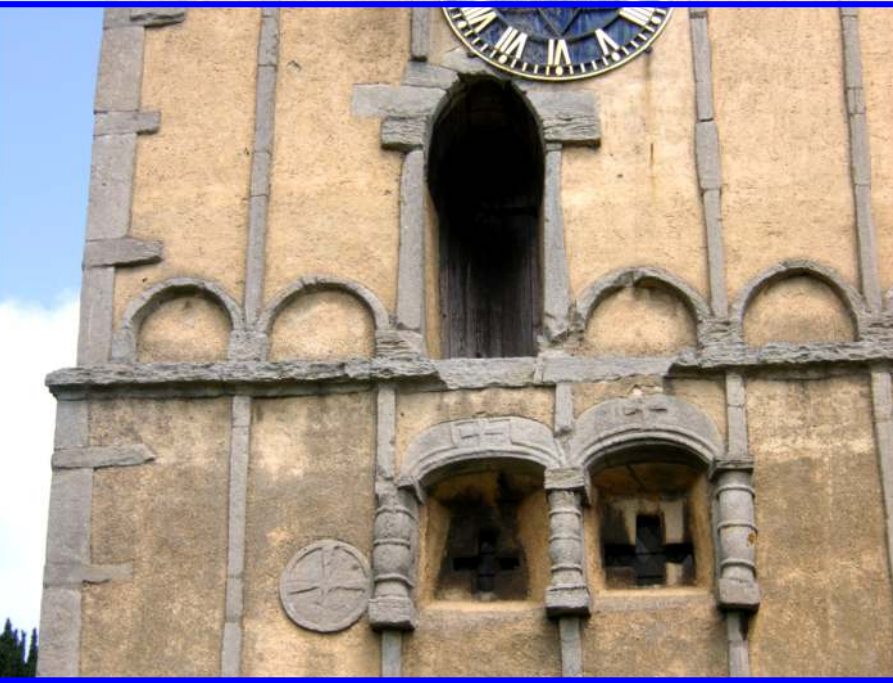
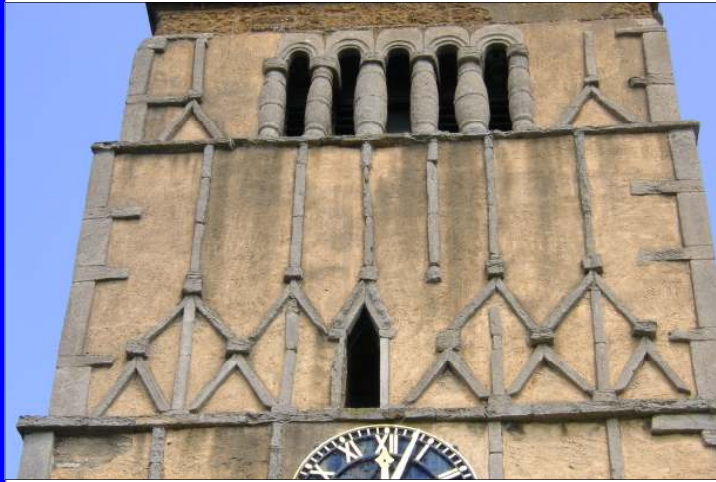
16 & 17. The church of All Saints, Earls Barton, Northants. The remarkable openings and strip-work in the tower are probably the most illustrated and most widely known example of Anglo-Saxon workmanship. Each face of the tower is enriched by vertical pilaster strips which rise from square corbels. H.Taylor devotes 5 pages in his "Anglo-Saxon Architecture", Vol I but suffice to say here that the openings comprise of curved and ornamented heads of single stones, and feature turned baluster shafts. The west doorway is quite remarkable itself and will be discussed further in another file upon the subject of doorways. H.Taylor dates this tower

to the period 950-1000.

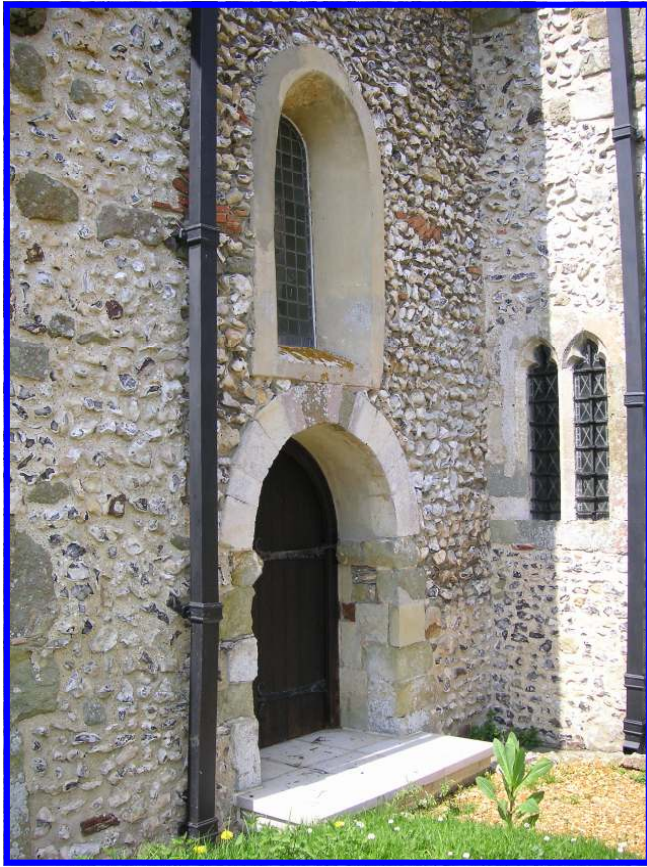
19. In Hampshire near the River Avon we find the late Saxon church of St.Mary, Breamore. Consisting of nave, low central tower, flanking transeptual chapels, or 'porticus', and chancel, all complete save for the lowered height of the chancel, and the north porticus, and a possible westwerken. Here (19) we see a generous sized double-splayed window in the east wall of the S porticus, set just above a low wide doorway. This window is mirrored by others in the nave. Set cheek by jowl with Breamore House, the church is situated part way up a slope of the Downland, and below some 1/2 a mile distant a large Anglo-Saxon cemetery was found on the banks of the Avon.

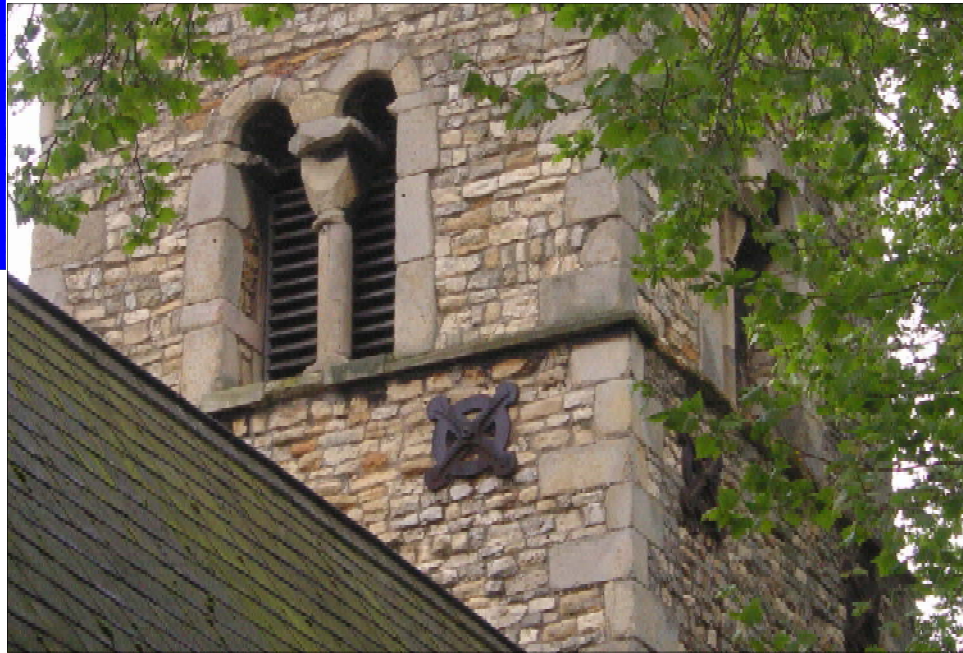
20. St.Mary-le-Wigford, Lincoln. The east and north face of the tower, with double-opening belfry windows to be found on all four faces, that on the west face being the most interesting (but not easily photographed however). The treatment of the central capital of the east opening is closer to a Continental-Romanesque school, whereas the others follow the Anglo-Saxon school. Note the long-and-short work of the jambs, the mid wall shaft supporting a through-stone slab and the arched round heads are supported at the sides on projecting chamfered imposts. The west doorway has suffered in more modern restorations and has been given an enriched hood-moulding with incised dog-tooth ornament. Otherwise the tall opening is the original Saxon doorway.

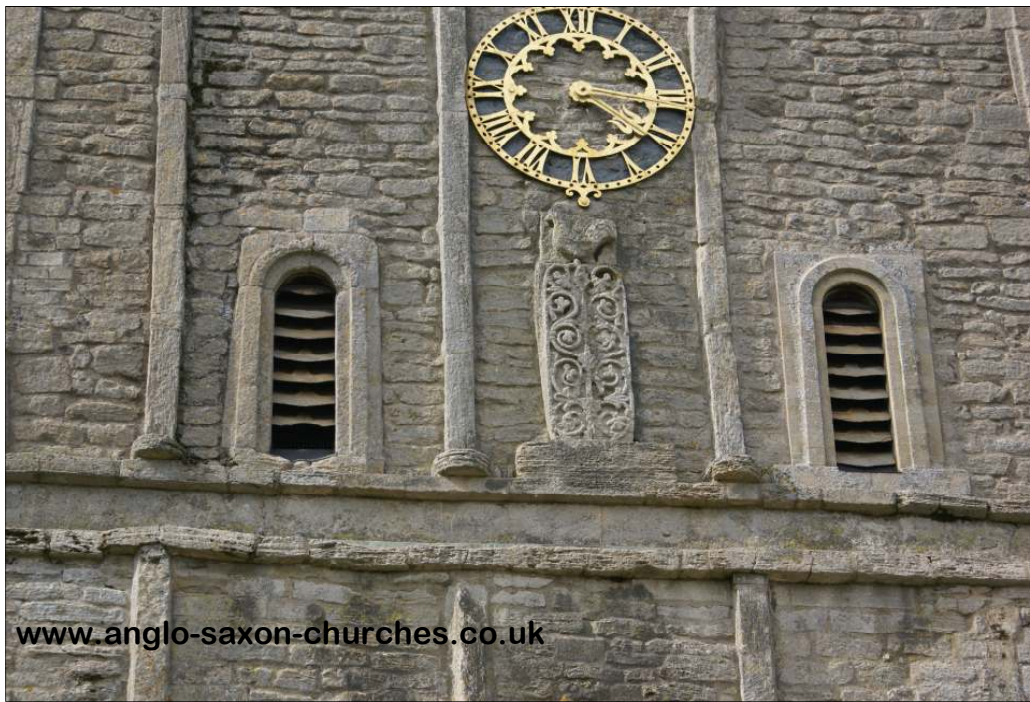
21. At the church of St.John the Baptist, Barnack we have a most interesting tower with strip-work pilasters, and constructed of roughly squared blocks of the well known Barnack stone from quarries in use since Roman times. The stone would have been brought up from quays on the nearby Welland. Seen centre in picture 21 a highly carved stone about 6ft high topped by a cockerel, the highly decorated stone showing stems and acanthus leaves. Either side are round-headed openings with simple stone frames. prior to 1935 they were

blocked up. It may be noted that the first stage has rather random quoin stones but the second stage has long-and-short work and is cut back to allow a plaster covering to be run up against the upstanding edge (see picture). This should be borne in mind when viewing the windows which would have shown as the upstanding 'rib' running around the window and surrounded by plaster rendering covering the main surface of the walling. It seems there are two stages/dates of building here.

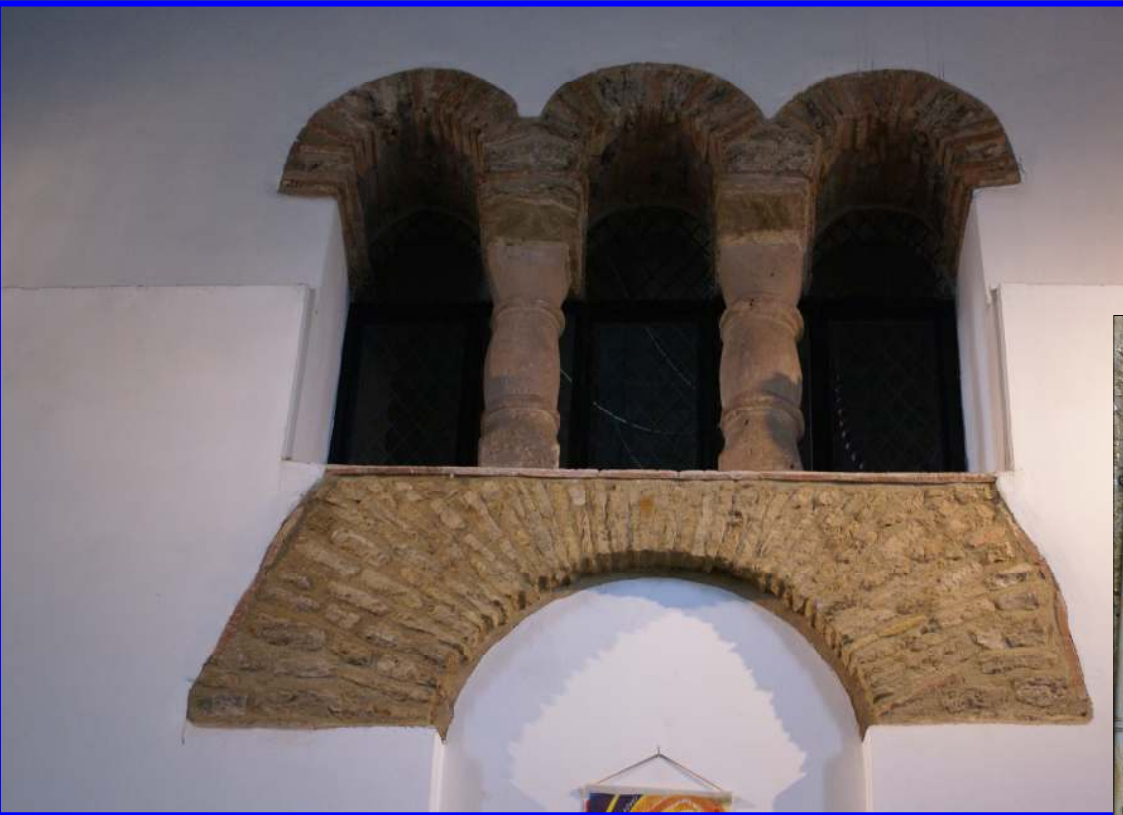
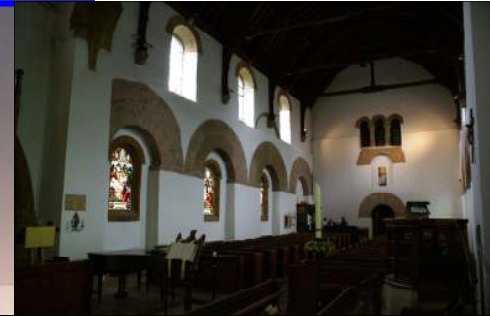
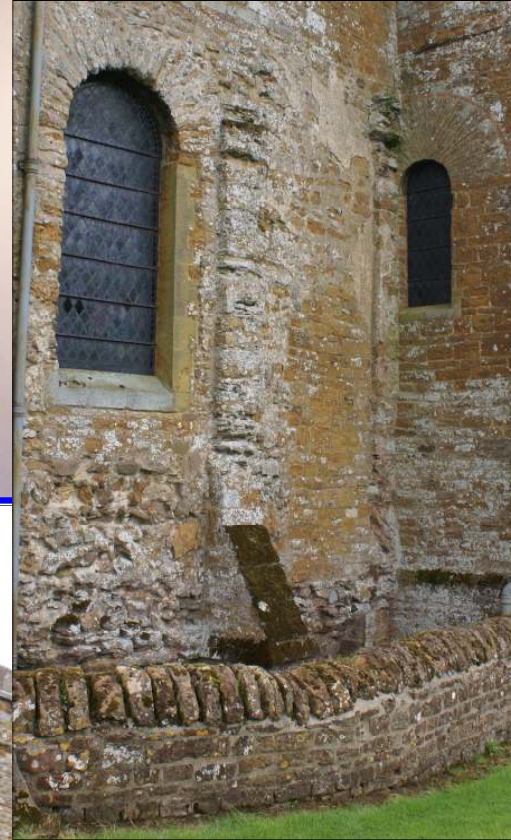
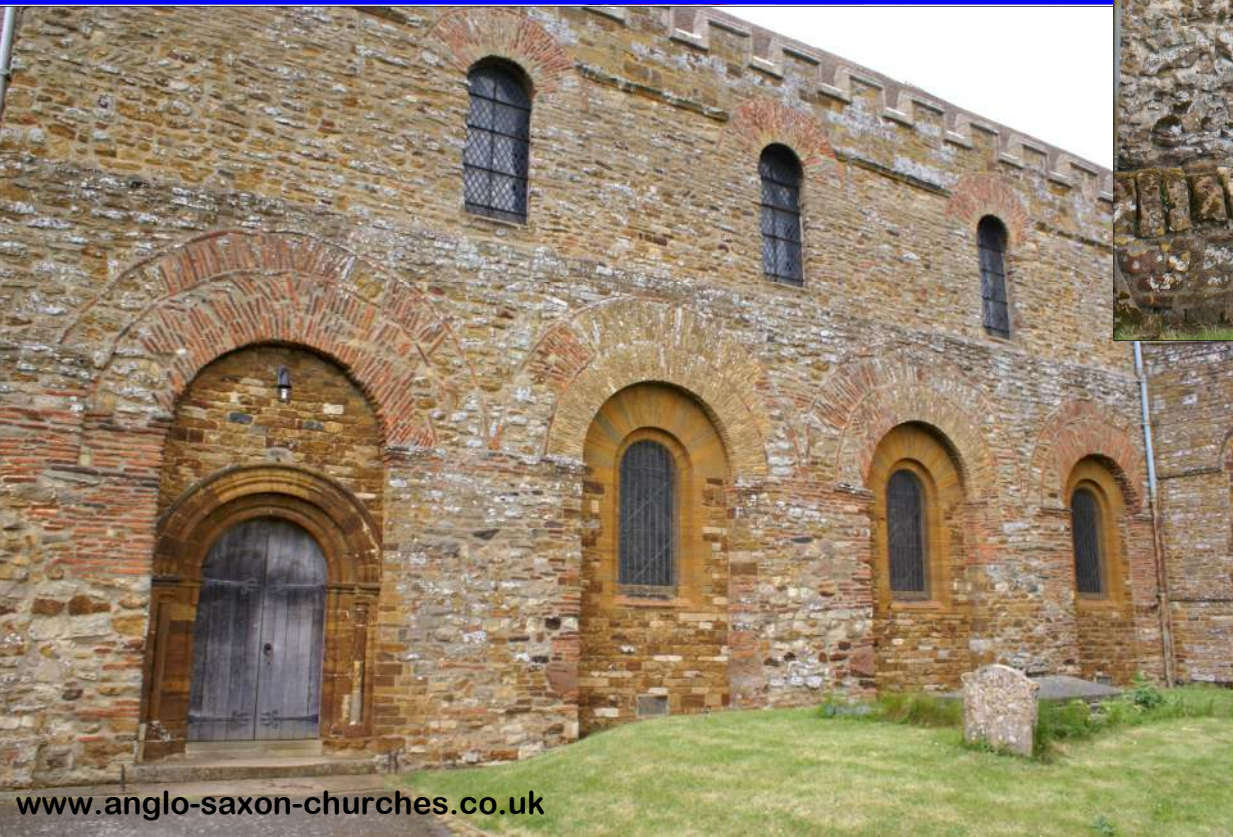
22. At the church of All Saints, Brixworth, Northants, we have a fine building, much altered during the time span of the Anglo-Saxon era and dating from 675. Here we see a triple headed opening looking out over the nave from the tower. Interestingly it cuts through the head of an earlier arch. The turned baluster shafts support heads worked in Roman brick. The smaller picture (23) puts the position of the opening in context (picture looks westwards), and shows the blocked south arcade to the left. The west tower, as is often found, is built over an earlier west porch, the whole being raised at a later date, and in a similar way as found at Deerhurst. Picture 24 shows the remaining original window in the north wall of the chancel (to the left) with its head made from tufa. Also the (partially) obscured window in the north west quarter of the nave (belonging to earlier work). Picture 25 shows the run of the clerestory windows on the south face of the nave, and there is much use of Roman brick, the heads of the windows being so constructed. The original 'aisles' (more likely side chapels, as at Deerhurst) have gone and the later blocking (10th century) has (?) Victorian windows giving additional light to the nave.

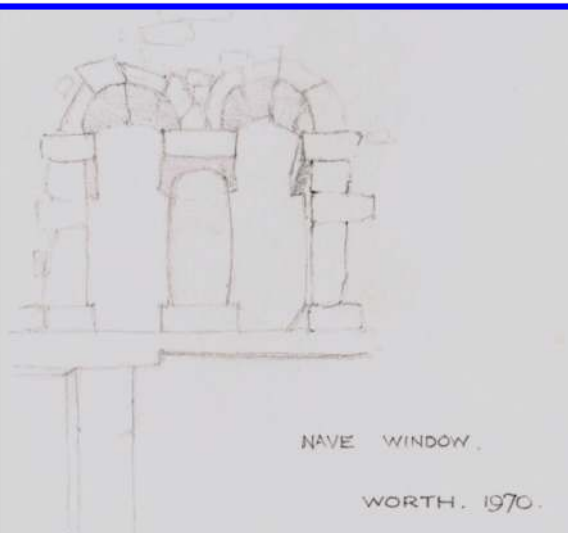
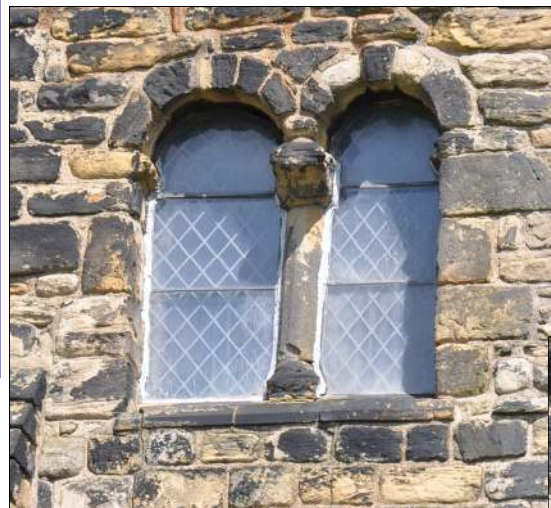
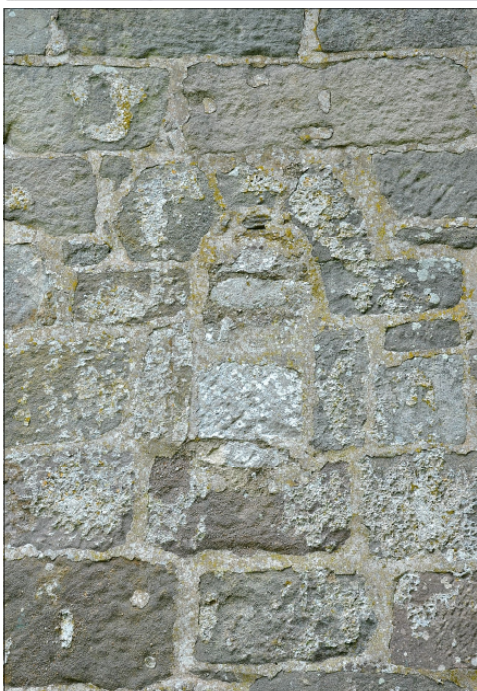
27 to 30. Monastery of St. Paul, Jarrow.

27. South facing window, tower.

28, 29 & 30. Three early windows, south facing, chancel.

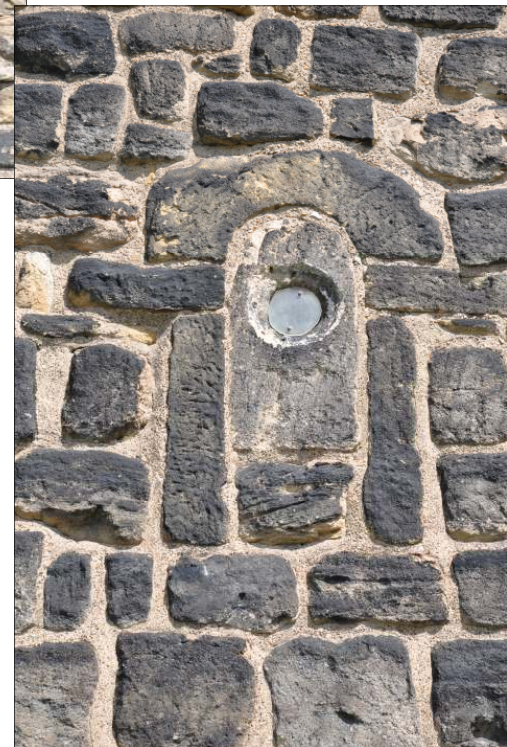
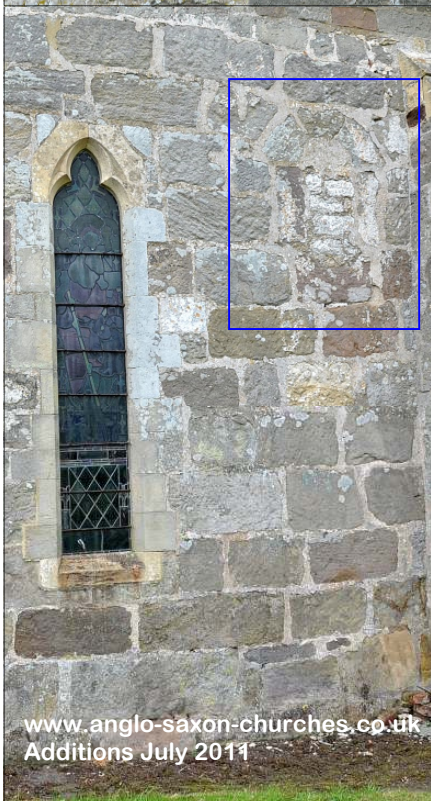
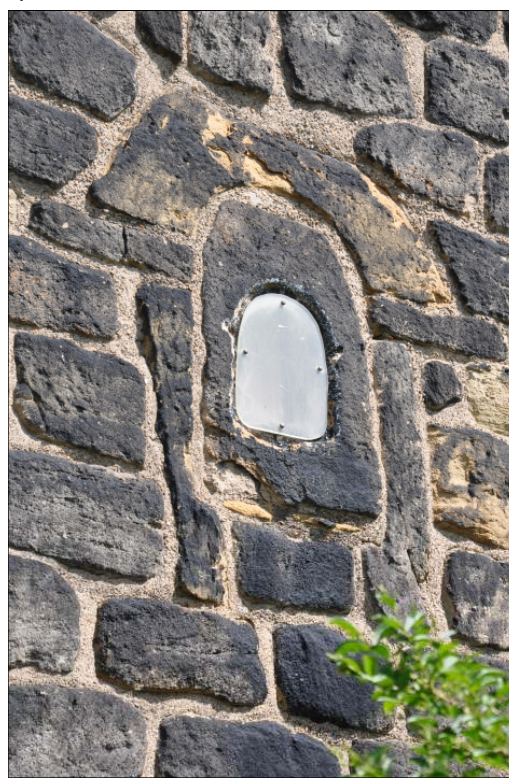
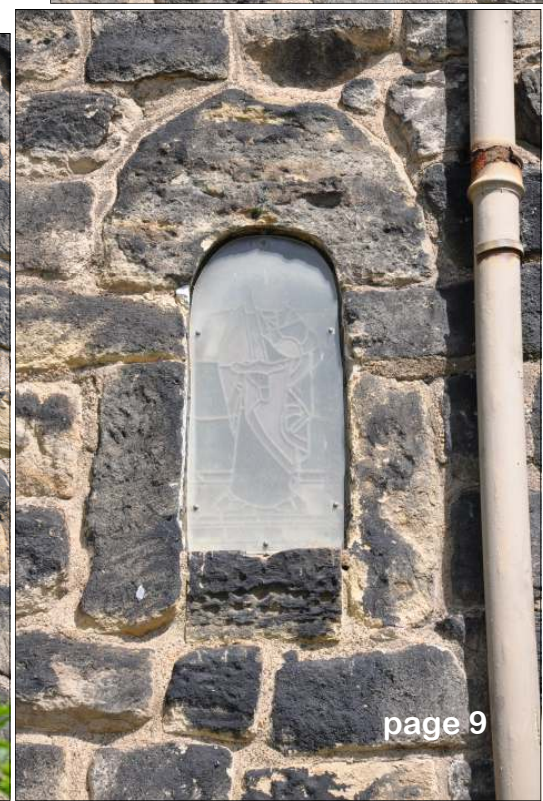
31 & 32. The church of St Peter & St Paul, Scrayingham, Yorks. In the north wall of the nave, two of the three newly discovered small (blocked) pre-conquest windows; firstly (31) the easternmost window, then lastly the 'middle' window (the westernmost is hidden underneath a medieval buttress). Pic 31 has the eastern window picked out within a blue square to make it more obvious. The first six courses of the chancel consist of very large stones laid with coarse joints compared to the courses above with finer joints, and also appear to include blocks exhibiting characteristic Roman tooling. In typical pre-conquest technique some stones are sawn/notched to accept the adjoining block. It is possible that the walling above that level represents a build of later date and/or different masons. The nave seems of an overall build but the first 2 courses do seem to be of a 'rougher' build and below these levels mentioned there is little success in maintaining level courses, again, all in all typically pre-conquest work.

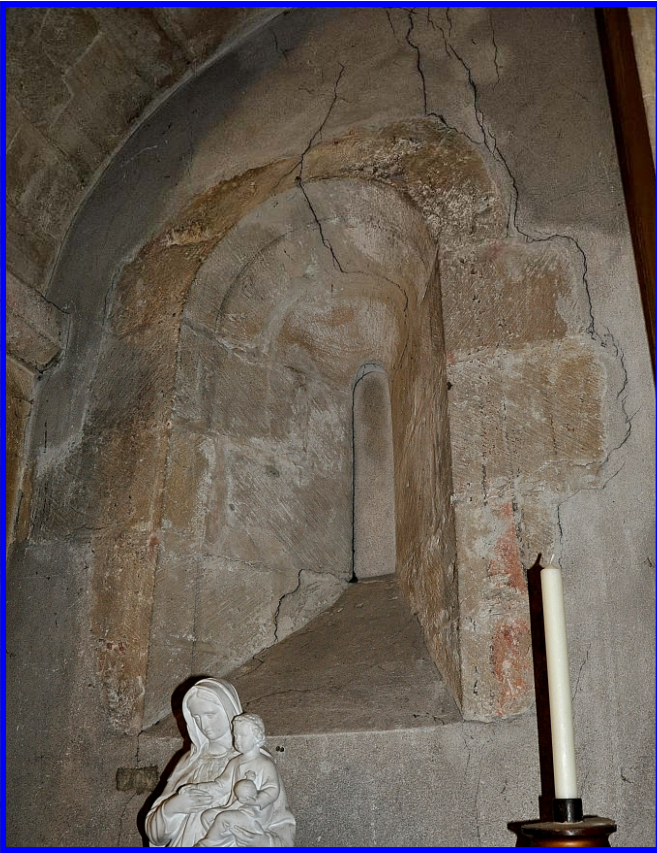
Picture/plate 33. The church of St. Denys, Warminster is a much altered edifice, not least the nave which is a Victorian replacement of a much rebuilt medieval nave. However, there exists an early window in the east wall of the north transept which is blocked where the glazing would have been. In fact behind this blocking there is an area of later medieval walling which has entirely masked any trace of the original exterior face of the wall. Furthermore the wall of the transept has received a build up to its interior face in Norman times so that this earlier window has a substantial arch to permit it to stay in use. It has been determined by measurement that the blocked glazing is some 15 inches distant from the original interior face; very obviously no exterior wall can be that thin so we must assume the window was originally built as a double-splayed opening and that would give a wall thickness of about 30 inches, a typical dimension for a pre-conquest wall. I would date this window to between 1035 and 1060. It seems that the pre-conquest church would likely be cruciform with transepts at the crossing. That some Anglo-Saxon walling might remain of the original crossing seems doubtful as little enough remains of Norman date, however the site of an earlier central crossing has been suffered to remain.
