### St. Nicholas, Worth, Sussex.

Date of building circa 1050, and possibly earlier (H.Taylor).  
 This page, clockwise from top left.

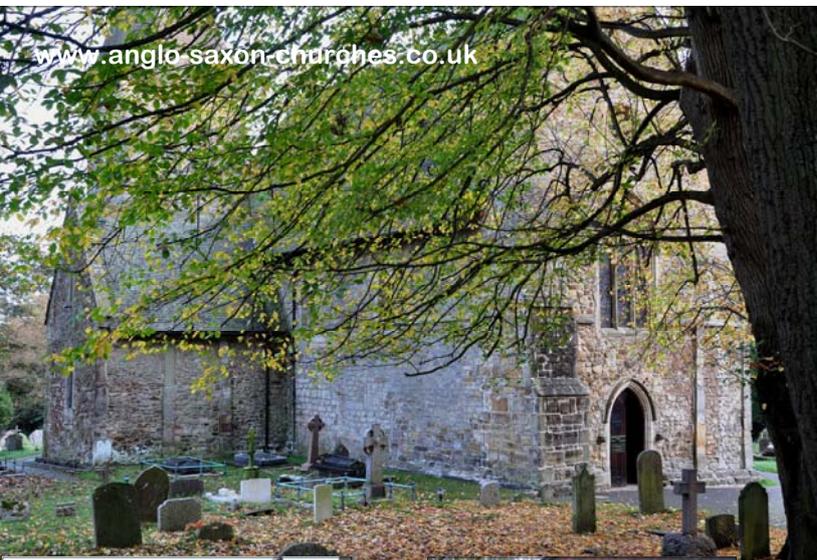
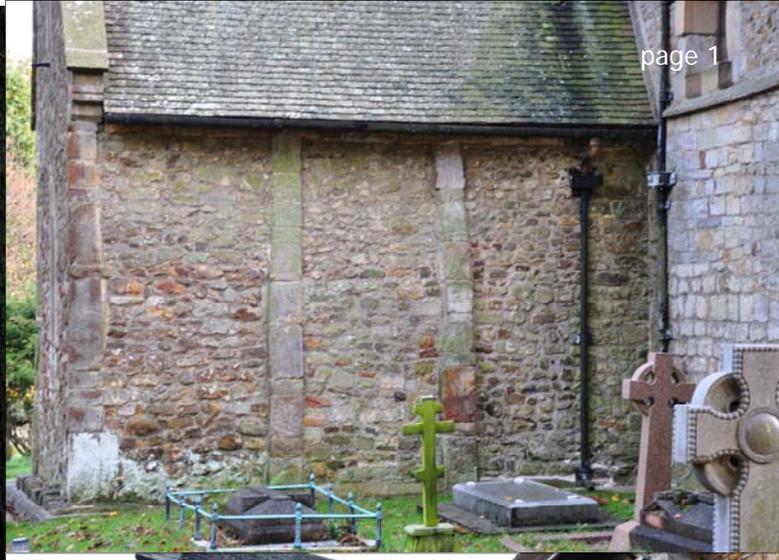
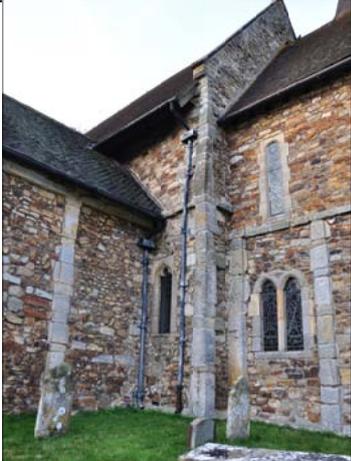
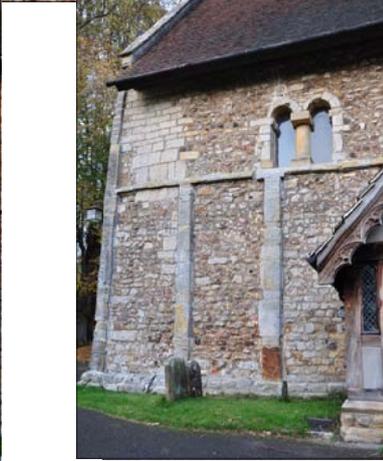
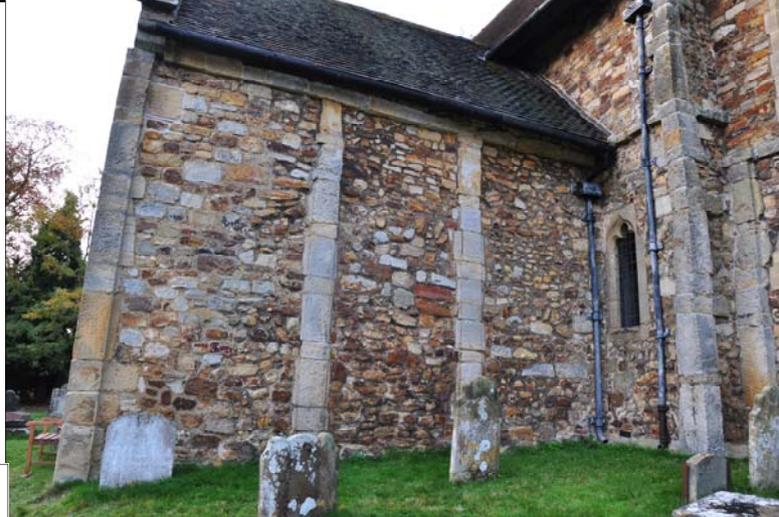
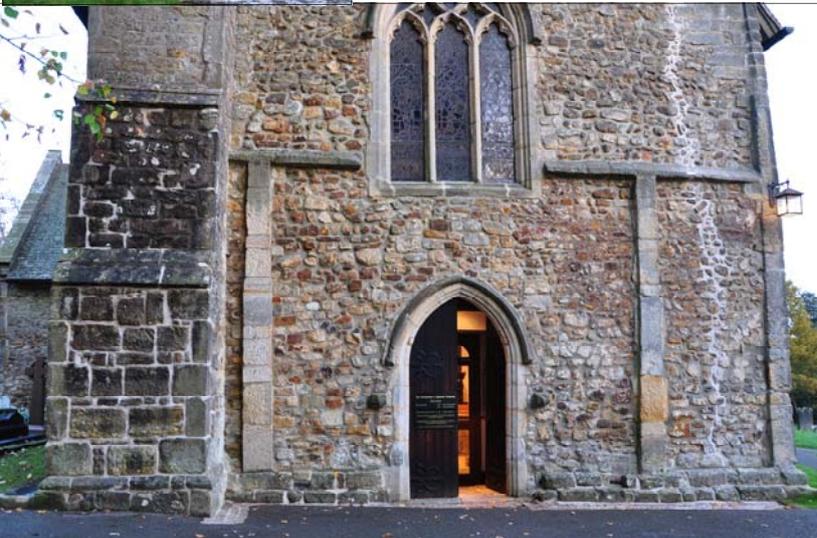
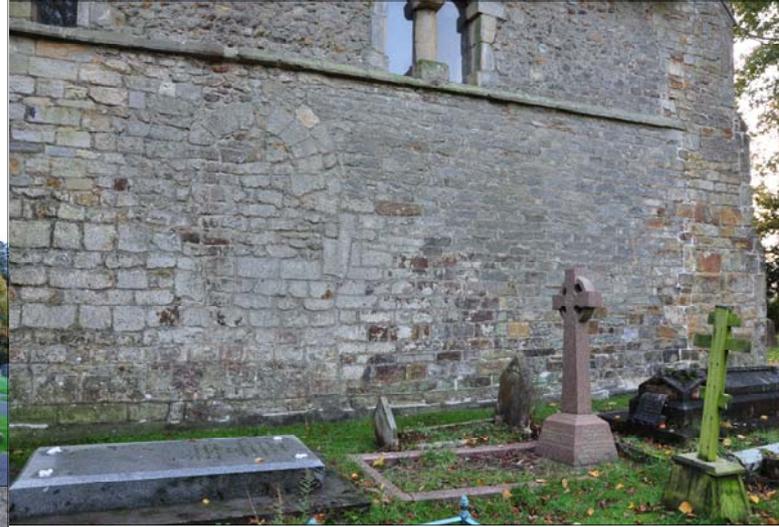
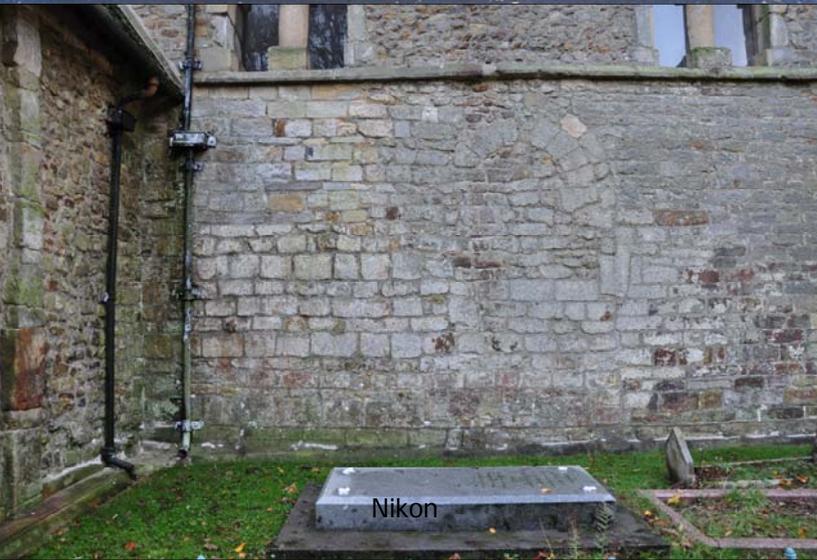
1. General view taken from the NW.
2. West wall of north transept.
3. East wall of south transept.
4. N wall of nave, note absence of pilaster strips, blocked doorway, and the remarkable double window of which 3 survive out of four.
5. As pic 4 and note the coursed stonework in contrast to the random rubble of the remainder of the exterior of the church. To the left the W wall of N transept.
6. The west front.
7. *Left.* The E wall of S transept and the chancel (restored 1871) to the right. 8. *Right.* The westernmost part of the S wall of the nave.

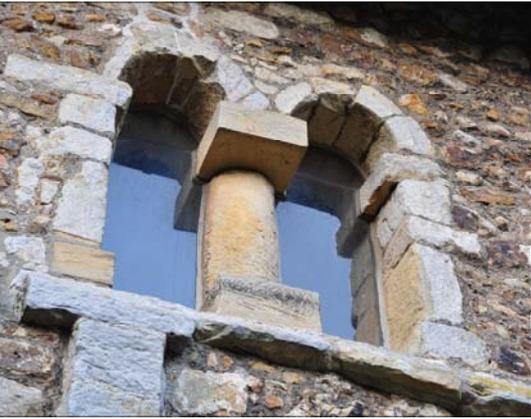
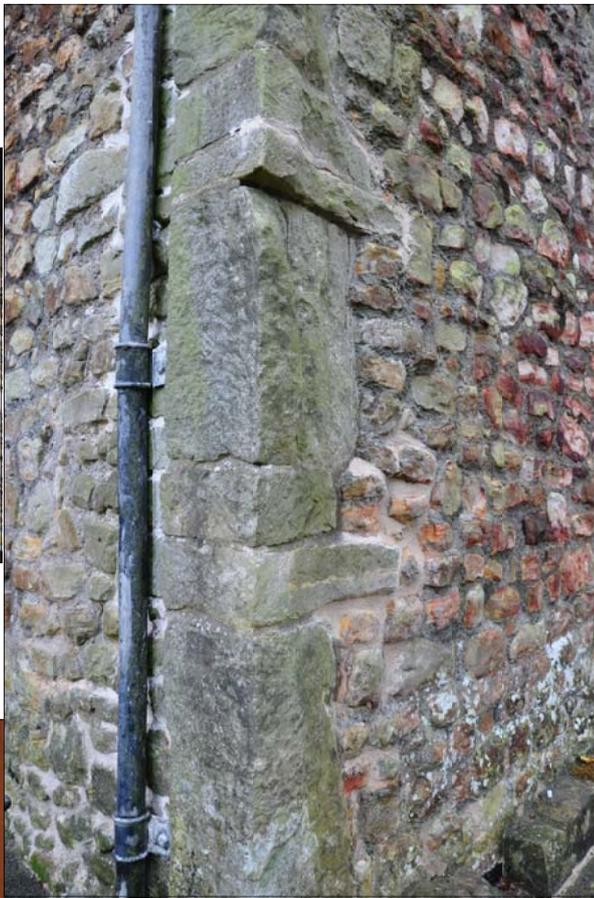
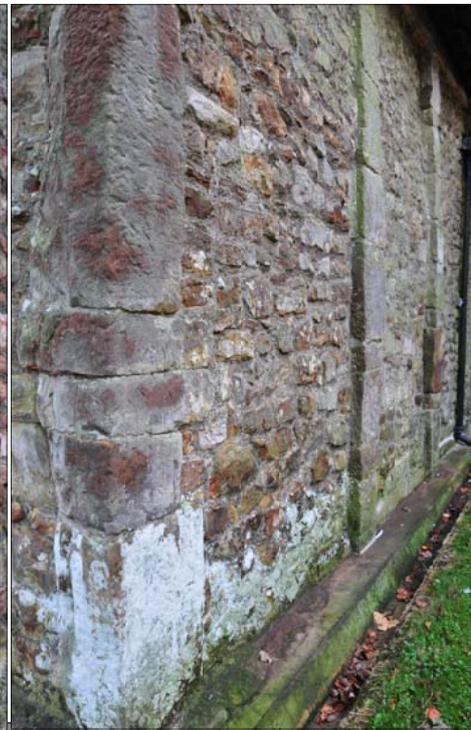
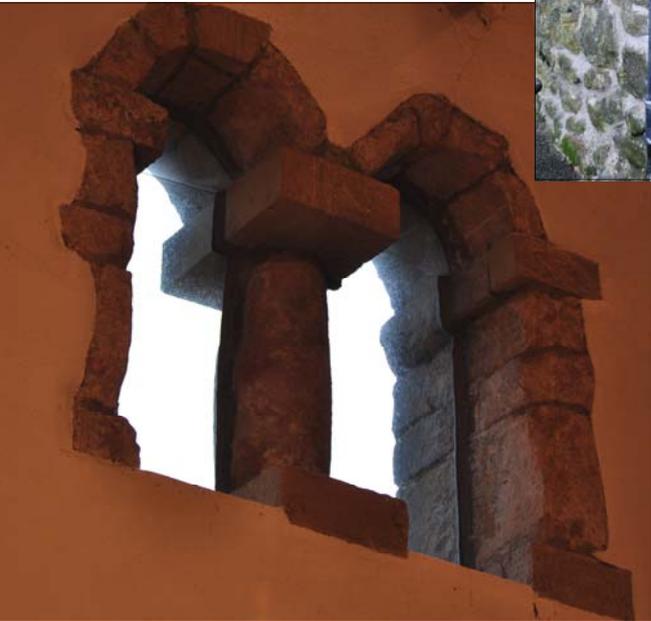
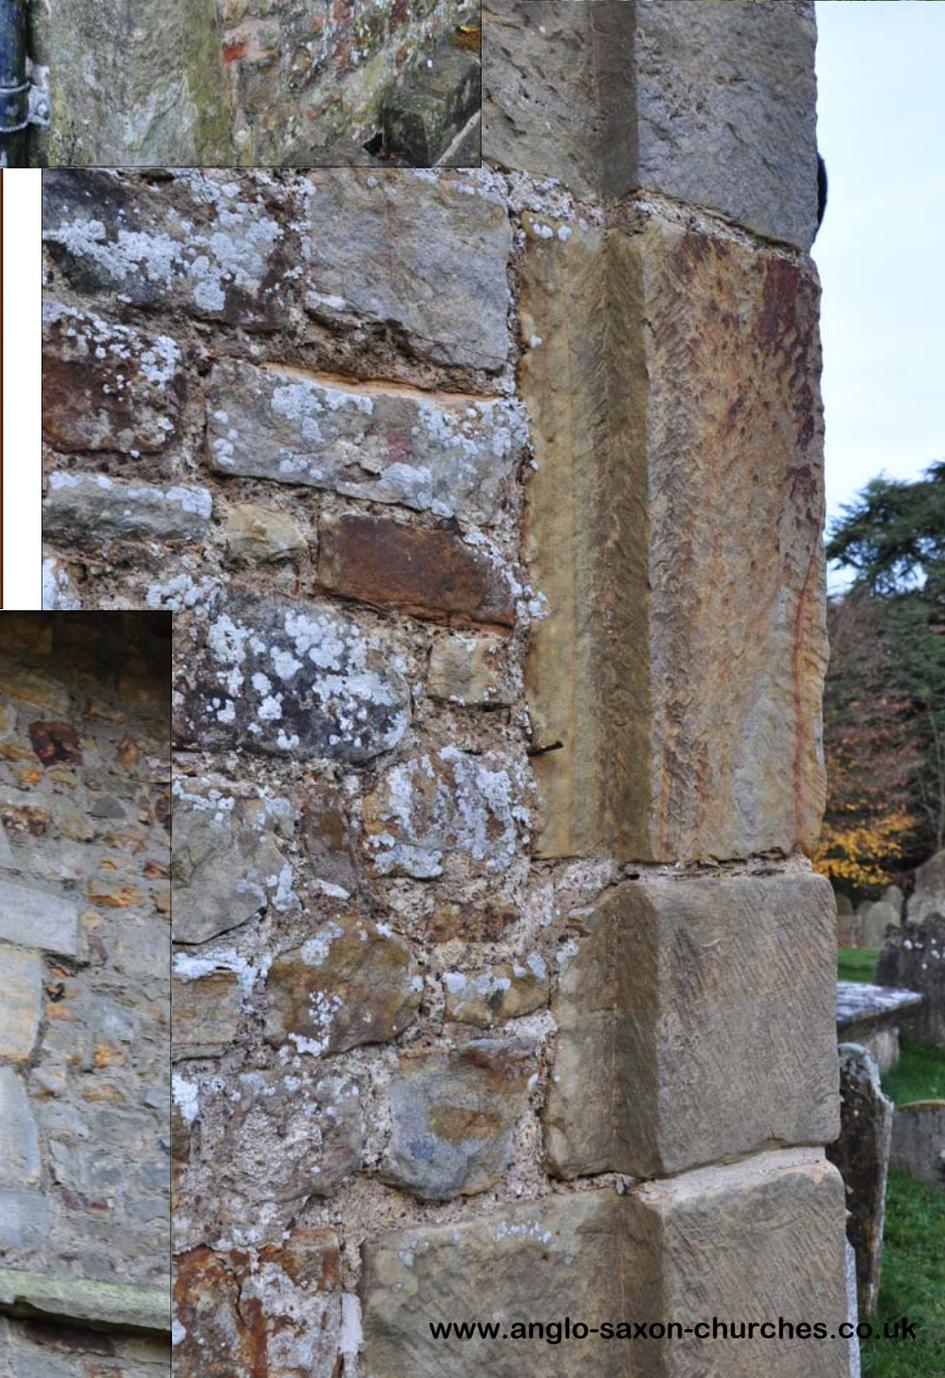
This page—pilaster strips and windows.

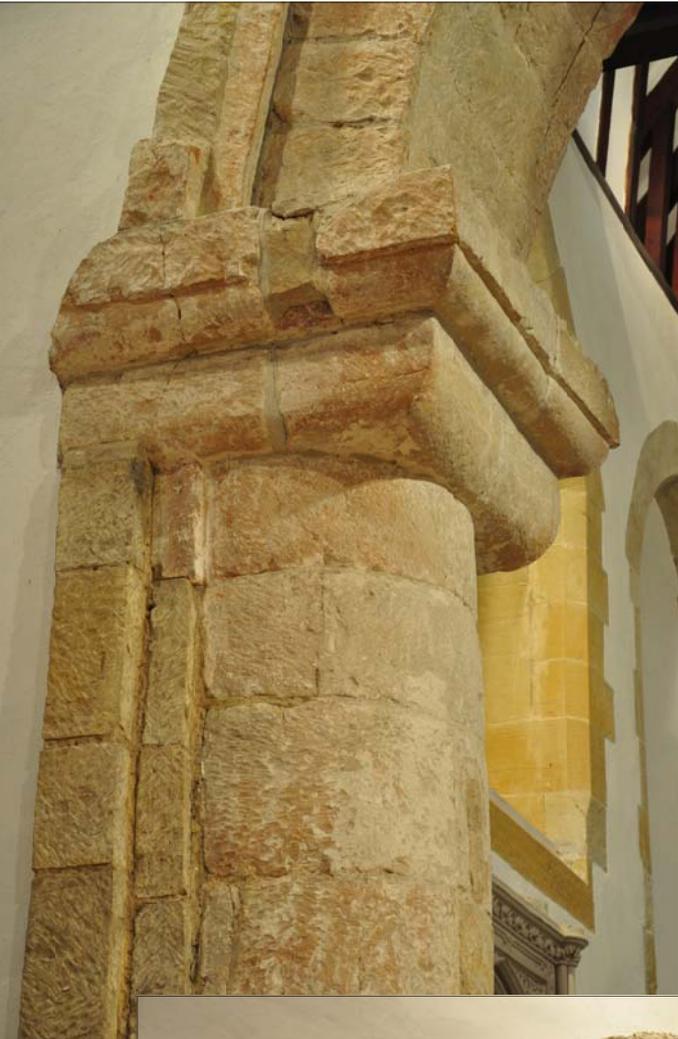
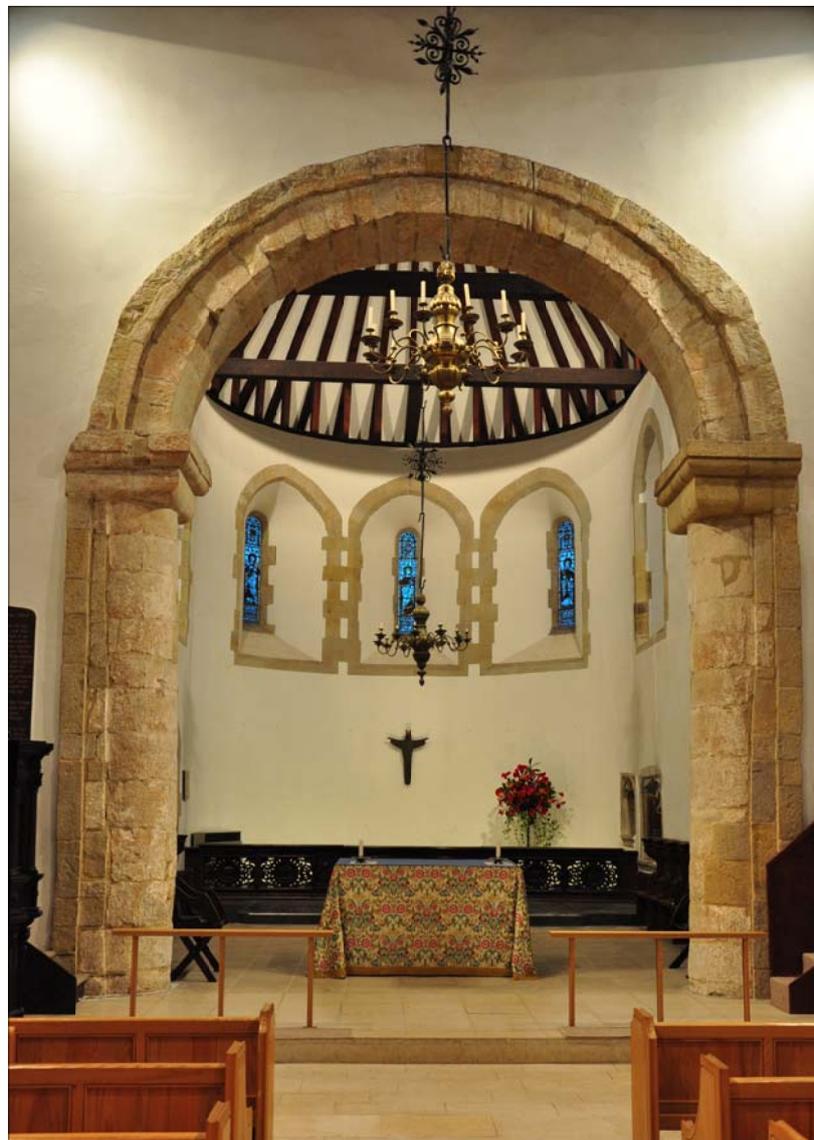
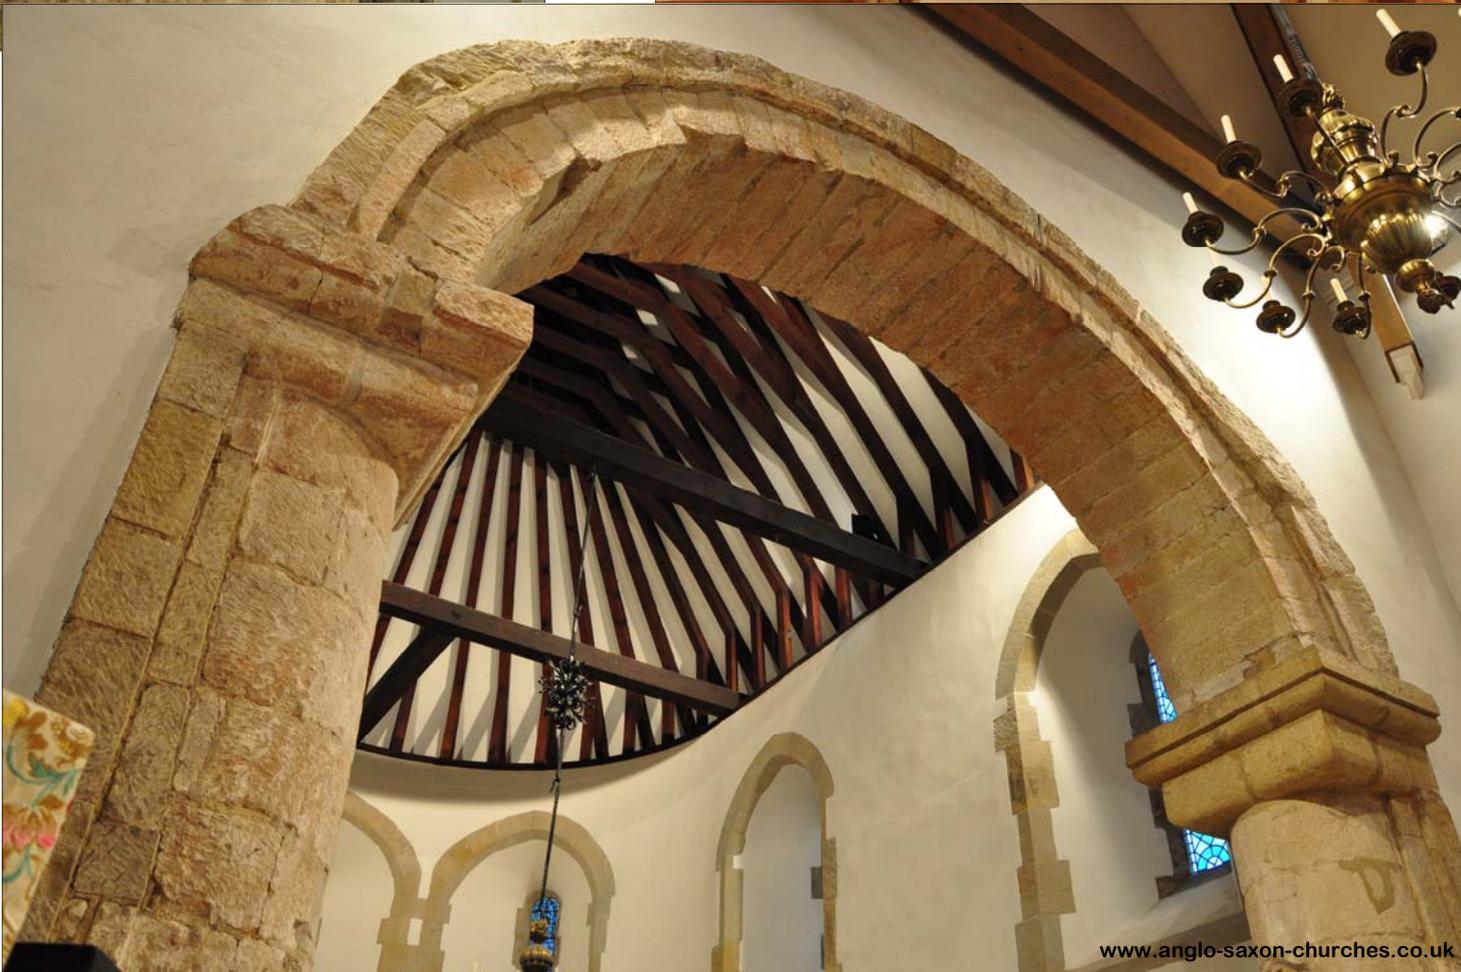
**St. Nicholas, Worth.**  
This page — the fine chancel arch.

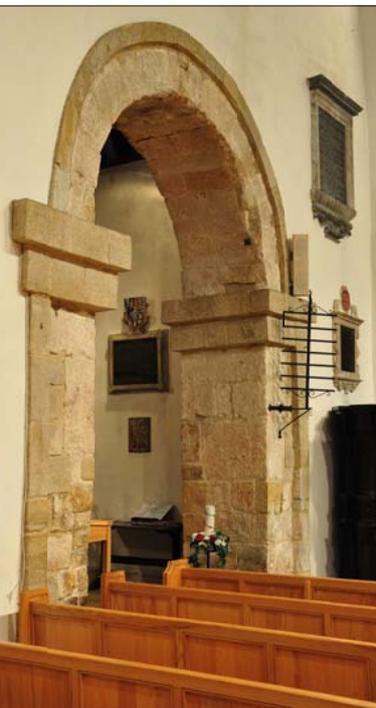
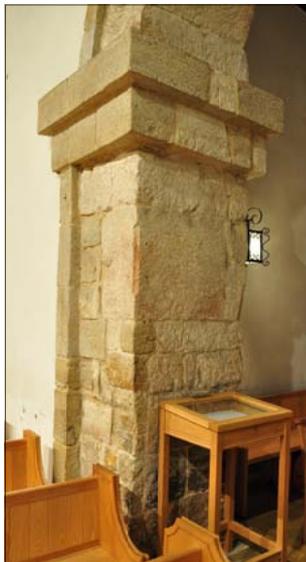
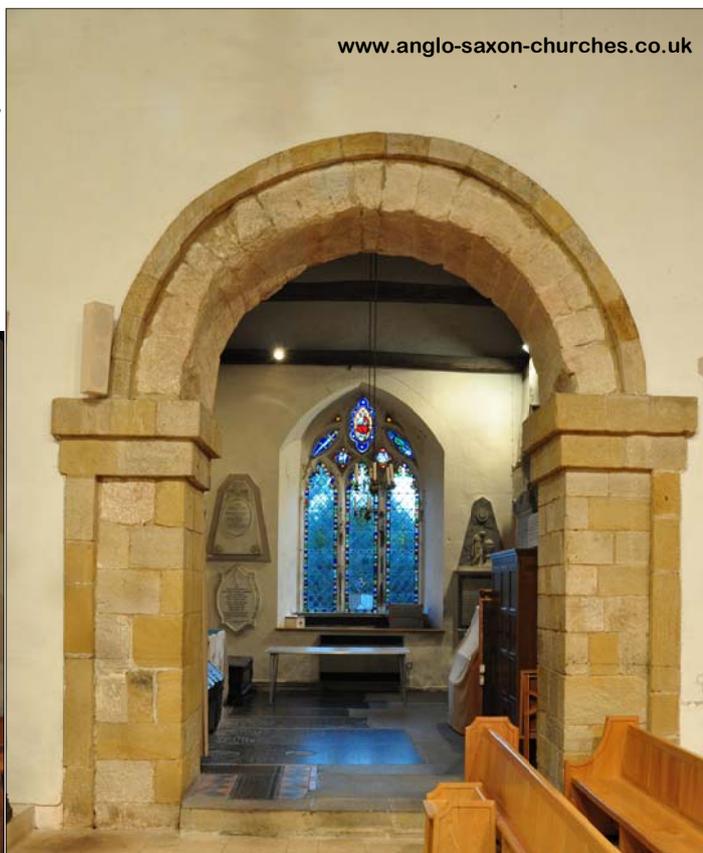
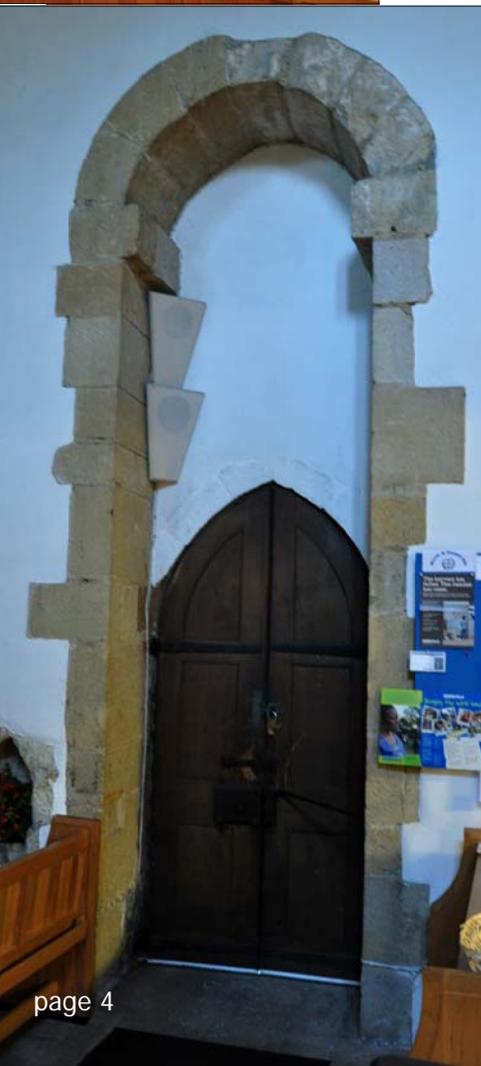
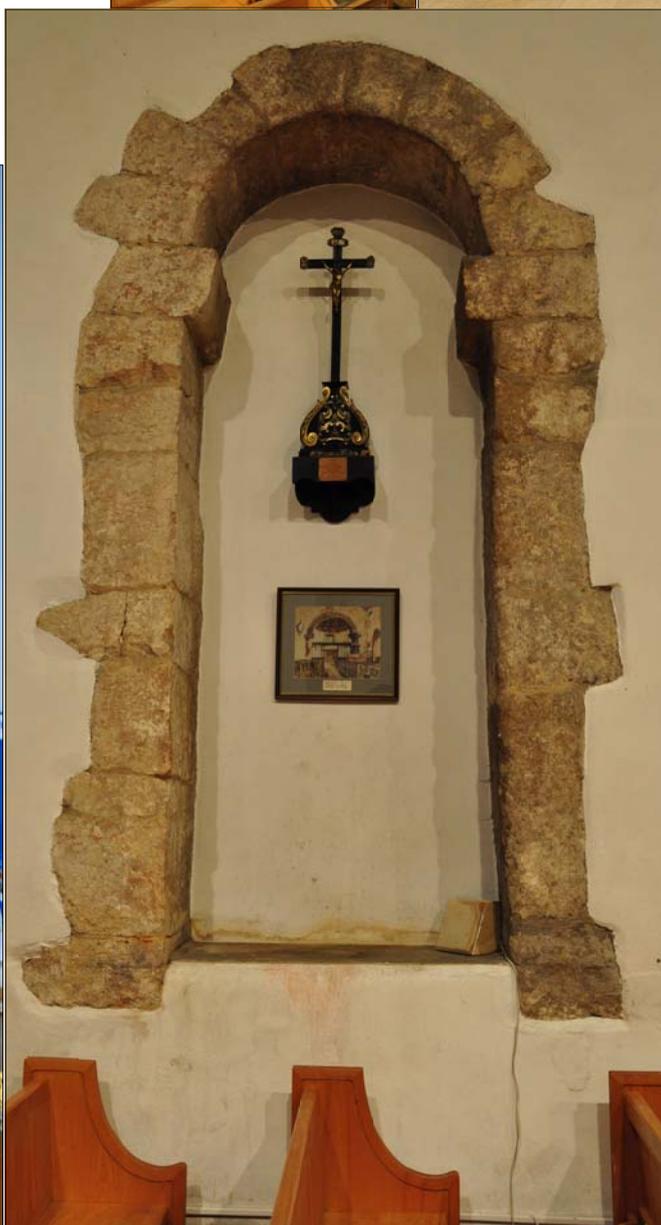
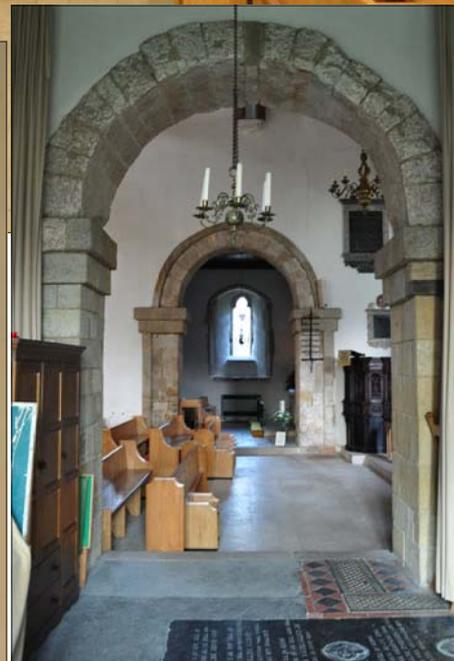
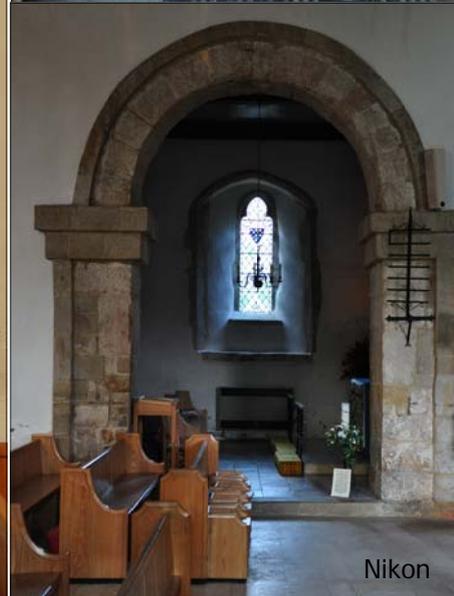
1. The archway to S transept (its jambs and imposts are almost wholly restorations) viewed from inside nave.
2. As 1, but viewed from inside transept.
3. N transept archway viewed from nave.
4. Blocked N doorway.
5. Tall S doorway with later inserted medieval doorway.
6. N transept archway viewed from SW. 7. As 6 but west jamb/impost.
