Church of St. Nicholas, Boarhunt, Hampshire.

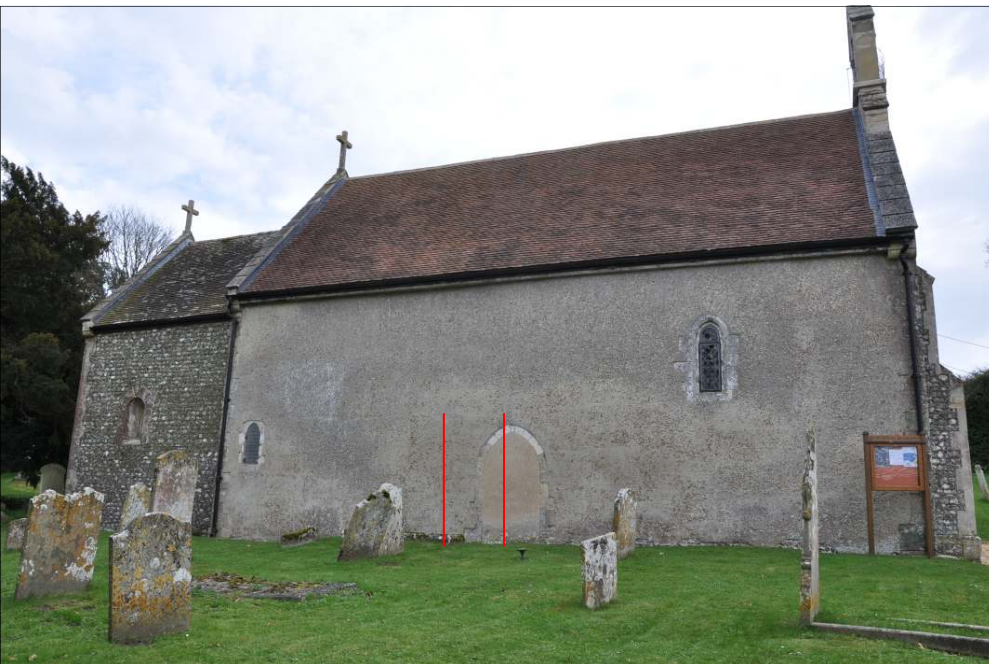
1. The church seen from the north. The site of the Saxon N doorway (observed by H.Taylor) is marked by a pair of red lines. The building is of uncut flints, partly plastered, with quoins of dressed stone in side-alternate fashion.

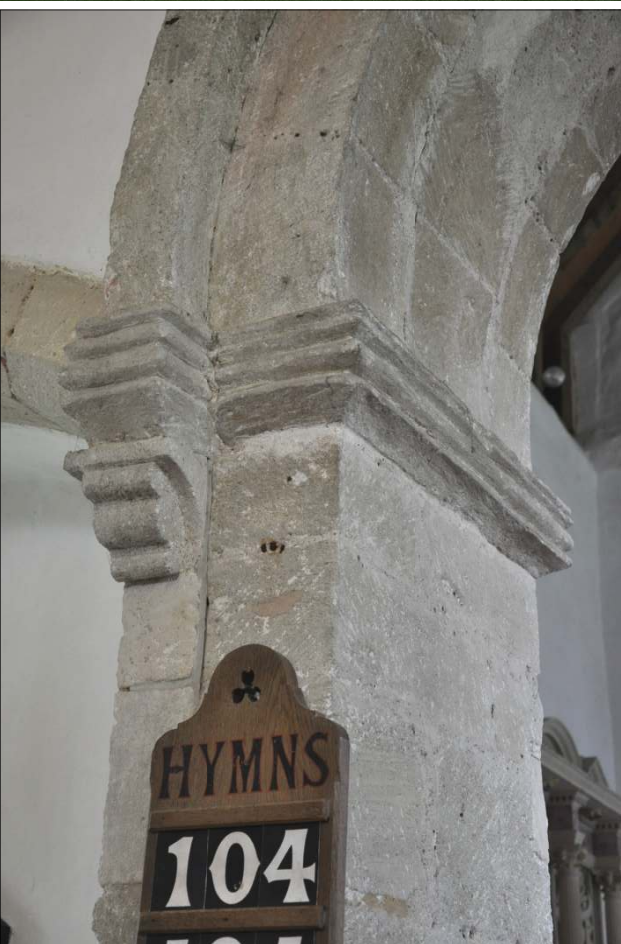
2. The chancel arch seen from the nave.

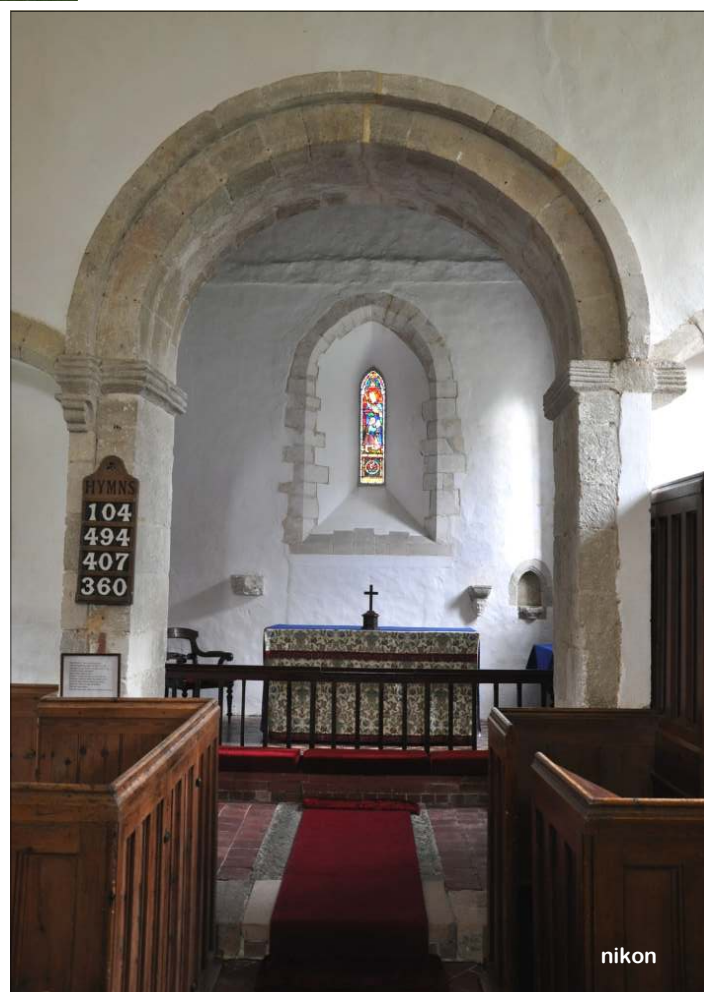
3. The N impost viewed from the nave. Square in section but chamfered below and enriched by four lines of mouldings carried horizontally on the faces of the impost. The treatment of the mouldings is in a strikingly similar manner to that of the capitals of the entrance doorway to be found at Stopham church, in Sussex. Perhaps a 'popular' decoration in that period because of the comparative ease with which the stone could be scribed/marked out with parallel lines, and the work executed possibly by an apprentice.

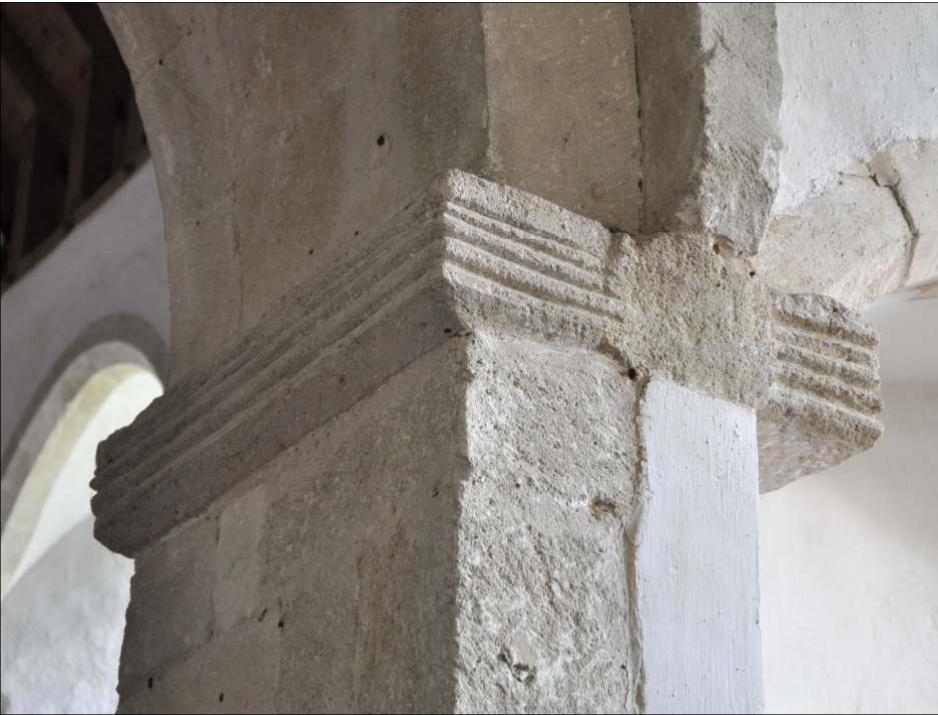
4. The south impost of the chancel arch; comparing this with its northern sister one can see it has been partly mutilated at the point of the hood-mould. Also, in this case, the five mouldings are of a shallower nature when compared to its sister, and are somewhat poorly executed in comparison.

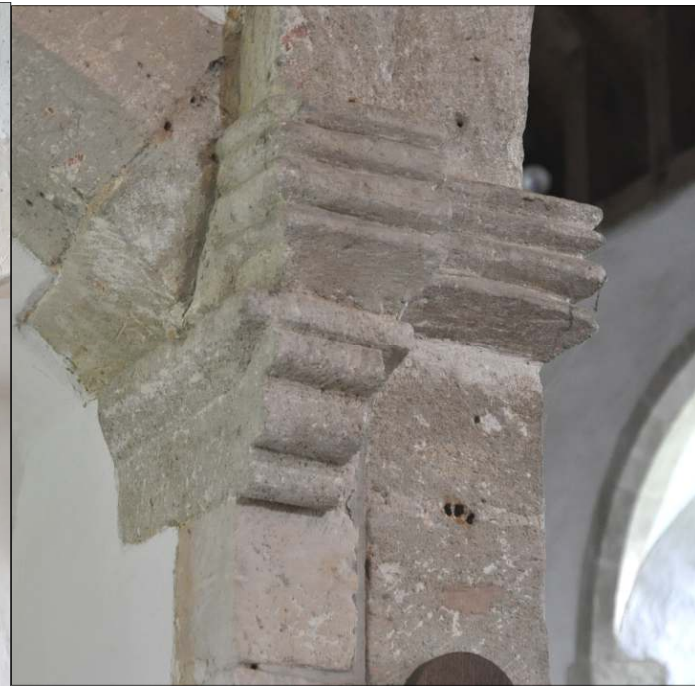
5. Seen here, the north impost, mutilated on the left hand (north side).
6. The western end of the south wall of the nave (this photo enhanced), the blue lines indicate the scar visible on this wall of the removed cross wall, and noted by H. Taylor and which see Vol I of Anglo-Saxon Architecture, page 77. This would have cut off the western entrance from the nave and no doubt with a sister archway to that of the chancel-arch. Taylor also noted outlines, visible on the plaster, of tall doorways (and externally that of the S doorway) and which partly cut by later, lower, doorways to both north and south (see red lines indicating the S doorway position).

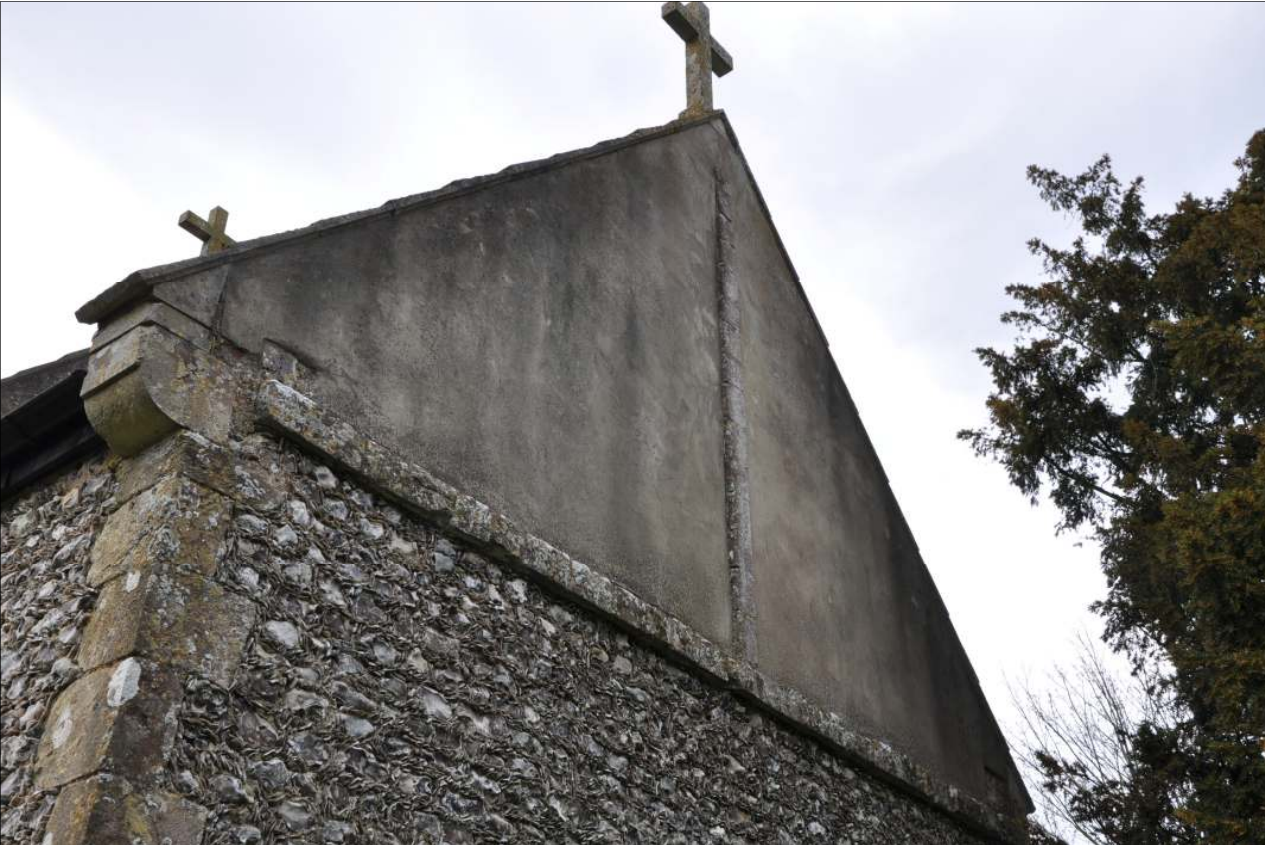
8. The eastern gable of the chancel with string-course and vertical pilaster-strip above.
9. A detail of the pilaster strip. This raises the question of the 'disappeared' pilaster-strips which may have been 'restored out' on the rest of the building, since the walls are patently the original walls of the Anglo-Saxon church despite the later features which have simply been inserted in those walls. Witness the clever and intricate Victorian flint-work which can be seen on the west wall (not pictured here).

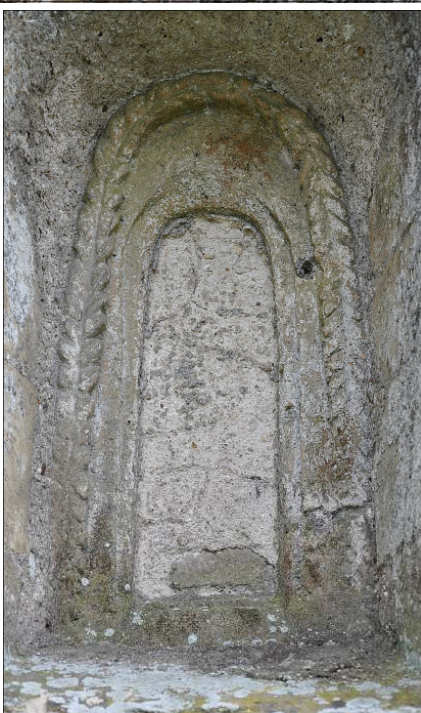
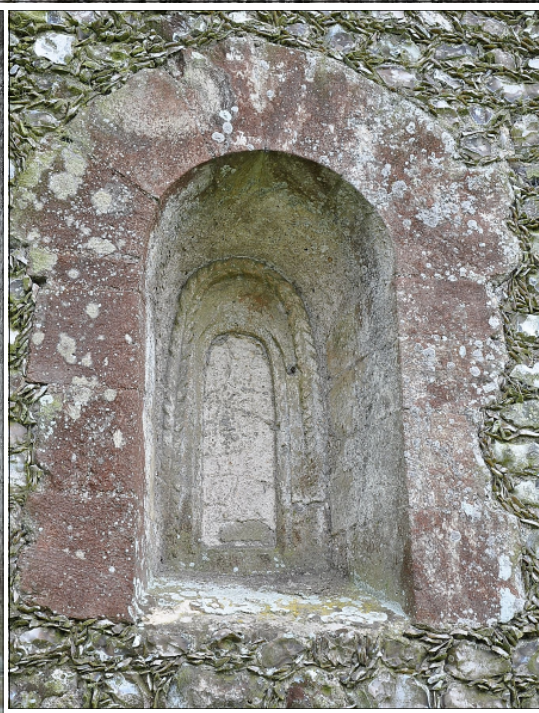
- 10 & 11. The blocked north window in the chancel. The outer face is of well-dressed stone (absent at the base), neatly laid; the aperture cut in a stone mid-wall slab narrows slightly to the top. The stone slab is enriched by a band of wheat-ear ornament which is carried up beside the opening and round its head. Note: the surrounding dressed stone is in very fine condition, hardly weathered and possibly from hails from the same source as the dressed stone at Stoughton church, which is only some 15 miles distant. However, the rather curiously decorated window perhaps dates this building to a previous time in comparison to Stoughton. Having said that double splayed windows are notoriously difficult to date, as H.Taylor mentions, but decorated windows are on the rare side.

Externally the distinctive features of the church are the horizontal string-course and vertical pilaster strip on the eastern gable of the chancel, and the double splayed window in its north wall. Internally the round headed chancel arch is of a square order (not of through-stones) and outlined on its western face by strip-work carried round its head as a hood-mould. The pilaster-strips which would originally have continued the line of the hood mould down to the floor have been
