Church of St Laurence, Bradford on Avon, Wiltshire.

Comprising chancel, and nave with flanking porches; all complete save for the south porch. The survival of this high status church, which stands on rising ground on the north side of the River Avon, was in great part due to Canon Jones the then vicar of Bradford, who published a paper upon the church in 1856. The chapel lay undiscovered, having been converted, the nave into a school and the chancel into a cottage, along with the insertion of fireplaces and windows. In 1871, due to the energy of the vicar, the chapel was bought from its owners, restored, reconsecrated, invested in Trustees as an Ancient Monument, and opened to the public. The history of the church is well known/documented; the original building was built as a chapel dedicated by St Aldhelm to St Laurence in the early 8th century. There have been suggestions, by Jackson and Fletcher, that the original building stood to the height of the first stringcourse and that the 'upper' part of the walls (containing the blind arcading) was a later addition. There has been some discussion upon the actual date of the present fabric but I feel firmly that (apart from the loss of

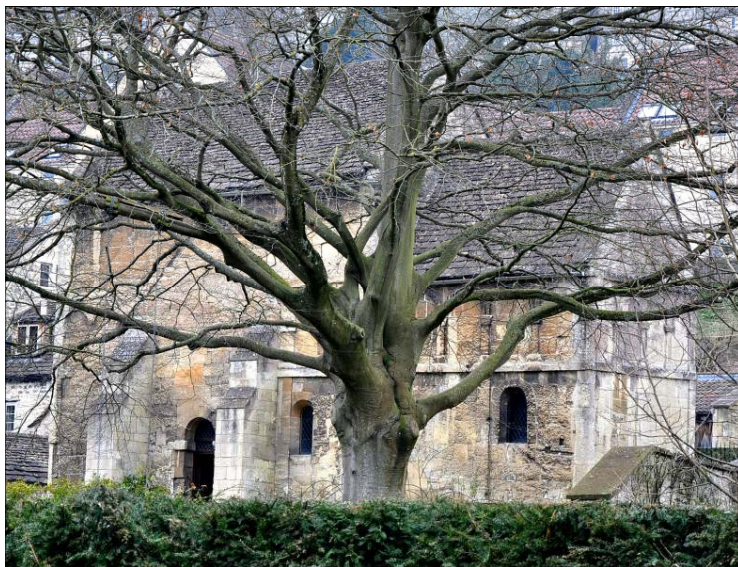
1. General view of the church from the south-east.
2. Closer view from the south showing site of south porch marked only by two buttresses.
3. 19th century photos of the building, also of the two carved angels which originally belonged to a Crucifixion.
4. A photo of the plan and elevations from the original drawings made in the 19th century when the building was in use as a school and cottage.

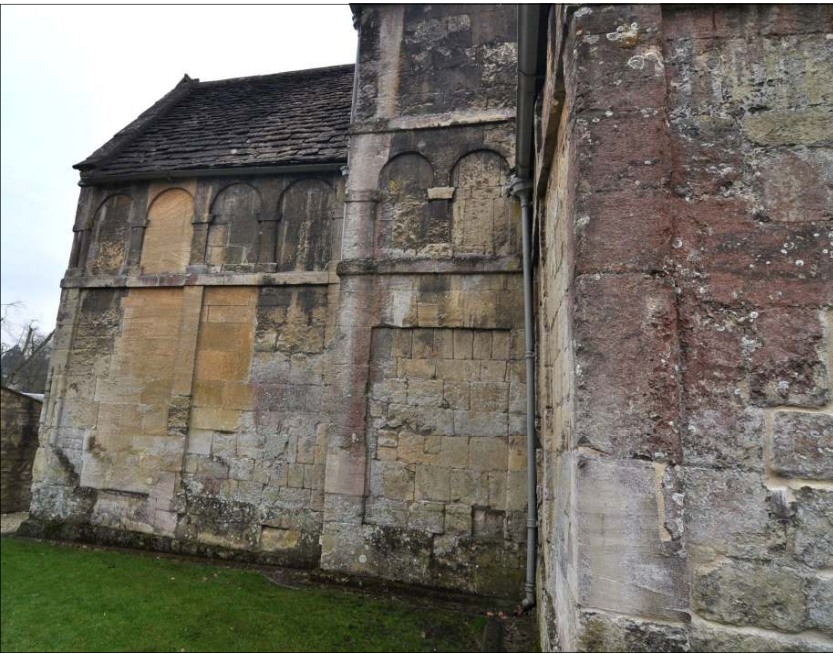
5. The north wall of the chancel running out to the left, with the NE quoin of the nave centre picture, and then right foreground the NE (cut back) quoin of the north porticus.
6. Looking west the north porticus is to the right and adjoining the north wall of the nave, the chancel running out to the left.
7. The north wall of the chancel with the NE quoin of the nave to the right.
8. The north wall of the north porticus (viewed from a cramped position!). Note the remains of three reeded shafts standing upon the uppermost stringcourse.

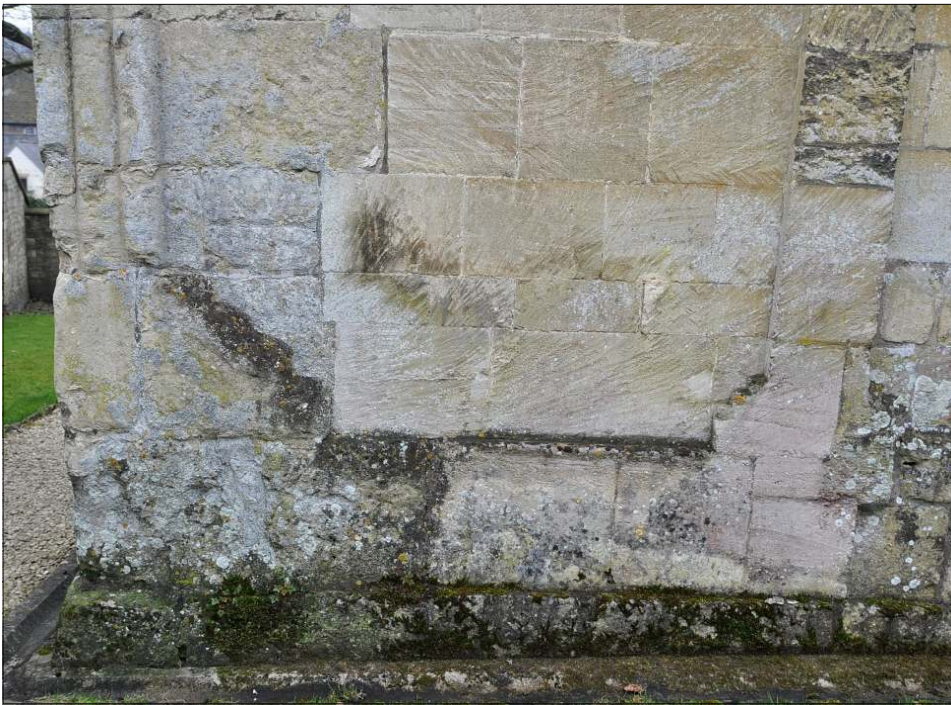
9. A portion of the north wall of the chancel and its NE quoin left. Note the stepped base which sits on the plinth (but is not set back from it) and from where the reeded quoin springs. Note also to the right the pilaster strip, again with stepped base in a matching style.

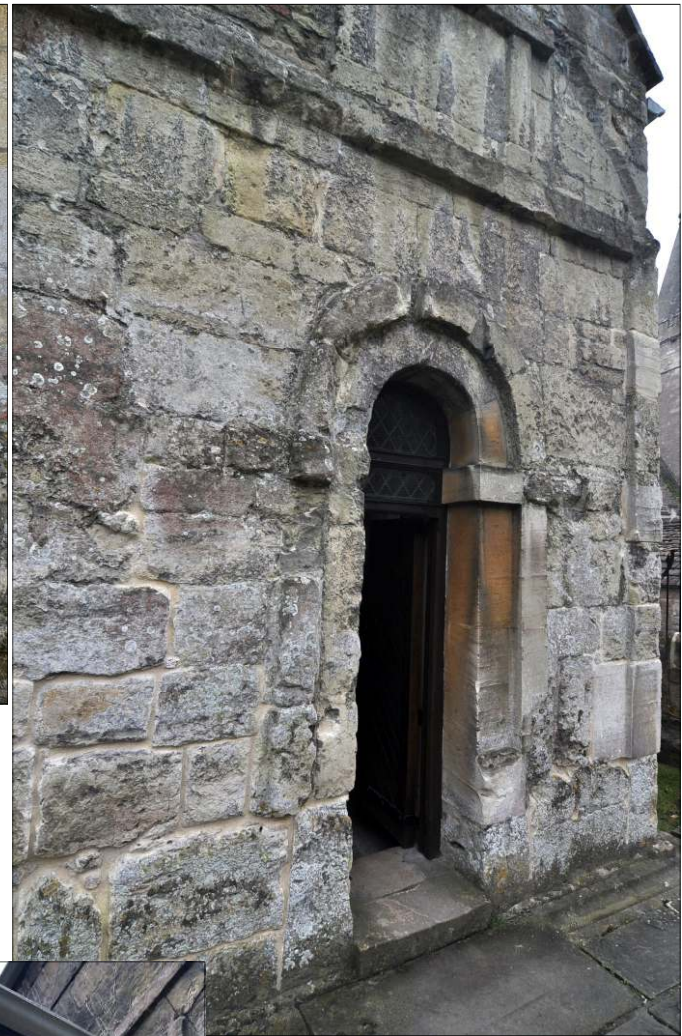
10. The north doorway (part restored) of the north porticus and with pilasters strips and matching hood mould.
11. One of the three remaining windows, this is in the west wall of the north porticus (and see picture 21 on page 7). Note how it is not contemporary with the original fabric, having been inserted at some later date. Note how it cuts through the pilaster strip which has been truncated (see red arrow). This window is extremely poorly executed in comparison with the other two, and the glass is not so deeply set back from the surface of the walling. It certainly does not belong to the same date as the other two windows, this window was constructed by workers far less skilled.

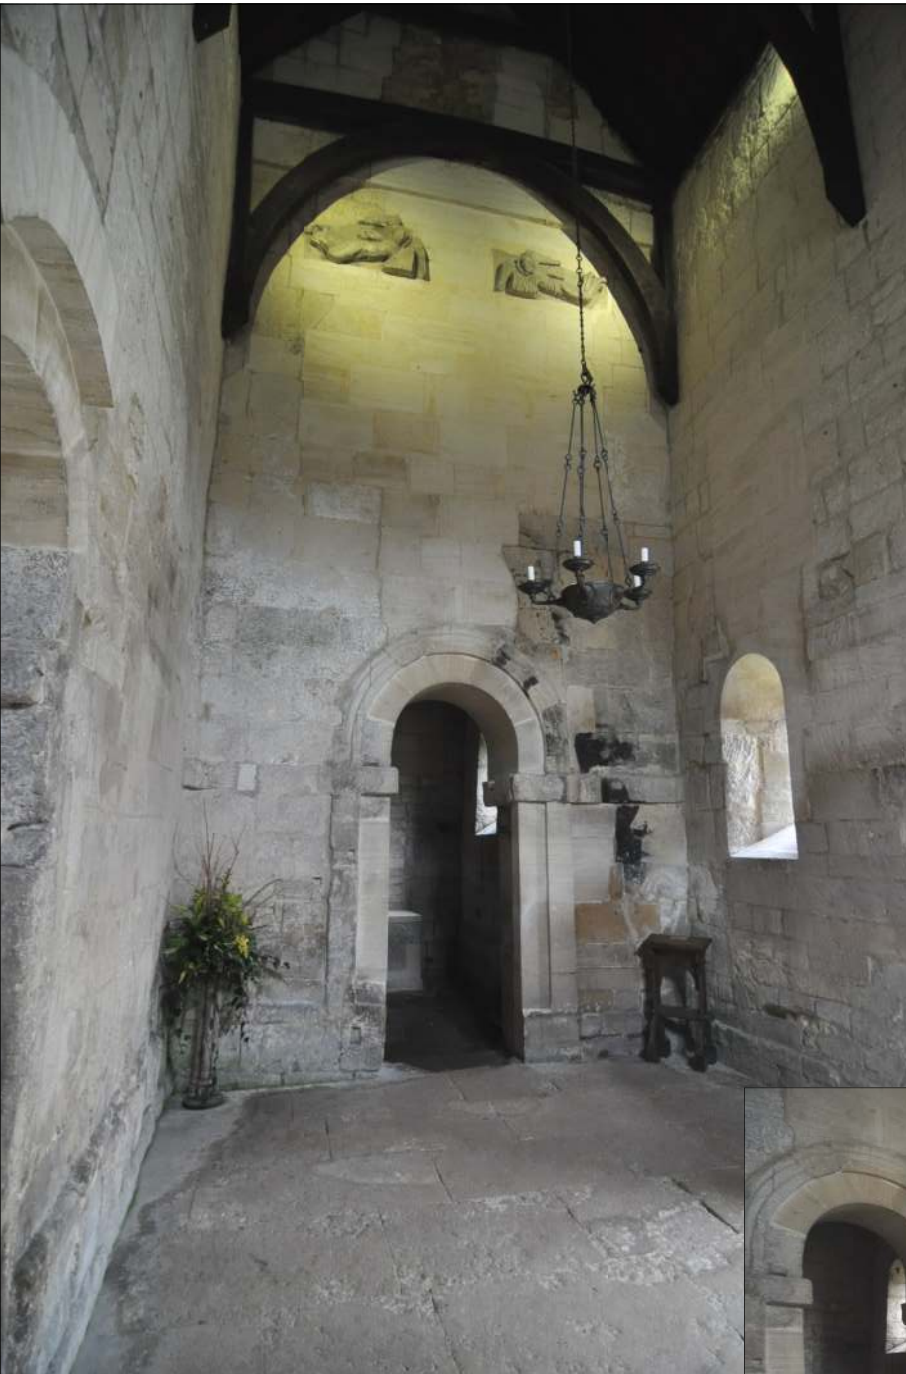
13. The nave interior looking eastwards with the chancel arch centre of picture, and high above the two carved sculptures of angels. These sculptures (for more detailed pictures go to the file entitled "sculpture") are not in their original position, it seems they are remnants belonging to a crucifixion, perhaps springing from just above the chancel arch. The archway leading to the north porticus is partly seen to the very left of the picture.
14. This picture looks westwards to the west wall of the nave and shows the windows inserted during the 19th century restoration. The archway, now with a door fitted, originally gave access to the (now vanished) south porticus.
15. The chancel arch seen to the left in this picture and with the south archway on the right.

20. A closer view of the chancel archway, seen from the nave. Note in this digitally enhanced photo, the "reeded" effect upon the hood mould, this feature is repeated time and time again on features in this building. Referring to picture 13 (on page 4) we can see how both impostors were extended across the entire width of the nave, almost in the form of a stringcourse.

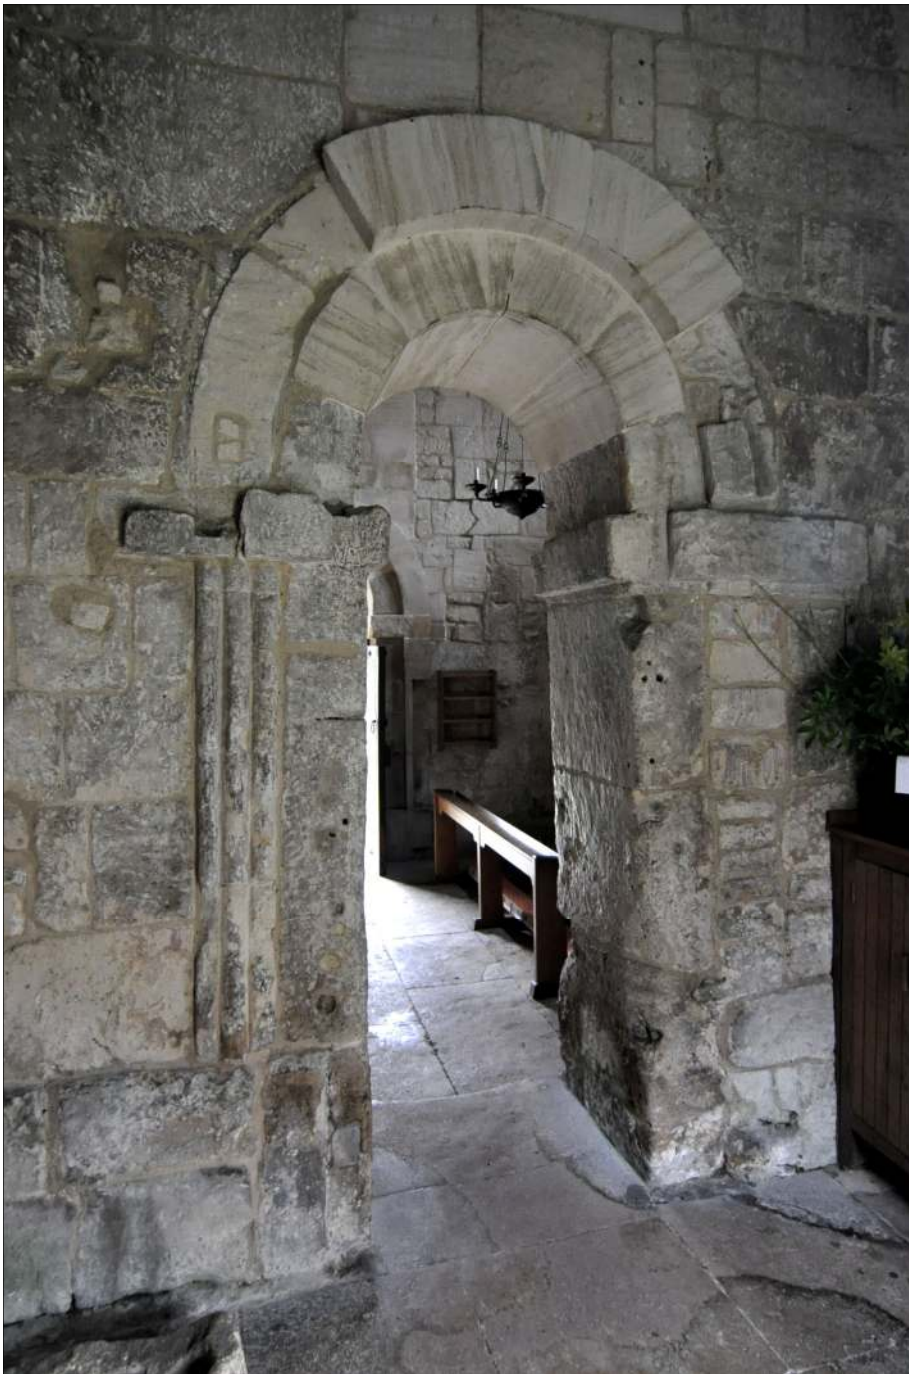
16. This picture is of the archway leading to the north porticus and is seen viewed from within that cell. The hood moulding and most of the arch is heavily rebuilt due to damage caused during the years of use as a school and cottage, but certainly the imposts and jambs are in fair original condition. Despite the right hand pilaster being absent/defaced, that on left hand is extant and is interestingly treated with a reeded effect, as is the original part of the hood-mould sitting upon the right hand impost. The chancel arch hood-moulding is so adorned, and similarly the NE quoin of the chancel and some of the blind arcading to chancel and north porticus. This particular adornment appears to be the one common feature that was applied throughout the building. The blocks of the jambs are through-stones, as are the head, and this is common to the other remaining doorways/archways.

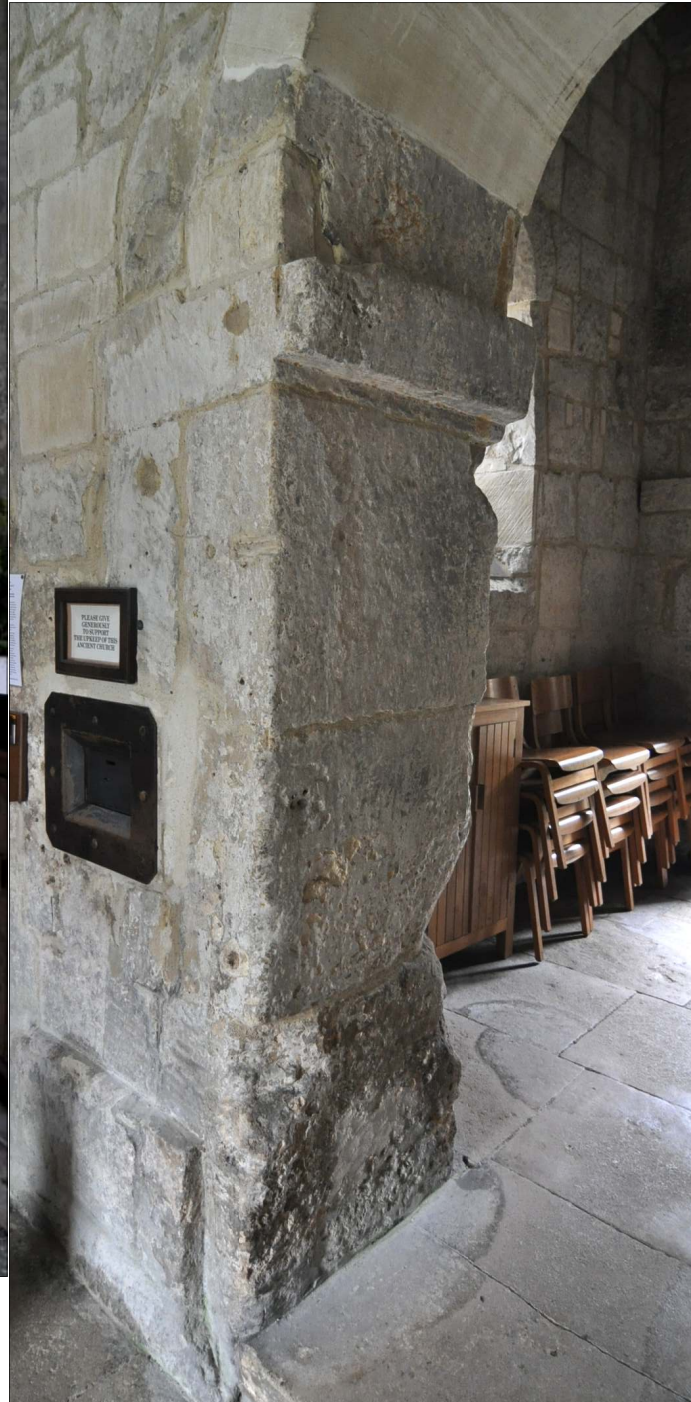
17. Here is the west jamb of the same archway but viewed from within the nave. There is little remaining of its pilasters which have been savagely defaced.

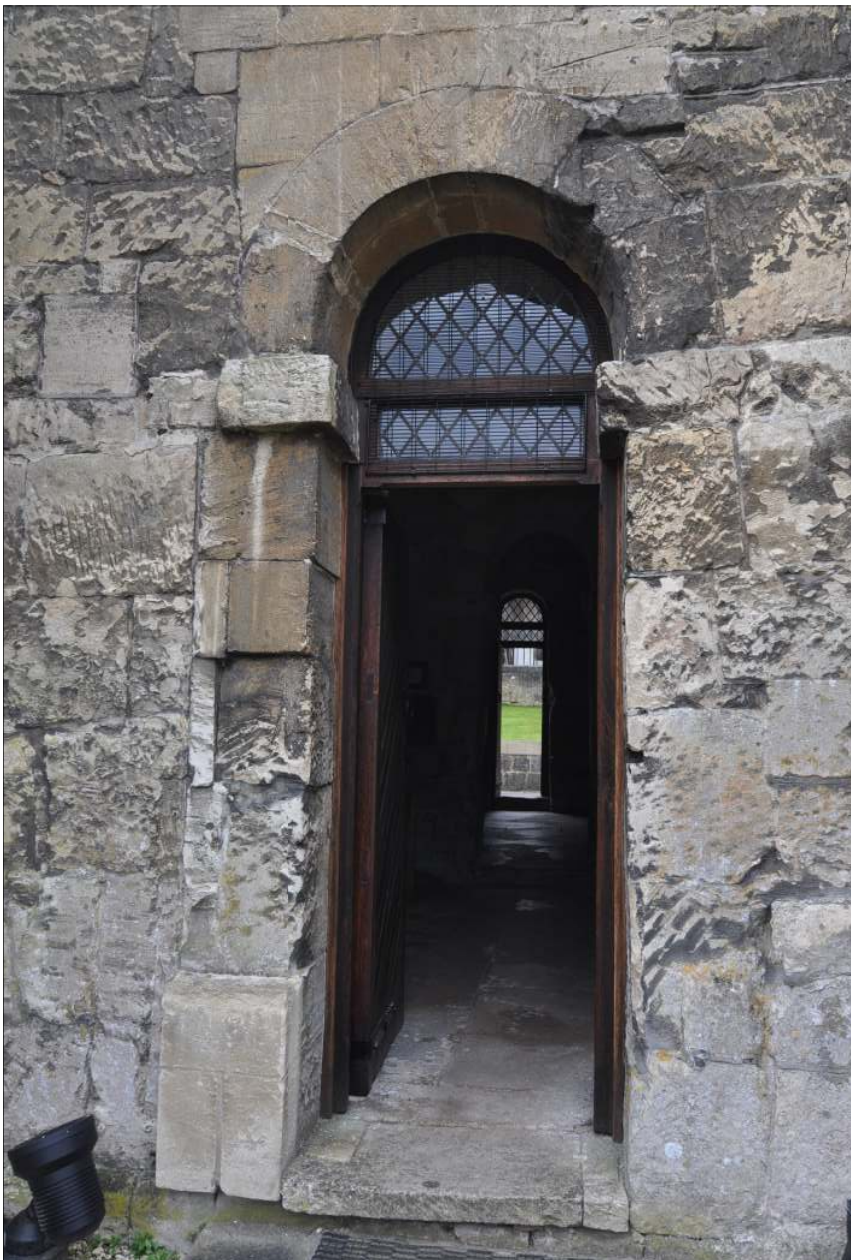
18. This picture is of the archway which now serves as the south entrance, and studying the surrounding stonework carefully we see there is scant evidence of a hood moulding or pair of pilasters (even allowing for some 19th century replacement stonework above the arch). If these features had been shaved back to the line of the walling then the stonework remaining would be clearly seen since these stones were not surface ornamentation but were a very

substantial part of the build of the archway and were seated deeply into the walling. Therefore we can compare this archway with its northern sister and which exhibits clearly the pilasters and accompanying hood moulds on both faces. Here, the south face, as built, seems devoid of these features. In the same way as at St. Peters, Barton upon Humber, where the east face of the archway in the east wall of the tower does not have, nor did have, the benefit of these features, and yet its west face did. There must be some criterion that demanded, or did not demand, the presence of those features. It probably depended upon the importance, the use, that the particular cell it opened on to was to be put.

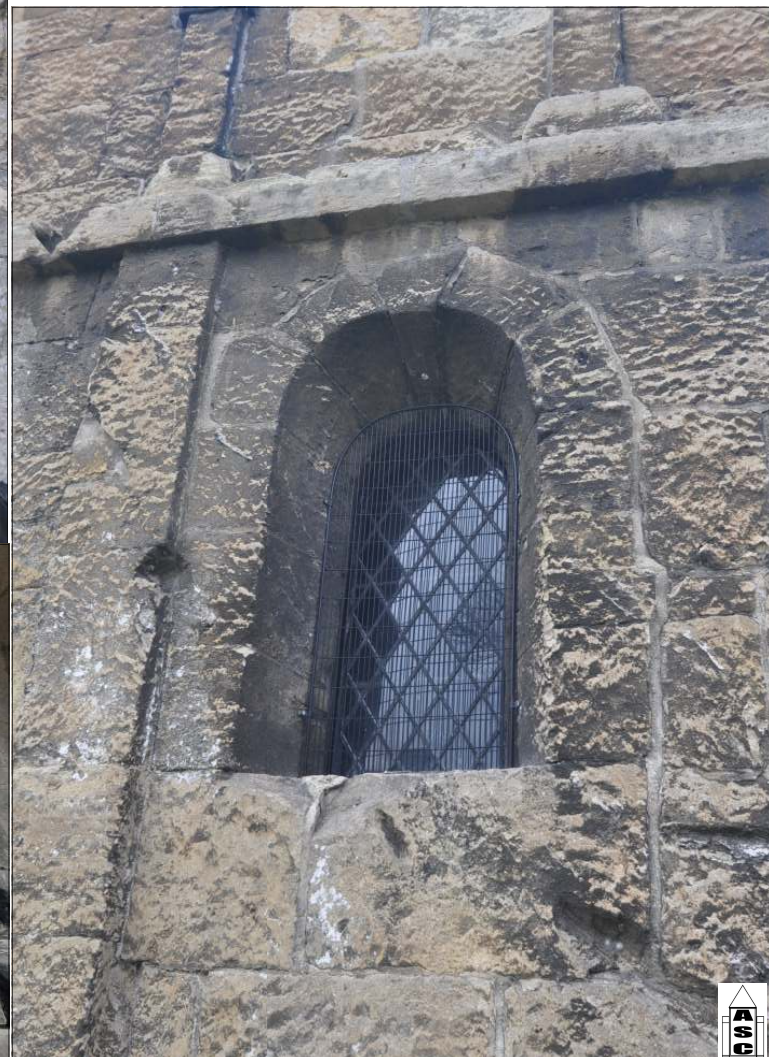
19. The window in the south wall of the chancel, compared to the north porticus window the glass is more deeply set being a true double-splay type.

22. The window in the south face of the chancel, referring to the picture number 19 (page 6) of its exterior face. However, in comparison with the window in picture 21, a far better fist has been made of the interior of this window where the finish of the stonework is very tidy indeed. It seems this window is contemporary with the main fabric (and not a later insertion).

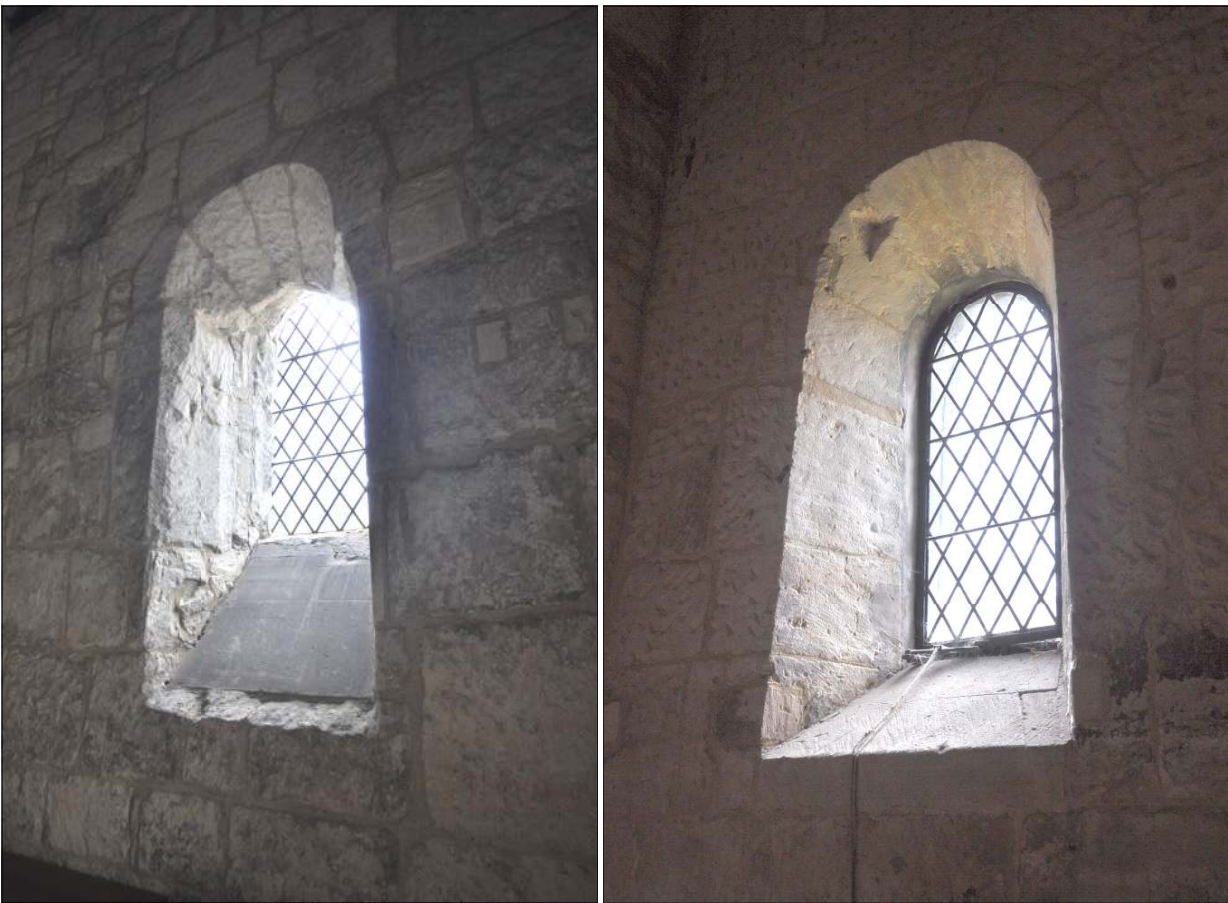
21. This is the window cut into the west wall of the north porticus, note the marks left where the existing stonework was sawn/hacked through, and the edge of the sill a very rough job indeed however much a thankless task it may have been to make good the existing stonework. The head of the arch has had new stonework at the time of the insertion of the window, again a pretty poor job. Viewing the picture (11 on page 3) of its exterior it is seen truncating the pilaster strip. I would say this window was tackled at a later date compared to the other two and perhaps using inferior labour.
