St. Mary Minster, Stow-in-Lindsey, Lincs. All pages pictures viewed clockwise from top right.

St. Mary Minster. Stow-in-Lindsey. This page.

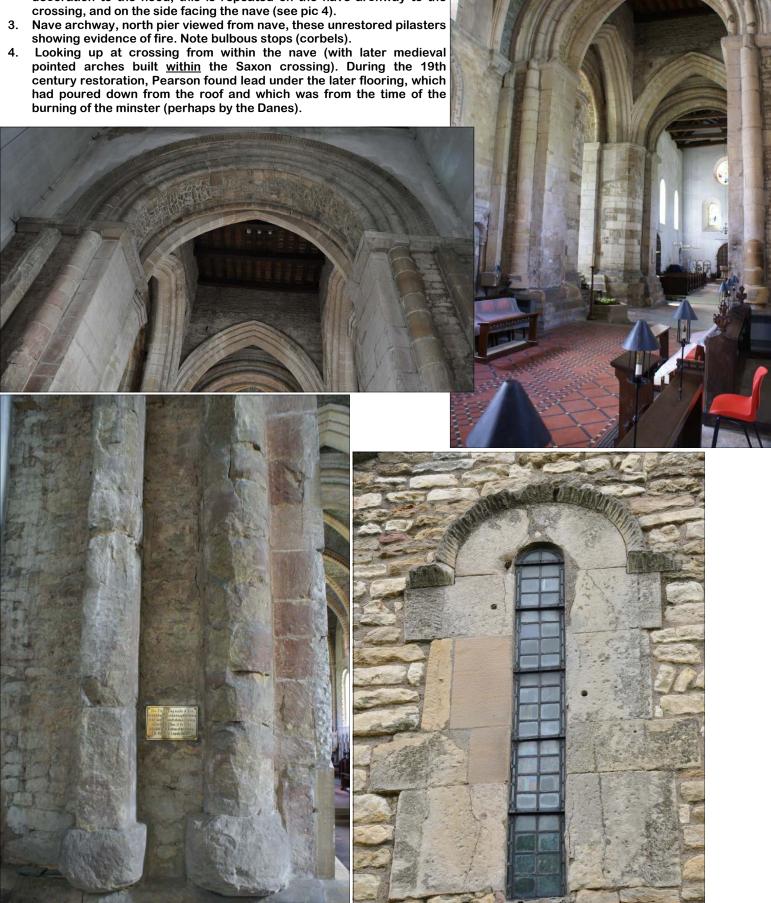
- 1. Chancel arch, from the east.
- 2. The Saxon window in south wall of S. transept, note the 'palmette' decoration to the hood, this is repeated on the nave archway to the crossing, and on the side facing the nave (see pic 4).

- 11. The nave archway (southern impost), viewed from the nave and showing the delicate 'palmette' decoration, and which can also be found to the head of the Saxon window in the south wall of S. transept.
- 12. NE corner of tower, quoins seen rising and built in 'cut back' style: note its plinth. Note also the Norman chancel with contrasting smaller fine ashlar, and accompanying plinth, all abutting the earlier work and running out to the left of picture.
- 13. The SE corner of the tower seen rising to the eaves with a fine example of 'cut back' quoins reaching to within 6 stones of eave level (where the style changes#), indicative of the tower being destroyed/badly damaged in the fire, and so rebuilt above that height.

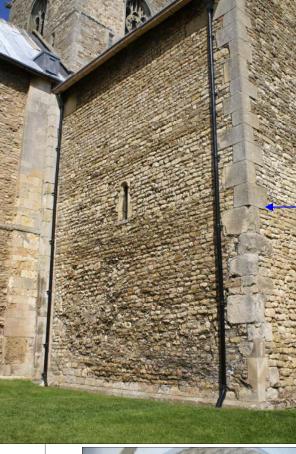
- 7. Saxon doorway in W wall of nth transept, viewed from interior, note typical non-radius stones in head.
- 8. The NE quoin, nth transept. Note again the older lower quoins and how they are cut back to receive plaster to butt up against that 'edge'.

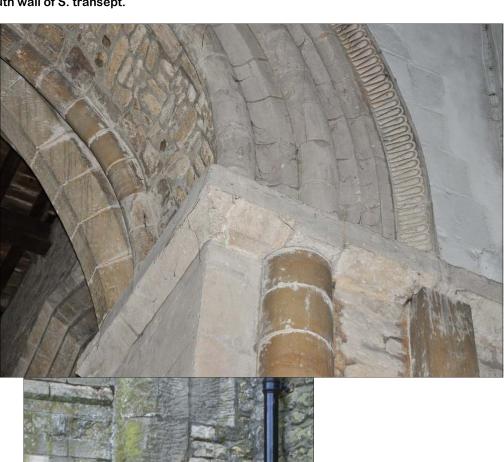
- 10. Detail of W part of archway to south transept, viewed from inside the transept. The various orders (above the imposts) belonging to all four crossing arches represent a later rebuild, the piers and pilasters below the imposts are from an earlier build. Presumably the damaged crossing and the burning belong to the same moment in time which occasioned the rebuild here (by Eadnoth?), as also the transepts above a certain level.

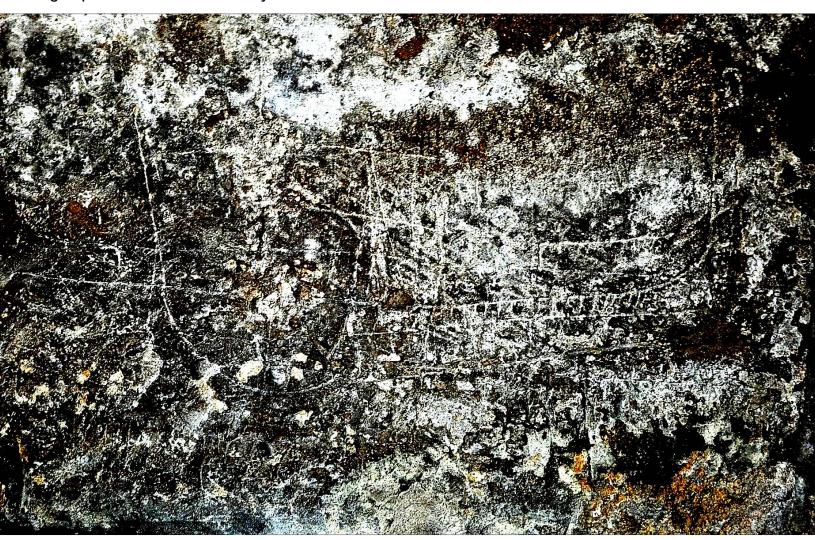
14. The incised 'graffiti' on the north face of the south pier of the chancel arch. This rare depiction is the earliest known example, a scratching of an oared "Viking" sailing ship, and may well date to foreign incursions at some point, probably in the 10th century. This graffiti exhibits excellent and intricate detail (note the vertical lines running below the gunwale) and would seem to indicate that the 'artist' was fully conversant with this ship and may well have been a crew member. This digital photo has been considerably enhanced.

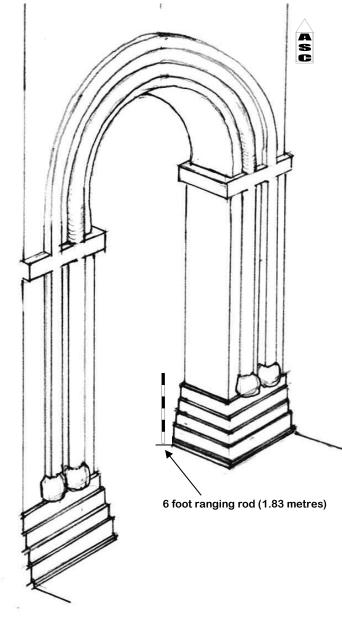
15. Line drawing of the nave archway viewed from the nave. This illustrates how it most probably looked as built and before the damage from the fire which took down the roofs. The tower and four semicircular arches were doubtless in such a badly damaged state that they were taken down (above impost level), and the arches were rebuilt in a more mature style with the multiplicity of mouldings we see today. In the drawing we see the vertical pilasters continued above, and springing from, the imposts. Note the imposts are drawn 'box' section, as at Brigstock. When the archways were rebuilt it seems the imposts were refashioned with the characteristic chamfer of that later date. There is evidence on them for this refashioning since the chamfer makes an awkward and contrived junction with the pilaster strips below, whereas a box section would suit the original scheme perfectly. It is immediately obvious upon viewing the previous photos (see 4, 10 & 11) that the mature style of the semi-circular archways, consisting of several orders, do not match or marry with the work below. Dr. H.Taylor noted this on page 590 in Vol II of his "Anglo-Saxon Architecture". The pilaster strips spring from great corbels which are set in the wall above the tall plinths upon which the jambs rest. Those pilaster strips that were not restored in the 19th century plainly show signs of having been subjected to considerable heat. However, this seems not to be general, there are differing areas of the cherry colour of the stonework on the arches and perhaps it depended upon how intensive was the heat of the burning timber roofing when it collapsed, and where it fell. Although the (Victorian) restoration has muddied the waters to a certain extent, the stonework belonging to that work has a uniform darker hue. H.Taylor noted that " . . the several churches which have arches outlined by double patterns of pilasters and hoodmouldings all have the same arrangements of a half-round next to the arch and a square one outside it." Taylor also notes that "The round arches which carry the walls of the original crossing are by far the tallest and widest that survive in a cruciform pre-Conquest church. and the fact that all four have survived is a wonderful testimonial to the quality of the workmanship." Taylor gives the arch dimensions as approximately 33 feet by 14 feet, all four arches being identical. See previous page for readings taken with up to date digital equipment. Most probably originally here at Stow, as extant at Brigstock, where

the single pilaster is of a square section, it is seen to change shape as it springs from the impost to continue above as a hood-mould and receiving the finishing touch of a chamfer upon its outside face. It would be the correct convention for a hood-mould. It is a little difficult to convey this in drawing 15 so a section taken at the apex of the archway may be seen in drawing 16 and which for clarity of this point. The plinths upon which the walling rests are of 5 orders, the bottom order being of square section and the upper four are chamfered. There is insufficient space here to elaborate at length upon the vicissitudes that this church has suffered, but suffice to say that parts of these plinths were buried as the floors were raised. The Rev'd G. Atkinson (who was Rector at Stow during the 19th century restoration) made detailed notes which included the observation that the original floor in the area of the crossing and transepts was composed of a kind of plaster. Between that and the Norman floor was a considerable amount of charred debris amongst which he found lead that had

Crossing archway dimensions.

Referring to the text on the next page, dimensions taken with laser measuring equipment. Date May 2011.

H1 is the height to the (underside) crown of the arch. H2 is the height to the underside of the impost. W is the width between jambs. T is the thickness of the walling of the archway jambs.

Mean dimensions (M) represent the average of the 4 crossing archways.

(M) - H1 is 9.63 metres (31 ft 6 inches). H2 is 6.754 metres (22 ft 2 inches). W is 4.375 metres (14 ft 4 inches). T is 1.34 metres (4 ft 5 inches).

Nave archway H1 is 9.6 metres. Chancel H1 is the highest measured at 9.74 metres (31 ft 10.75 inches).

Plinths belonging to the four archways. Height is 1.25 metres (49 inches). Width is 2.33 metres (91.6 inches).

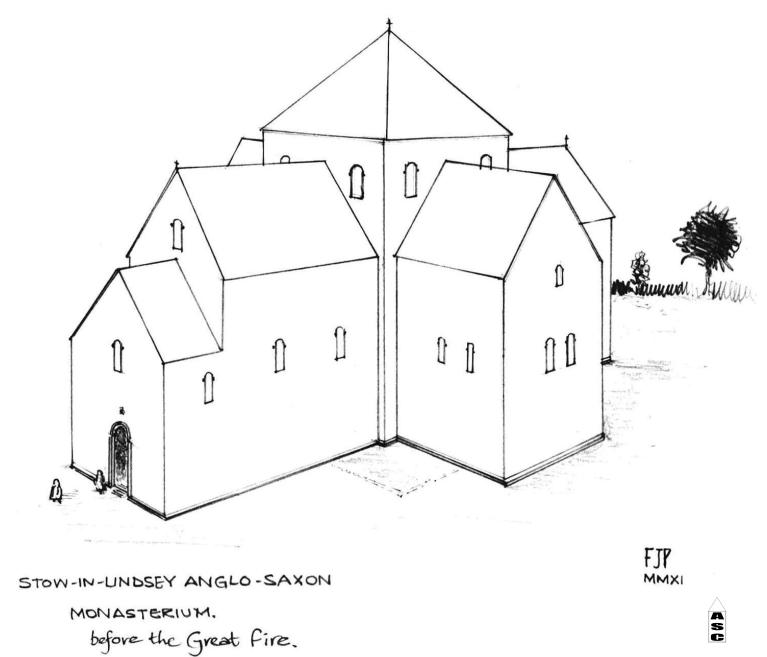
17. Viewed from the south-west, an impression of how the Minster church may have looked at a date just before the Great Fire. The only matter for conjecture is the length of the nave which I have assumed was somewhat short and finished at the west with a porch (which may have contained a rood). This presumably would be the second church on this site. The rebuilding, after the Great Fire, it is assumed was carried out by Bishop Eadnoth II (1034-1050). It may be useful to note here that a later rebuild was undertaken by Remigius (Wulfwig's successor) who installed Benedictine monks at Stow (before 1076). He found the church in a 'ruined condition and did much re-construction'. However, one should move with caution, the Normans were fond of 'blowing their own (political) trumpet.' In some cases blithe assumptions were often made later (which with the passage of time has stuck) where reference had been made to documents noting that such and such old (pre-conquest) church was demolished and built anew. Propaganda is not a recent beast, it was alive and well in the days following 1066; care should be exercised not to repeat it. At Stow it would be realistic to say that work by Eadnoth had encompassed reconstruction of the upper part of the crossing (witness the beautifully rebuilt tower arches), the transepts (new quoins/fabric above about 10 feet) and quite possibly the (short) chancel, but that work had stalled on the nave. Work on the latter is generally attributed to Remigius (or Remigus) de Fécamp, who died 7th May 1092. The new chancel is attributed to Bishop Alexander (died Feb 1148).

Referring to H.Taylor's text on page 593 of Vol II of "Anglo-Saxon Architecture", he gives the thickness of the crossing walls as 4 ft 6 in, the side walls of the transepts as 2 ft 6 in and about 33 feet tall.
