Church of St Andrew, Greensted, Essex.

The timber nave is thought to date to the second half of the 10th, or the first half of the 11th century.

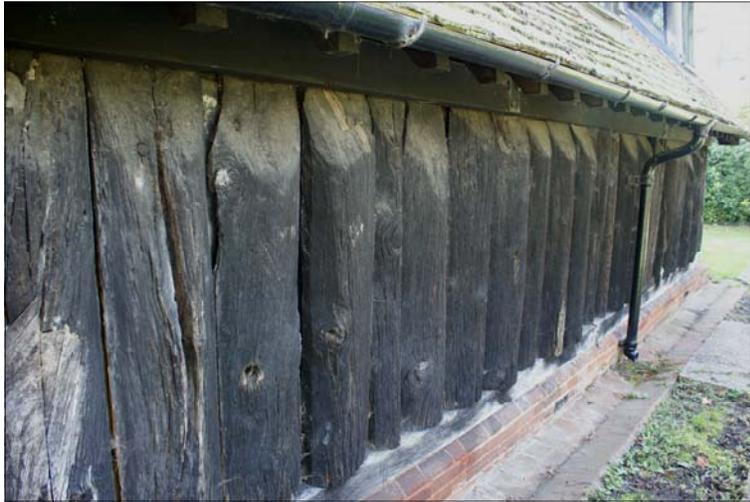
1. The church from the south.
2. Detail top of uprights (N wall nave) with roof plate running across top of picture.
3. Detail, this picture is of S wall.
4. NE corner of nave.
5. The run of the N wall nave, truncated at the base (standing on the brick plinth of 1848).
