## The church of St Mary, Reculver, Kent.

*The wanton demolition in 1805 of St. Mary's church, on the north coast of Kent between Herne Bay and Margate, was an act of vandalism for which there can be few parallels even in the blackest records of the nineteenth century.* So wrote H.Taylor in his book (vol II. page 503) "Anglo-Saxon Architecture". The Anglo-Saxon Chronicle records that in 669 King Egbert of Kent gave Reculver to Bassa the priest to build a minster there. Leland stated, in about 1540, that the sea was a quarter of a mile or so to the north. The houses and village street within the Roman fort have now gone and the church in places stands barely a few yards away from the cliff edge. Mr.Nailor, the vicar, was persuaded by his mother to take the church down (1805). The two (Norman) west towers remain, with much walling of various heights despite the nave walls with its associated Transitional arcading having in the main vanished. Importantly, the two columns and capitals of the triple chancel arch (arcade) remain, safely housed in the crypt in Canterbury cathedral, having been rescued from an orchard near Canterbury by a Mr.Sheppard in 1860. More detail can be found on t

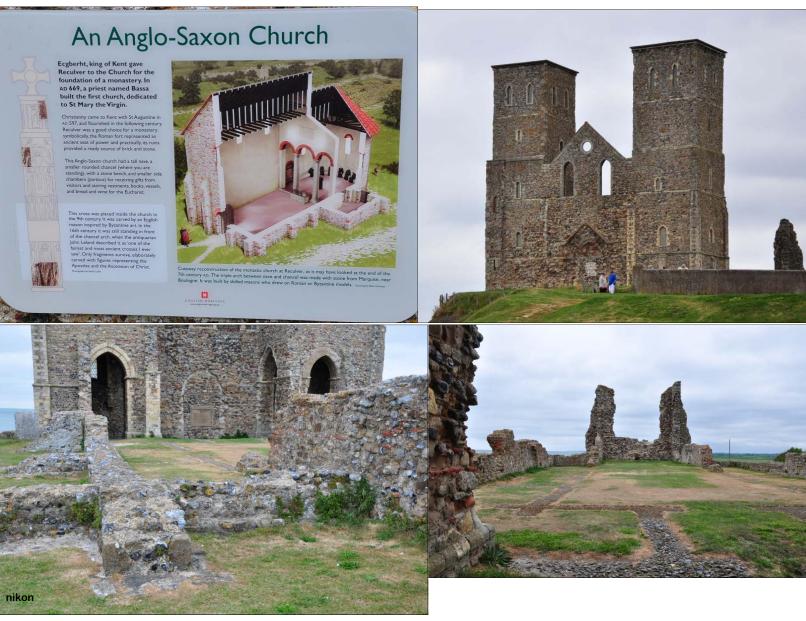
- 1. The information plaque for visitors to the site.
- 2. The church seen from the south-west.
- 3. Inside the church looking eastwards. Note the foundations of the nave in outline on the ground.
- 4. Looking westwards, the run of the south 'aisle' to the left with the nave and chancel wall standing higher to the right. In the distance the two west towers seen rising, with the their fine Transitional arches.

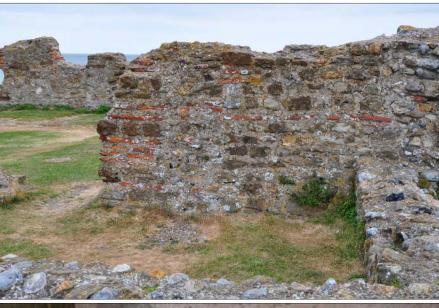
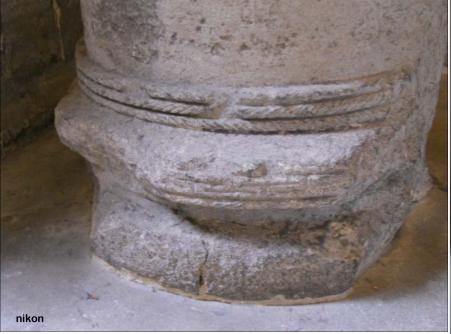
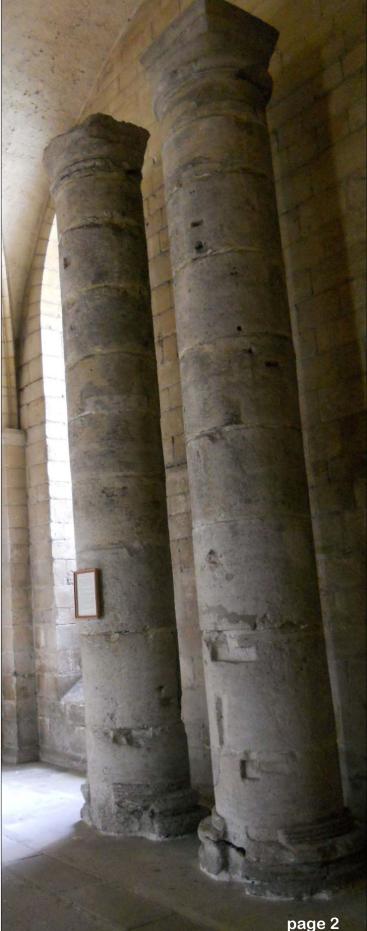
5. The walling at the junction of chancel and nave, viewed from the north.

6. The two columns, which each consist of nine cylindrical stones, belonging to the triple chancel arcade, now situate in the crypt of Canterbury cathedral. The capitals each consist of a triple fillet beneath three superimposed bevelled members. The columns taper in diameter from 2 ft 3 in. at the base

to 1 ft 11 in. at the top. 7. The base of the left hand column seen in picture 6. Note the three boldly projecting rings of intricate cable moulding, and again a ring repeating below the 'squared' design running round nearer the base.

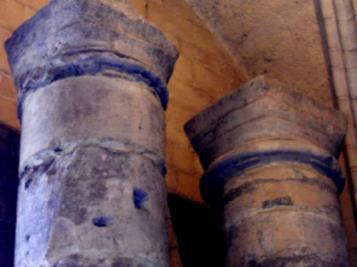
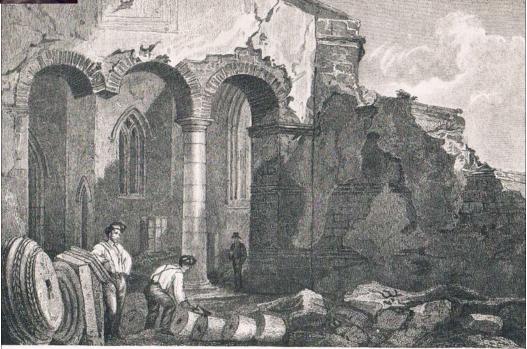
- 8. The two columns shown on previous page; the capitals, as described in previously.
- 9. An old print showing the demolition of the church and in particular the triple arcade.
- 10. An illustrated plaque on site with view of the church showing the apse, side aisles and roof cut-away to show the triple arcade.

The careful excavation in 1927 by Peers showed a rectangular nave and an apsidal chancel from which doorways led to small rectangular north and south porticus. The similarity of plan and of workmanship to that of other early Kentish

churches convinced Peers that this was indeed the church erected by Bassa in 669. The nave had external doorways in its west, north, and south walls; and, as was known from the picture published by Mr.C.R.Smith, it was divided from the chancel by an arcade of 3 round columns. Peers confirmed Dowker's earlier report of the sleeper wall which supported these columns and of the square responds of walling which carried the outer ends of the arches. On excavating the apse he found it was polygonal, of seven sides, and internally semi-circular, the inner face having a low stone bench running along most of its length. The doorways accessing the chancel from the porticus were thought to have had their jambs originally lined with upright stone slabs (the device of lining the jambs with slabs of stone may be compared with the existing work at Britford in Wiltshire). The porticus were soon lengthened by carrying their external walls to the west and beyond the west wall of the nave and returning them so as to enclose the nave on the north, south and west within a line of flanking chambers while at
