## Abbey church of St Mary, Sherborne, Dorset.

A fine building of seemingly Perpendicular style, but where the fabric under the later coverings is of a far greater age (see dedicated text page for detailed information).

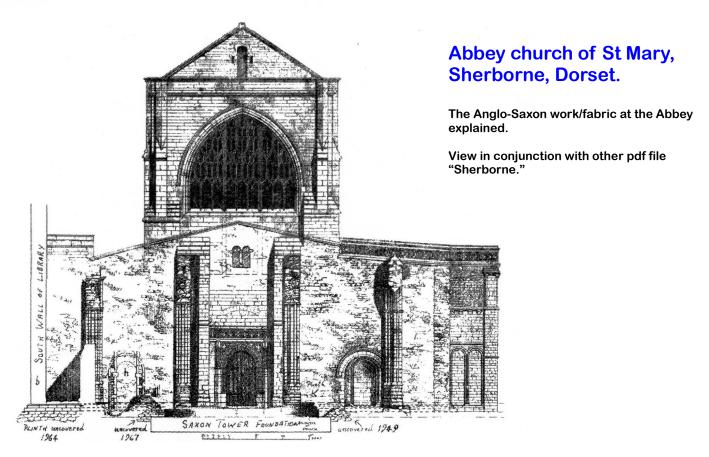
Above. West elevation of St. Mary's Abbey (as in 1845), preserving the east wall of the Anglo-Saxon westwerken and its porticus. Note the two-light window and blocked round-headed doorways (Gibb 1969).

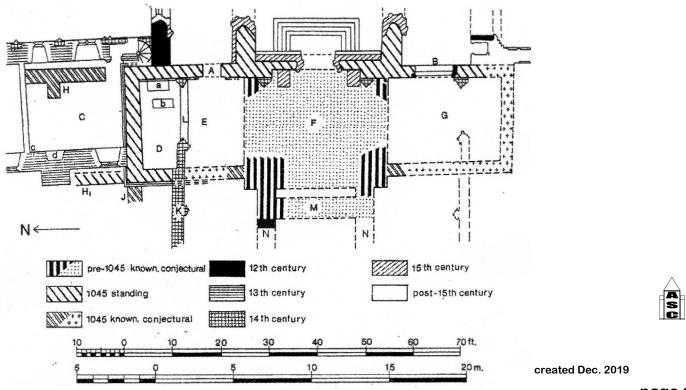
Below. The archaeological evidence. Excavation plan of the tower at the west end of the cathedral (Gibb 1975-76.

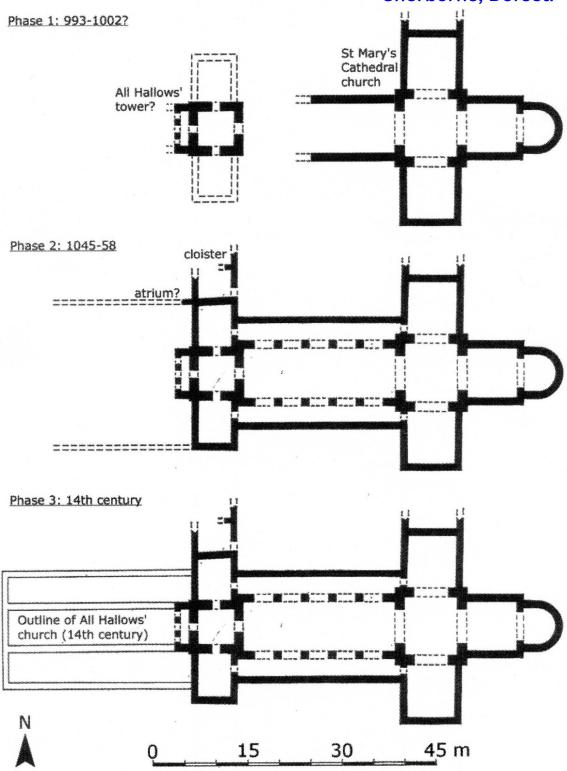
Above. Suggested development of the Anglo-Saxon cathedral (modified from Gibb 1975, 99).

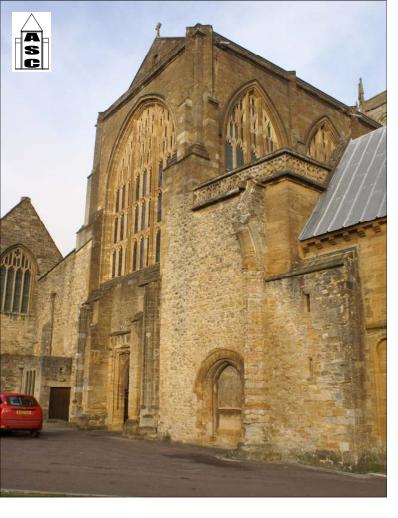
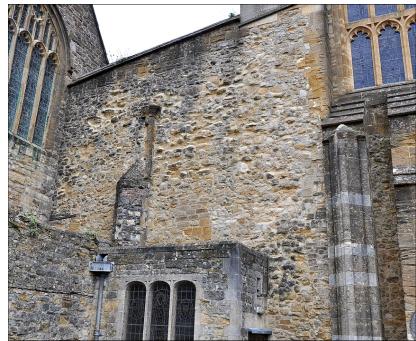
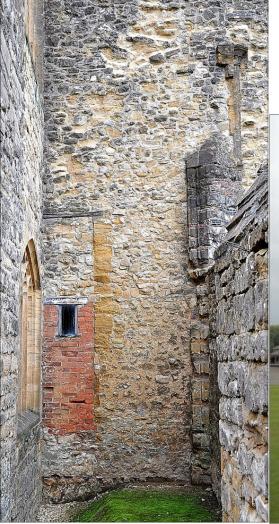
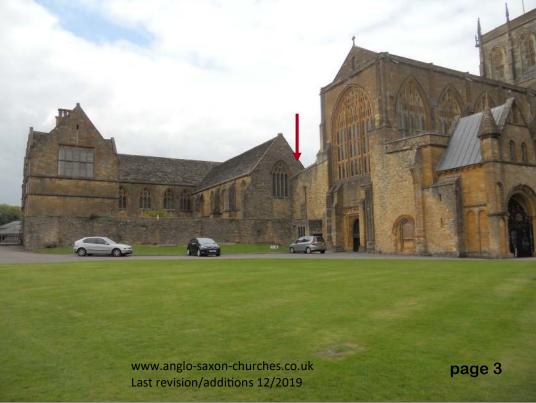
Pictures this page viewed clockwise from top left -

- The west front and the site of the Saxon westwerken, from the SW; the 'uneven' rubble work is the Saxon walling, which is extensive (see H.Taylor). Saxon work is also to be found in the N wall of the N transept up to eave level (not illustrated).
- 2. A closer detail of part of the north aisle/porticus from the west.
- 3. A general view from the SW with some of the Abbey buildings to the left (now a part of the adjoining school).
- Run of the west wall of the north porticus (standing 1045), the left -hand corner abuts an Abbey building now in use by the adjoining school as a Library (and see red arrow in previous picture for location).
