Minster Church of St. Cuthburga, Wimborne Minster, Dorset.

St. Cuthburga, Wimborne Minster.

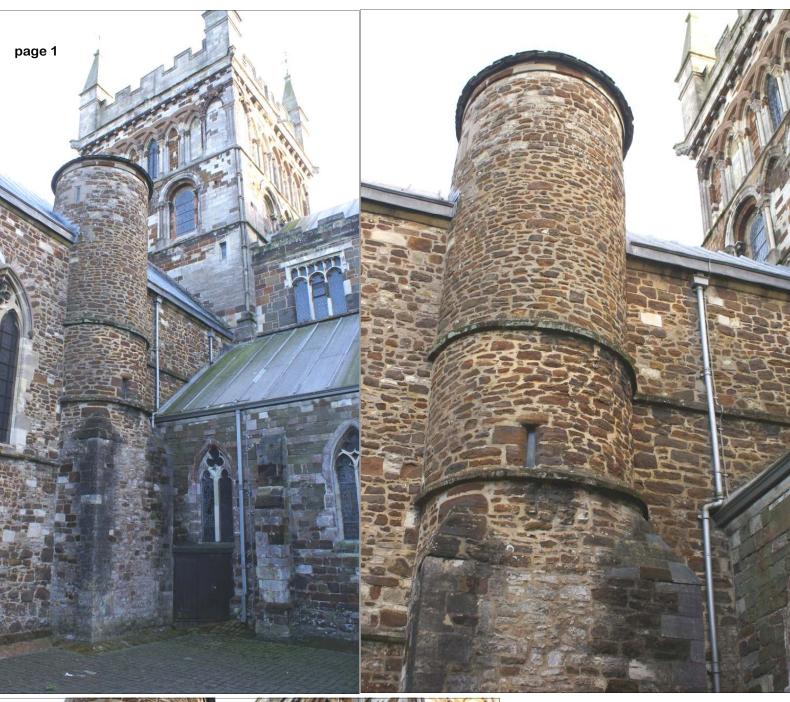
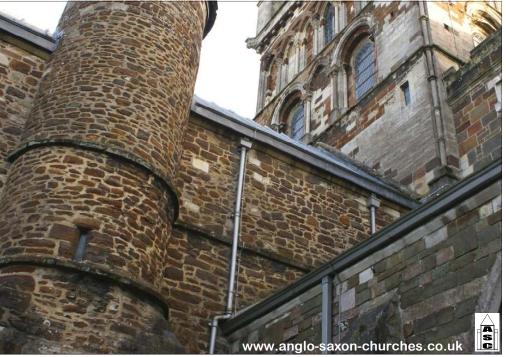
- Late Anglo-Saxon stair turret, west wall of N transept.
- 2. A closer view of the turret and its stringcourses. Note the random coursed Saxon walling of the turret and transept which is quite different to the central tower (which raised/cased in Norman times).
- Note that the four abutments to the tower are less than the width of the central tower, a Saxon trait (and not found in postconquest fabric).

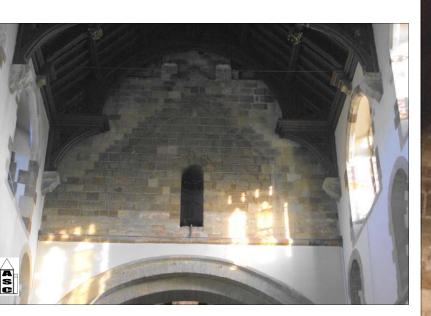
- 7. Viewed from the nave, the west wall of the tower has an elevated doorway sited over the inserted Norman nave arch and which would have perhaps given access to a gallery, or a floor over (part of) the nave, in a similar manner to the earlier church of St. Marys at Deerhurst. The archway consists of vousoirs some of which are non-radial, indeed as does its sister doorway in the east wall of the tower. It is possible these archways remain from the Anglo-Saxon build although the (rebuilt) interior face of the tower exhibits a post-conquest (Norman) arcade on all four faces. A similar doorway is to be found in the north wall of the tower (north face), having climbed the north transept circular stairway. This elevated north doorway today still gives the only access to the tower at that higher level, and that extant north doorway would seem to indicate that the pre-conquest fabric remains to that height today. There is a stringcourse some few feet or so below that north doorway and which matches exactly the section of the various stringcourses found externally on the transept walls and stairway turret.

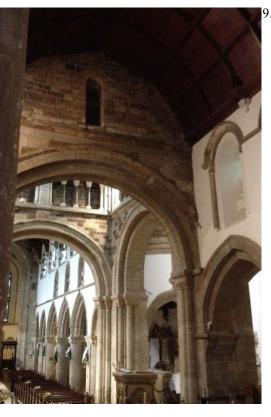
- The sister doorway sited over the chancel archway, and which also sits over a stringcourse of identical size/section as the other pre-conquest stringcourses.

A general view of elevated the chancel doorway seen in the previous photograph. In the case of both nave and chancel the roof line/ original pitch can be seen as a 'mark' on the stonework of the tower walling. This

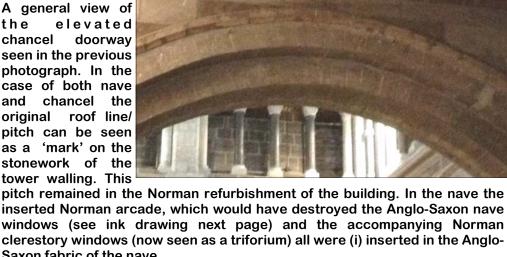
inserted Norman arcade, which would have destroyed the Anglo-Saxon nave windows (see ink drawing next page) and the accompanying Norman clerestory windows (now seen as a triforium) all were (i) inserted in the Anglo-Saxon fabric of the nave.

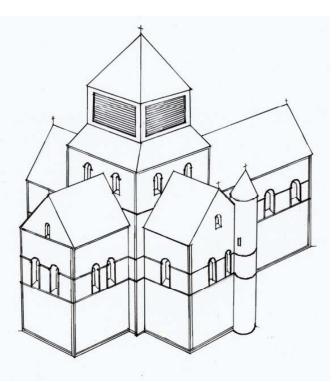
Left below. A birds eye view of the Saxon church seen from the north-east, the north transept visible with its (extant) stair turret, as the church may have appeared in the late Saxon period. The two stringcourses which run round the turret when extended along the nave and transept walls clearly make more sense where the lower is the springing for windows set in the walls at intervals. A higher (third) stringcourse belonging to the tower still remains today and may be viewed from inside the north transept (having ascended the turret stairs). This stringcourse has been removed outside when the tower was refurbished in Norman times but appears here and set below the elevated north doorway in the tower which today gives access to the tower proper. All four doorways remain at this level and all exhibit non-radial vousoirs in the head. Naturally the capping of the tower is a feature that is now totally lost but I have given it a timber 'roof' of the type that Breamore still has to this day and which houses bells (and which were often cast in situ in the churchyard), a common feature of Anglo-Saxon churches

Pencil sketch bottom right. I have included this pencil sketch, which I made in the late 1960's; it is a view of how the church may have appeared after the Norman refurbishment (viewed from the north-east). It shows the old north Saxon transept with its turret, and the top two stages of the tower as rebuilt by the Normans, in fact as it appears today but without the fenestrations which were built after the fall of the spire in the 16th century. Just worth considering whether the top stage to the tower (with its finely executed interlaced arcades) is a slightly later date than that below, much in the manner where towers were often raised when funds permitted. The eastern apses are a possibility and remain to be proved (or disproved) by excavation. The Norman clerestory windows in the nave still exist today and can be seen 'hidden' under the aisle roofs and now serve as a triforium on both south and north sides.

A note about the Saxon north turret: it is very probable that the stairs led to a floor, or at least a part floor, over the north transept, and which would have been used as a chapel with an altar, this being quite normal in Saxon times. Monks (or in the case of Wimborne, nuns) would then have held services and prayers in small groups and the different levels and 'rooms' inside a church enabled separate devotions to be held independent of each other. Deerhurst is a case in point with its doorways and windows on higher levels allied to the west tower and to the nave and leading and giving access to 'rooms' within the church and above the main body of the church. Now that these higher floors have disappeared 'mid air' doorways (where they exist), which lead nowhere, tend to look puzzling. In the case of Wimborne the Saxon turret stairs are now utilised to lead from the transept to the tower via a walk, to give access to the higher stages of the tower.

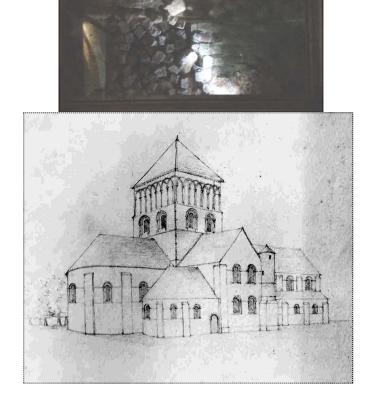
Right picture. Roman floor. Revealed some 10 inches beneath the present nave floor on the south side and some 15 feet from the tower, is a part of a Roman mosaic floor made of small tesserae. It is viewable and is protected beneath glass. In several known instances a room in a Roman villa was used for Christian worship and its use continued, developing into a building used as a church, such as at Rivenhall, Essex.
